PACK RUST IDENTIFICATION AND MITIGATION STRATEGIES FOR
STEEL BRIDGES

A Thesis

Purdue University

Patel, Chintan Hitesh M.S.C.E., Purdue University, December 2018. Pack Rust Identification and Mitigation Strategies for Steel Bridges. Major Professor: Mark D. Bowman.

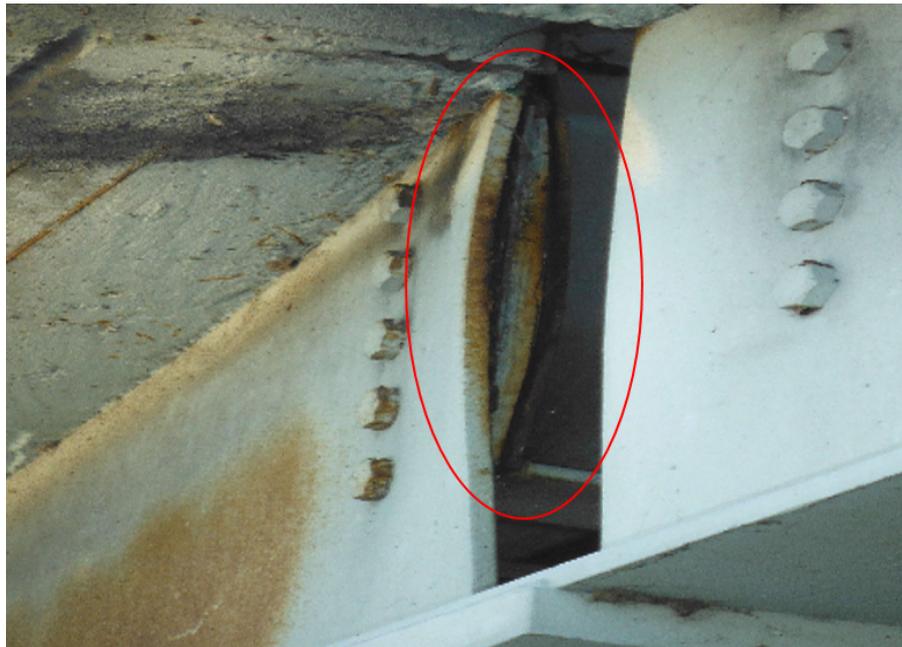
The expectation of pack rust occurrence in diaphragms was high because of the presence of deck joints above them, which are the entry point for the salt and water. At the end of the inspection process, the expectations were not met. The explanation for the lower number of occurrence is likely due to the limitation set by the quality and number of images present in the inspection reports.

Fig. 4.2. Most severe pack rust in the diaphragm found in Indiana

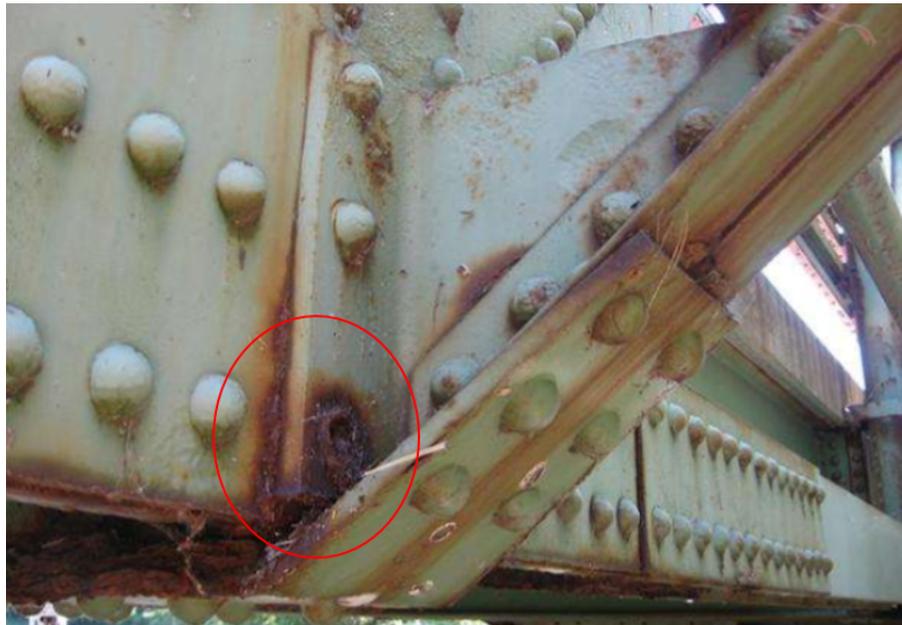
Pack rust in the gusset plates is seen in all the truss bridges. Most of the truss bridges in Indiana are relatively old, with nearly all built before the 1960s. The most common location where pack rust is observed are the connections in the lower cord of the truss. Figure 4.3 shows a missing rivet in the connection of the bottom chord of a truss bridge. There could be three likely scenarios for the failure of the rivet: first, the stresses in the rivet due to pack rust exceeded fracture strength of the rivet, or second the crevice corrosion led to significant section loss in the rivet causing it to fail, or third a combination of the first two. It is difficult to tell by looking at the image as to what could be the reason for the failure.

Fig. 4.3. Pack rust in the lower chord and gusset plate

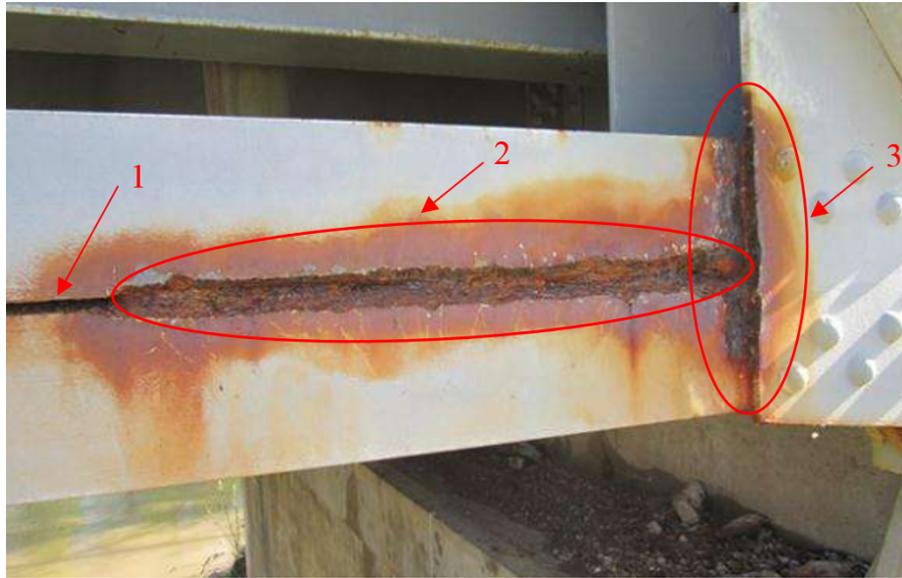
location 2 circled in the image. The second location is the connection between the gusset plate and the angle members is also affected by the pack rust marked as 3.

Fig. 4.4. Rivet failed due to pack rust

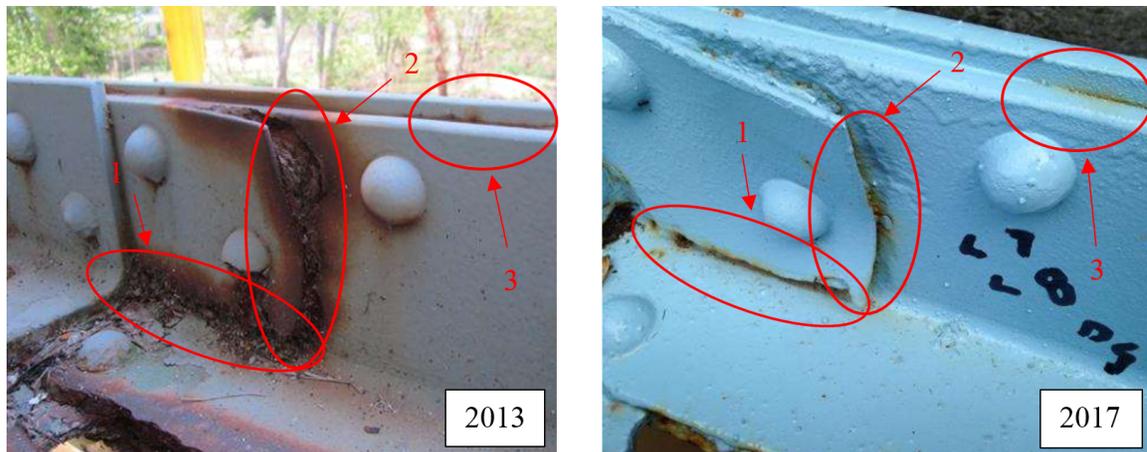
Figure 4.5 shows same connection detail after four years. The image on the left was taken in 2013, and the connection had severe pack rust causing section loss and bending of plate. The bridge was painted in 2016. The image on the right is of the same connection in 2017. From the post painting image it looks like some of the rust product has been removed but not completely. It is seen that just after one year of painting rust bleeding is visible at the locations 1, 2 and 3 marked in the Figure 4.5. There are chances that this is not an active corrosion. No field testing was conducted for this study.

Fig. 4.5. Pack rust in connections of the bottom chord

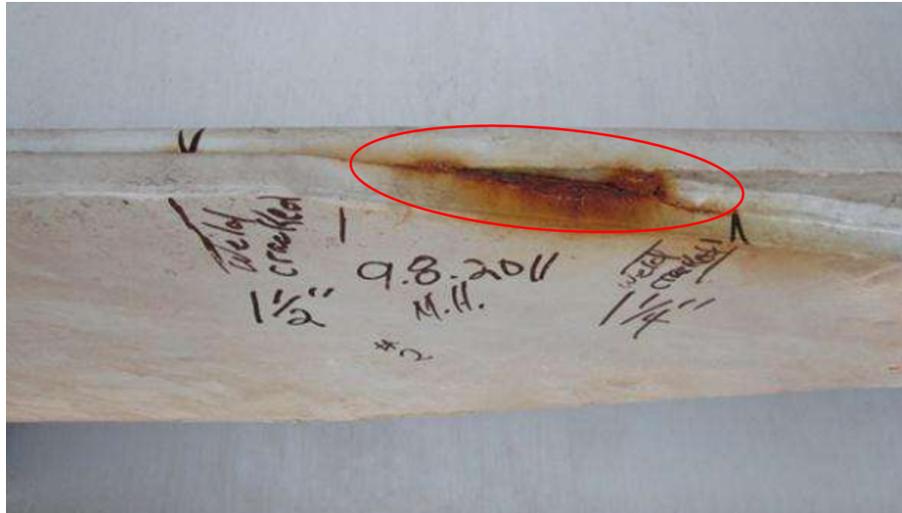
Fig. 4.6. Pack rust at the tapered location for wider cover plates (location 1)

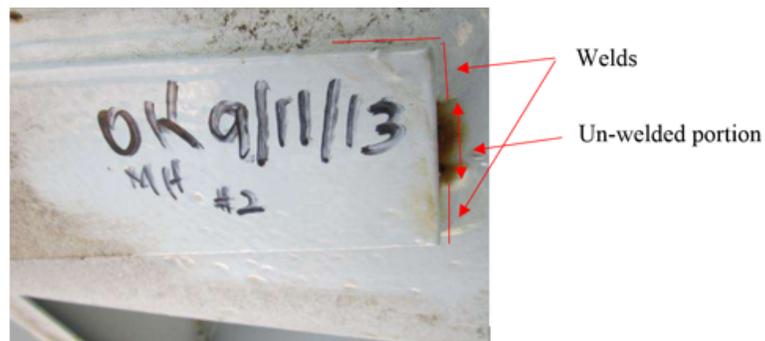
The growth of pack rust in this portion causes welds to crack. Due to the low level of lighting available when the photograph was taken the welds at the end are not clearly visible in Figure 4.8. Figure 4.8 shows a severe case of pack rust at the ends of the cover plate. The welds have cracked, and the cover plates have bent.

Fig. 4.7. Un-welded portion at the end of cover plate (location 2)

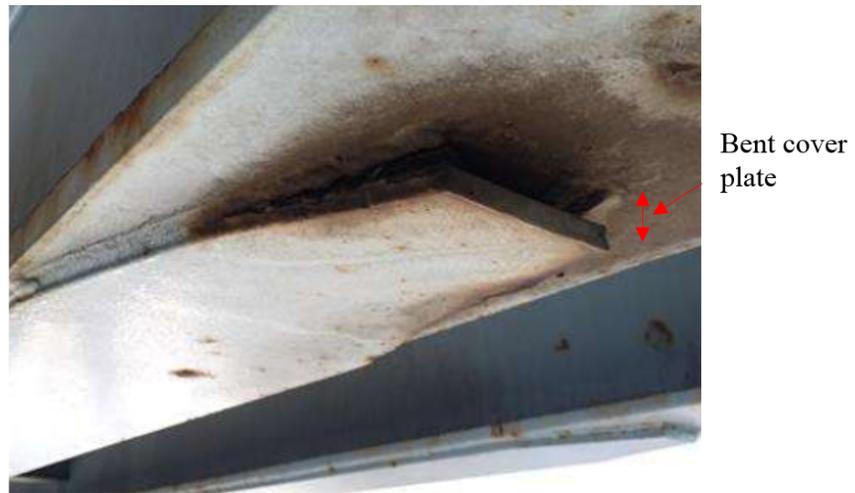
Fig. 4.8. Pack rust at the end of the cover plate (location 2)

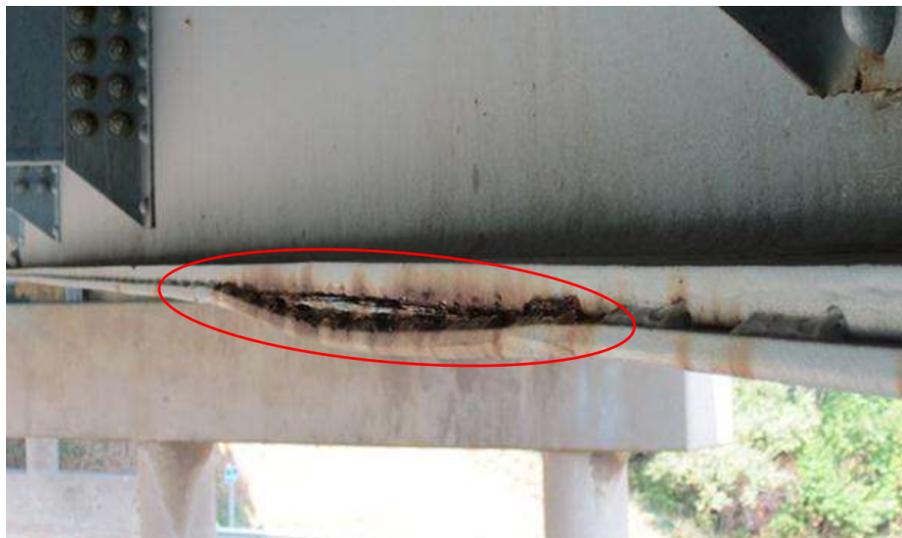
inside the crevice. Figure 4.9 shows bowing of the cover plate due to pack rust and failure of the welds.

Fig. 4.9. Non-continuous welds between the cover plate and bottom flange (location 3)

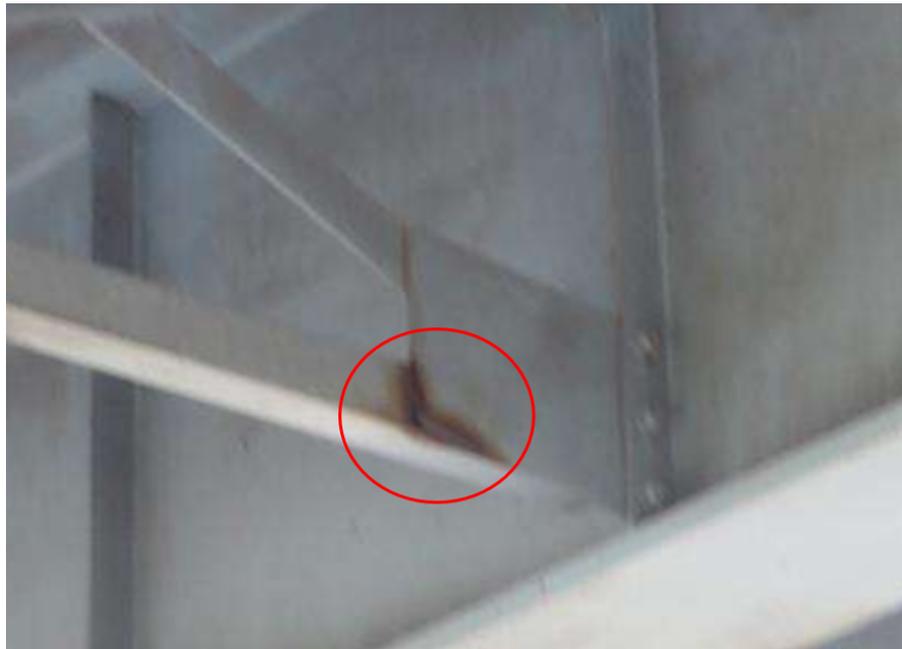
Figure 4.10 shows moderate corrosion between the cross-bracing members and the connection plate. The connection plate seems to have bent at the end due to the development of pack rust. A case was observed where the whole angle section came off and fell on the pier, as shown in the Figure 4.11. The welds undoubtedly cracked due to pack rust.

Fig. 4.10. Example of pack rust in cross bracing

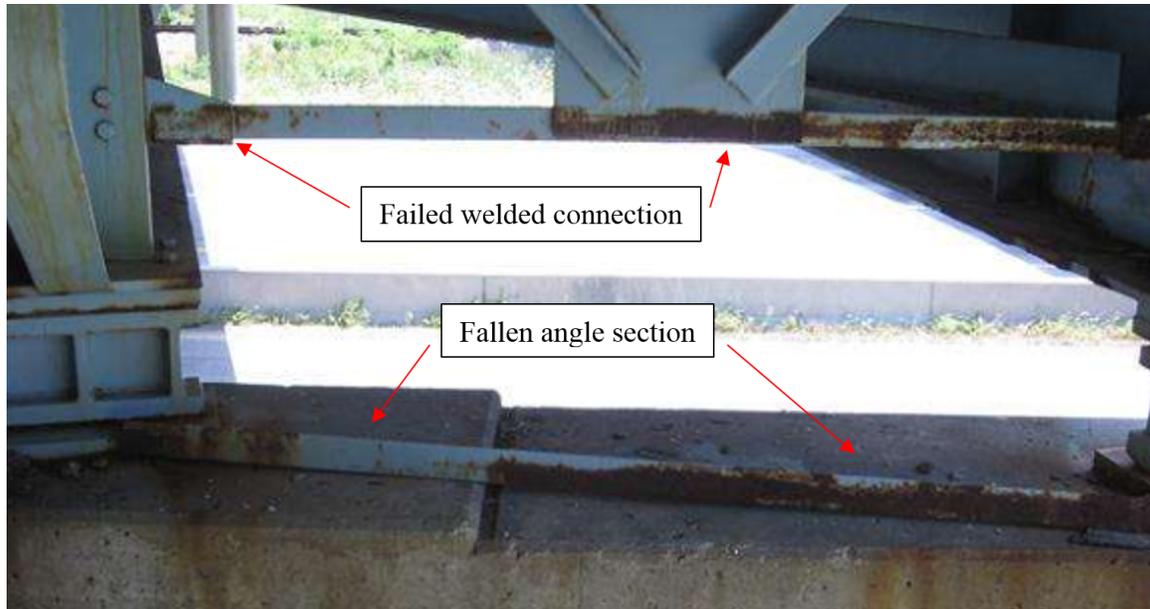
Fig. 4.11. Angle section fallen down because connection got failed due to pack rust

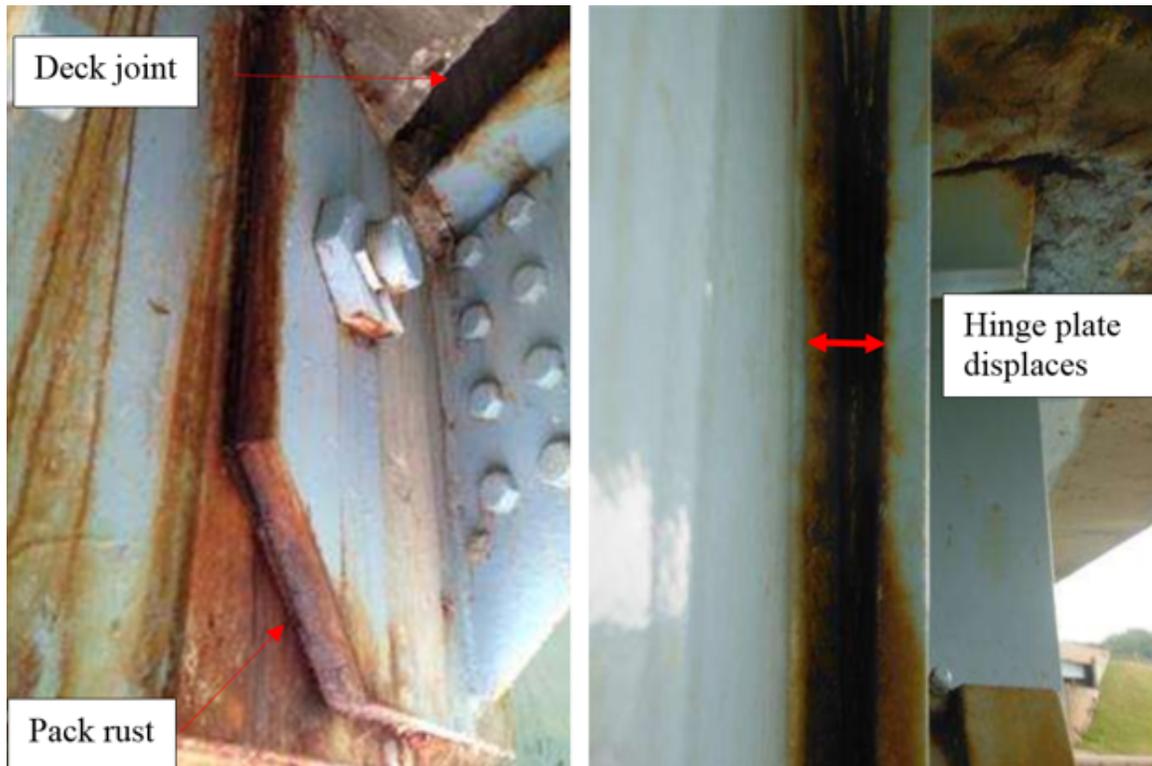
Hinge-pin connections are the details were observed to be highly prone to pack rust. Hinge-pin connections are located below the deck expansion joints as seen in Figure 4.12 and Figure 4.13 on the left. The water and salt from the deck flows down into the crevice formed between the hinge plate and the web of the girder. The formation of pack rust prevents the free rotation at the connection. Visual inspection does not give a clear picture of the extent to which the pins have rusted. Ultrasonic tests are required to find the amount of section loss in pins. Depending on the severity of the section loss of the pin, a severe decrease in the shear capacity could occur. Pack rust between the hinge plates and the girder web causes an out of plane bending of the hinge plate, and it also displaces the hinge plates as seen on the right of Figure 4.13. The out of plane bending will introduce eccentric loading onto the pins for which they are not designed. It was suspected that this was the reason for the collapse of the Minus River Bridge.

Fig. 4.13. Pack rust in the hinge-pin connection

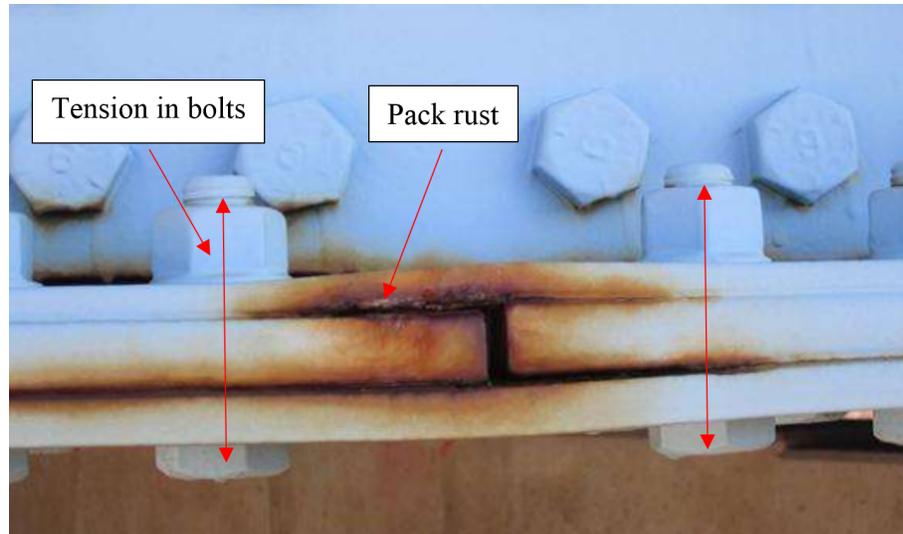
Fig. 4.14. Pack rust in the middle of the splice plate (location 1)

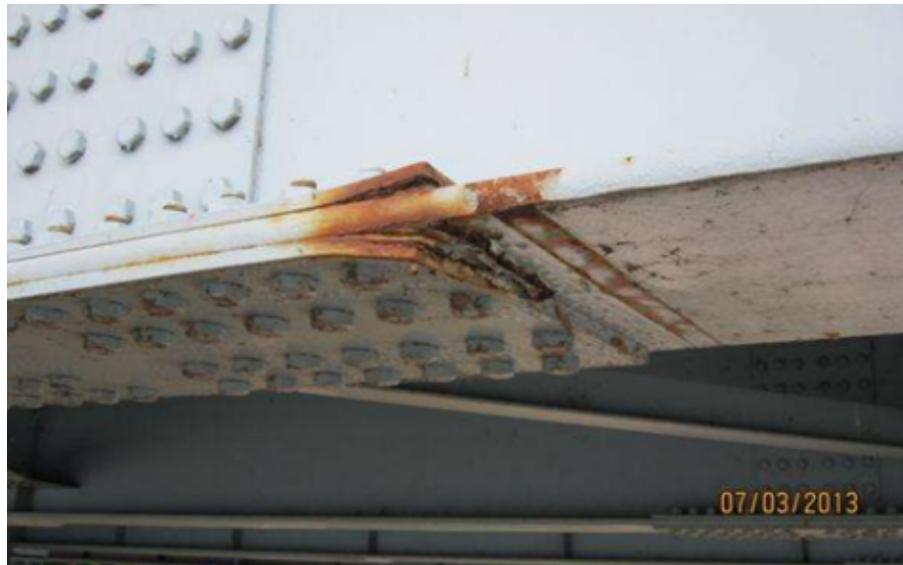
Figure 4.15 shows pack rust at the corner of the splice. There are two things to observe from the image; first, the bolts are arranged in a staggered pattern, and second, the splice plate is not very thick. The staggered pattern of bolts used in this case increases the distance between the nearest bolt and the corner. This causes a reduction in the clamping force at the corner. Reduced clamping force will cause a larger crevice height and thus allow easier entry of salt and water. If the arrangement

Fig. 4.15. Pack rust in the corners of the splice plate (location 2)

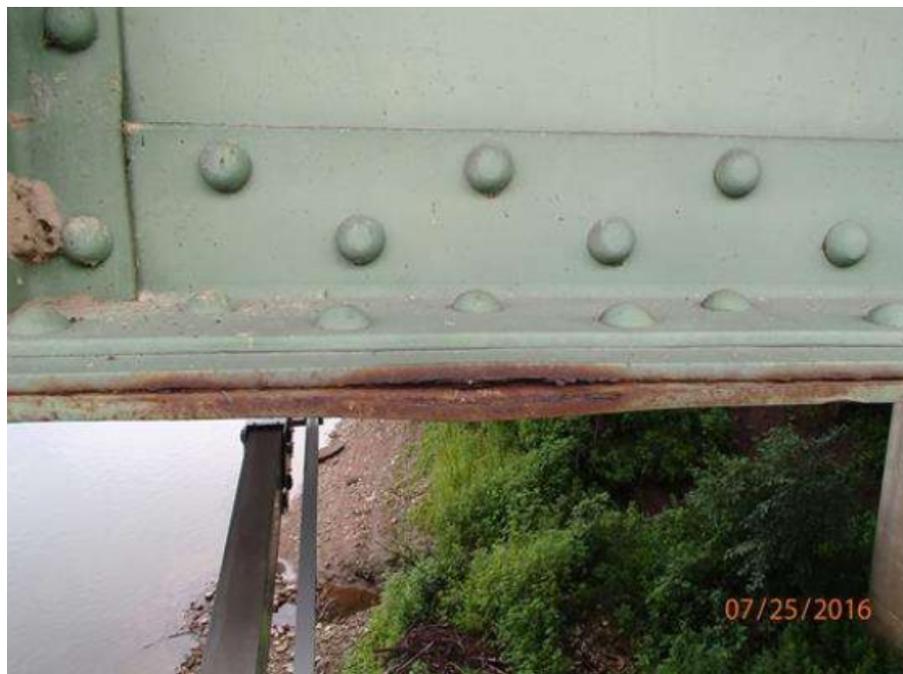
Figure 4.16 shows a built-up bridge girder. It has a staggered rivet arrangement. It is evident that at the locations where the rivet is positioned away from the edge, pack rust and rust bleeding is visible at those locations only. Figure 4.16 sets a clear example that edge distance does play a major role in preventing pack rust.

Fig. 4.16. Pack rust in the edges of the splices (location 3)

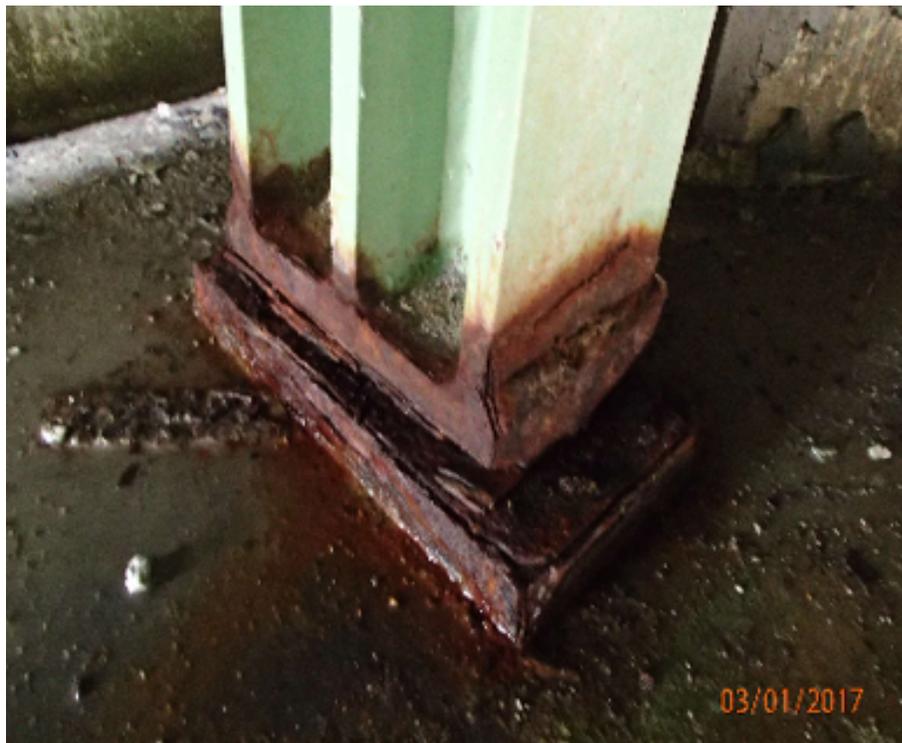
Figure 4.17 shows pack rust between the rocker bearings and the masonry plate. Figure 4.18 shows pack rust between the retainers and the sole plate. There are many cases where multiple shim plates are inserted between the sole plate and the beam/girder to adjust the height and make a fit. This leads to the formation of multiple crevices between shim plates and results in the formation of pack rust in these crevices.

Fig. 4.17. Pack rust in the rocker bearings

Even though pack rust in rocker bearings occur quite frequently, mitigating pack rust in rocker bearings is not a high priority since INDOT plans to eventually re-

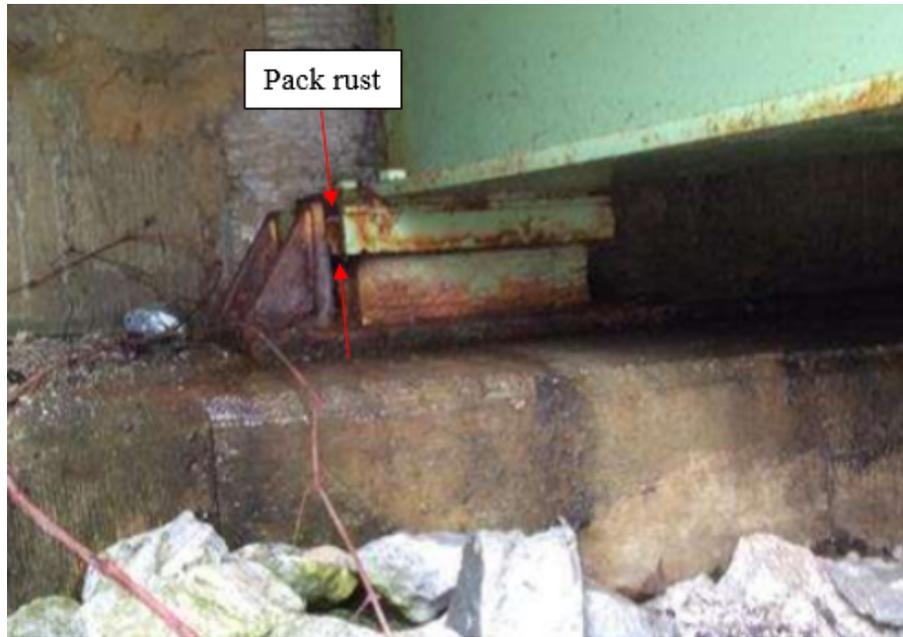
Fig. 4.18. Pack rust in elastomeric bearings

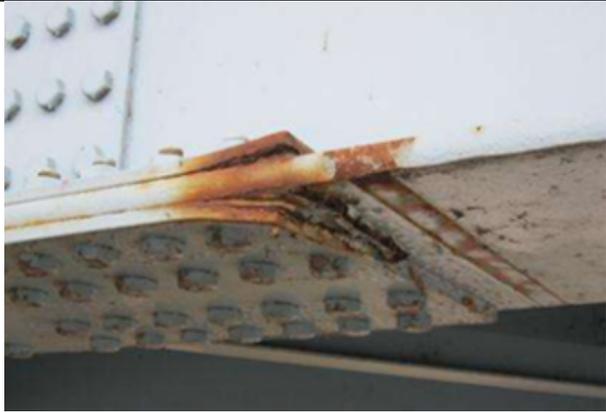
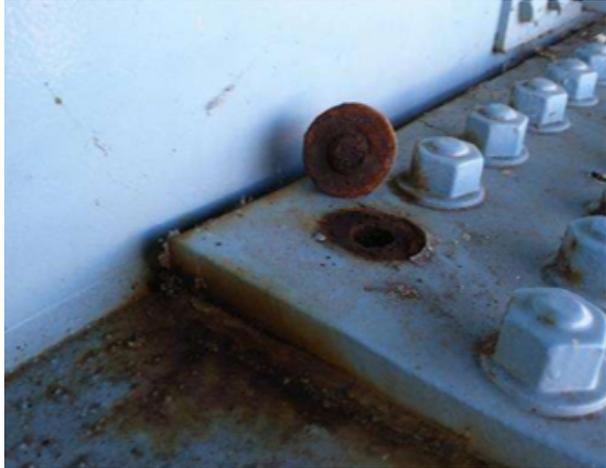
Pack Rust (PR) Severity Rating		
Rating	Description	Examples
1	Severe PR: >3/4 inch bowing of splices or bolt failure

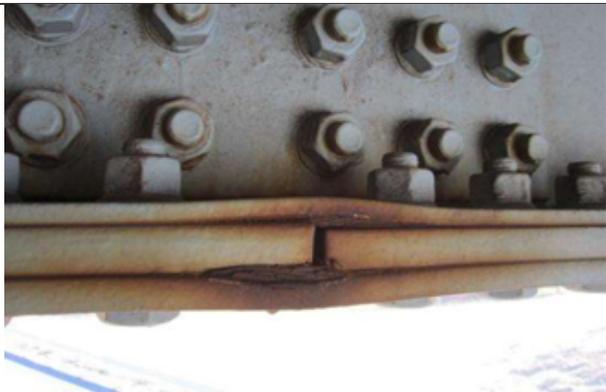
(c)
2	<p>Moderate to severe PR: 1/4 inch to 3/4 inch bowing of splice plates</p>

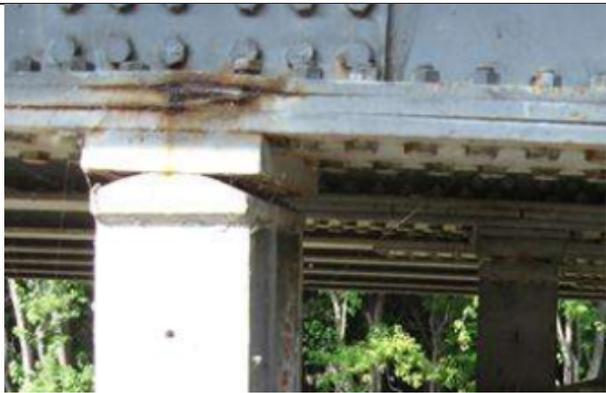
(d)
3	<p>Moderate PR: visible bowing of the splice plates, <1/4 inch</p>

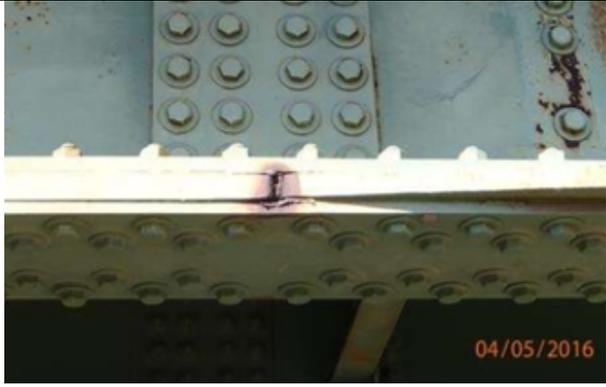
4	Minor to moderate PR: visible corrosion in middle, edges, or corners of the splice connection

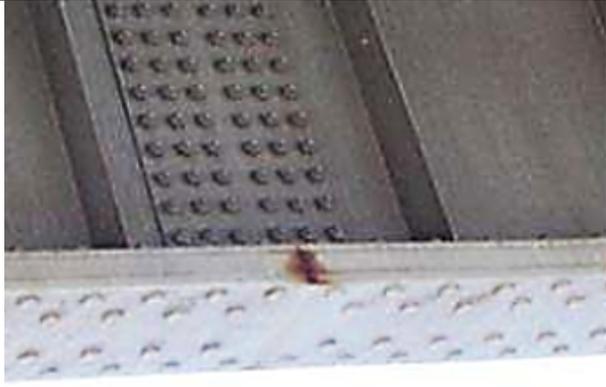
(f)
5	Minor PR: Rust bleeding in middle, edges, or corners of the splice connection
