AN UNMANNED AERIAL SYSTEMS EVALUATION CHAMBER FOR BRIDGE INSPECTION

A Thesis

Master of Science in Civil Engineering

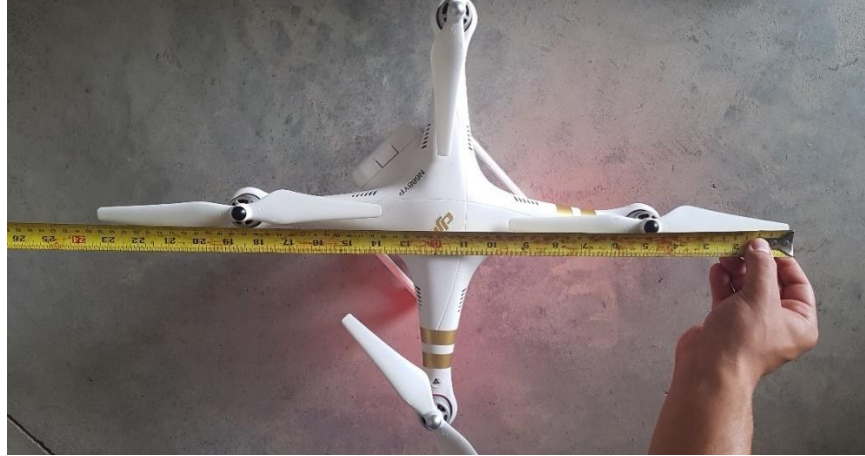
Zone 1 is delimited by a circumference formed by either the tips of the propellers, the rotor, the spherical shell or the element in the UAV that is located at the farthest from the center of the vehicle in the horizontal plane. The center of the circumference of Zone 1 effectively matches the center of the UAV. In most cases this measurement can be easily found by pointing two opposite propellers towards each other and drawing a circumference with center in the center of the UAV, as presented in Figure 3. For some UAVs, this could vary based on extra features added to the vehicle, such as a protection cage or propeller guards. In the absence of a protective cage around the UAV, Zone 1 is the zone in which collision with the UAV will result in the pilot almost certainly losing control of the vehicle since the rotor blades will inevitably be damaged or destroyed. This obviously represents a risk to the pilot or other elements in the nearby environment. This value is given for all the UAVs described in Table 2 as diagonal distance.

Figure 3 Process to measure Zone 1 around an UAV.

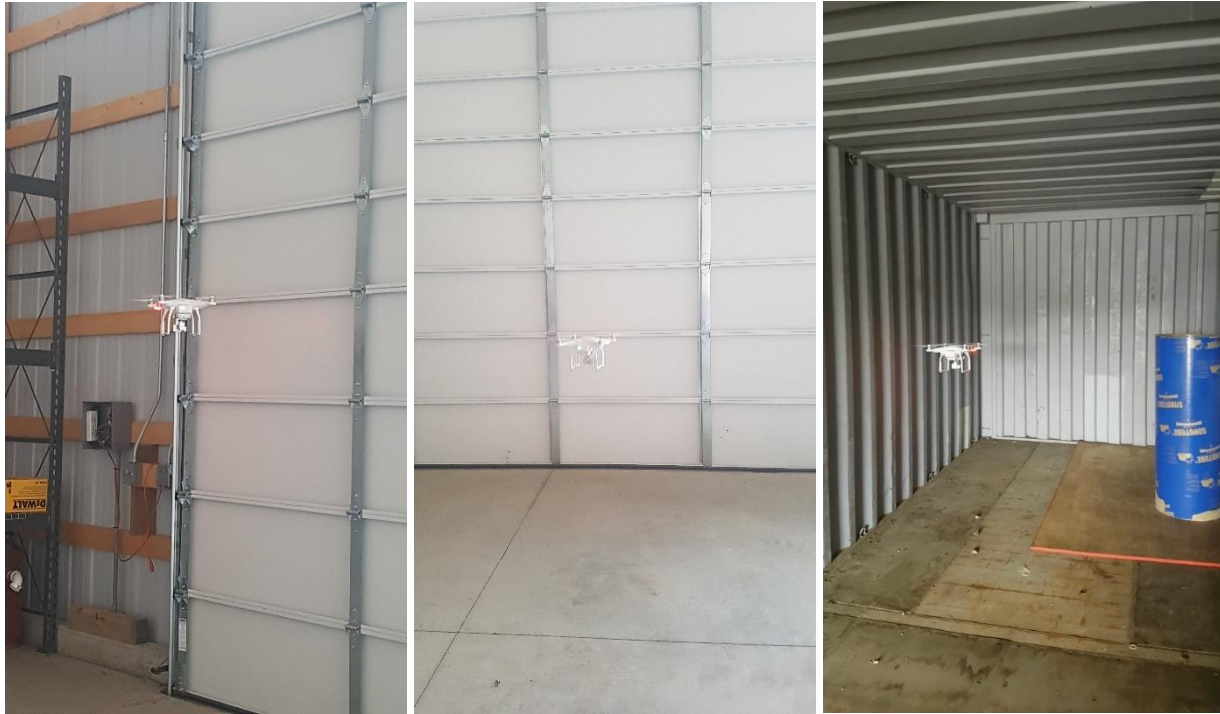
To estimate the distance of the surrounding effects (which are not related to ceiling or ground effects), a series of tests were performed by running flight tests with the UAV close to planar and circular elements, as presented in Figure 4. In the three images, the UAV flew from bottom to top of the elements, varying the distance to those elements for each flight.

Figure 4 Testing surrounding effects.

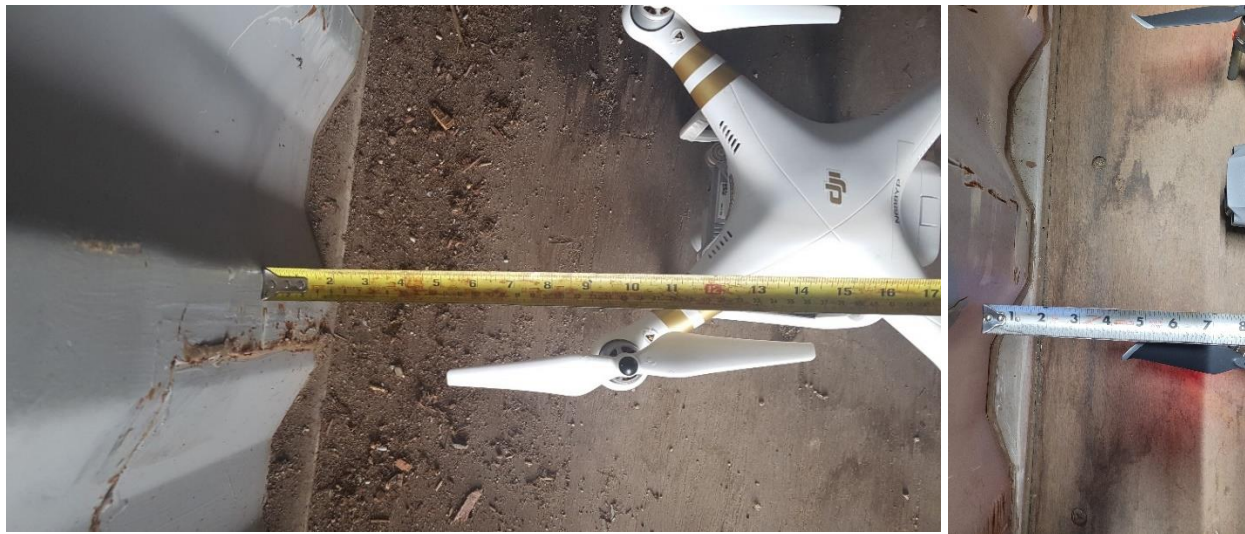
Finally, the same flights were performed to distances less than 6 inches. At this distance, the performance of the UAV began to be affected. Specifically, the UAV experienced “pull-out” and “pull-in” effects towards (or away) the side walls of the shed and the container. As expected, the effect was increased when the UAV took off or when flying closer to the roof. In order to isolate those effects from surrounding effect, several distances were evaluated only at the medium height of the walls. The distances recorded from the flights to test proximity effects were between 3 inches to 5 inches: 5 inches the distance where the effects started to affect the UAV, as presented in Figure 5; and 3 inches as the maximum approaching distance without compromising the integrity of the UAV, as presented in Figure 6.

Figure 5 Distance where UAV performance will start to be affected by surrounding effect: 5 inches.

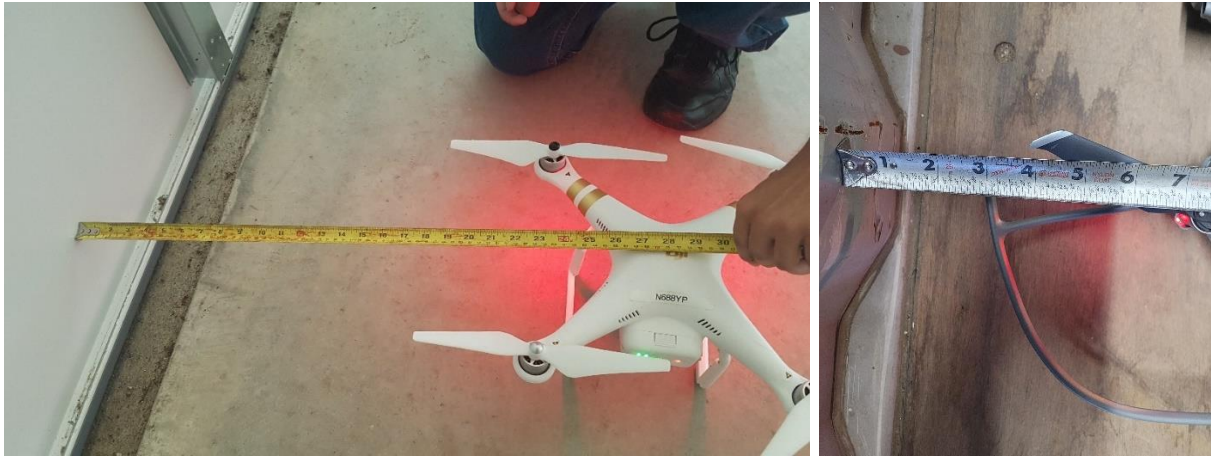
Figure 6 Delimitation of the end of Zone 2 around UAVs performed inside a shed and a cargo container at S-BRITE.

As a result, the clearance distance obtained in the three directions is added to the diameter of 2.5 feet (2 feet 6 inches or 30 inches) of the sphere around the assumed UAV in section 3.1.1 to account for proximity effects, obtaining the following possibilities of increase in Zone 1, giving as a result Zone 2:

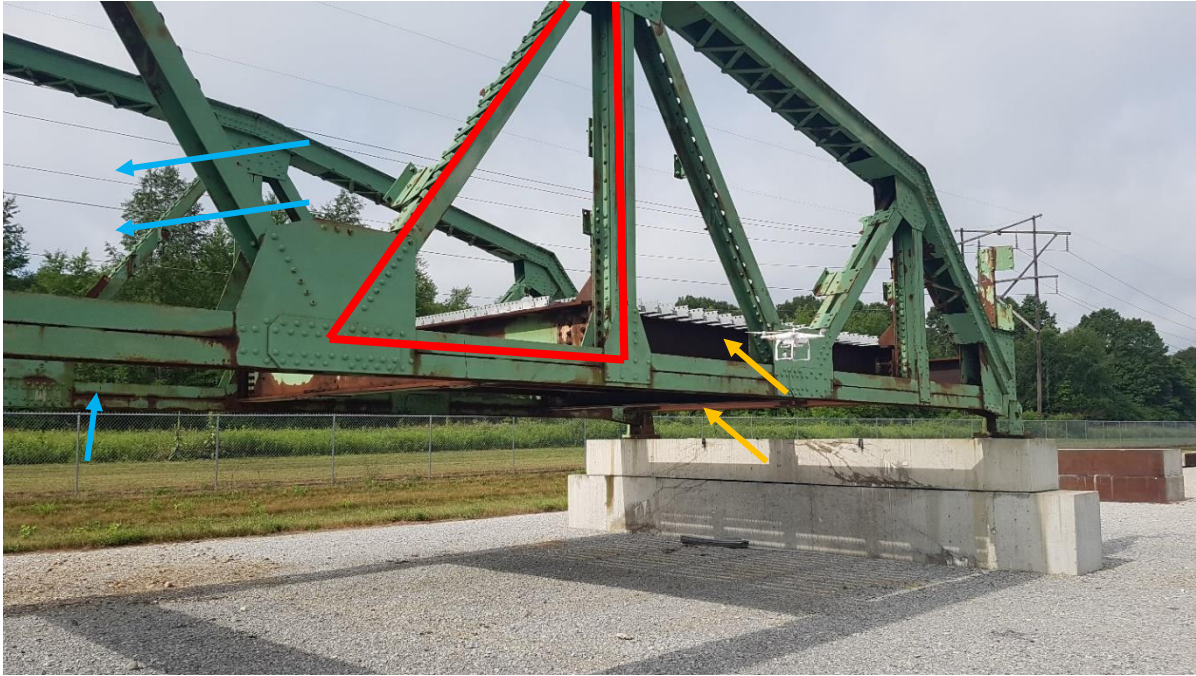
Figure 17 presents a flight in a truss structure to gather information regarding challenges and important features to consider in the design of the evaluation chamber (red and blue). The behavior of the UAV with this structure was portrayed as a segment of a truss in Obstacle 6. The deck and substructure elements (orange) are represented by Obstacle 1 and Obstacle 4.

Figure 17 Inspection of truss bridge at S-BRITE.

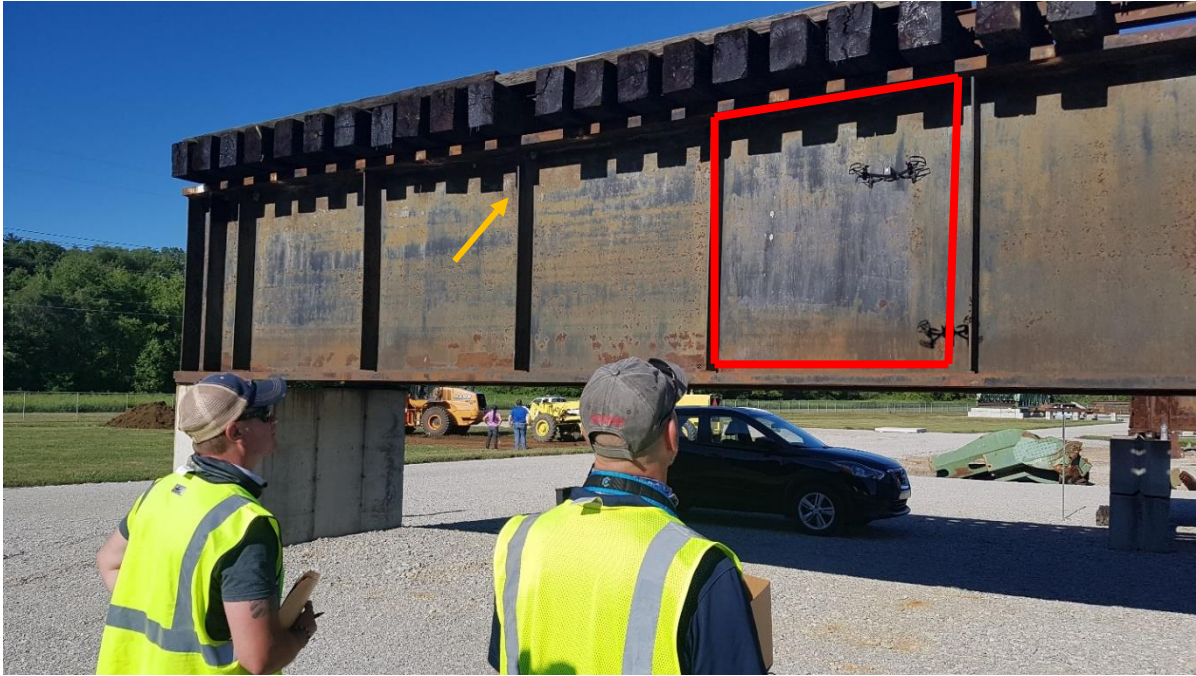
Figure 18 presents a flight along steel plate girders (orange). This situation is portrayed in Obstacle 1, the height of this type of inspection is reflected in Obstacle 2 and the side faces of the structure in the Figure (red) in Obstacle 5. In addition, the blue arrows represent the situation considered to portray a passage along steel members to reach inside a bridge structure, from the side face and below.

Figure 18 Inspection of welded bridge at S-BRITE.

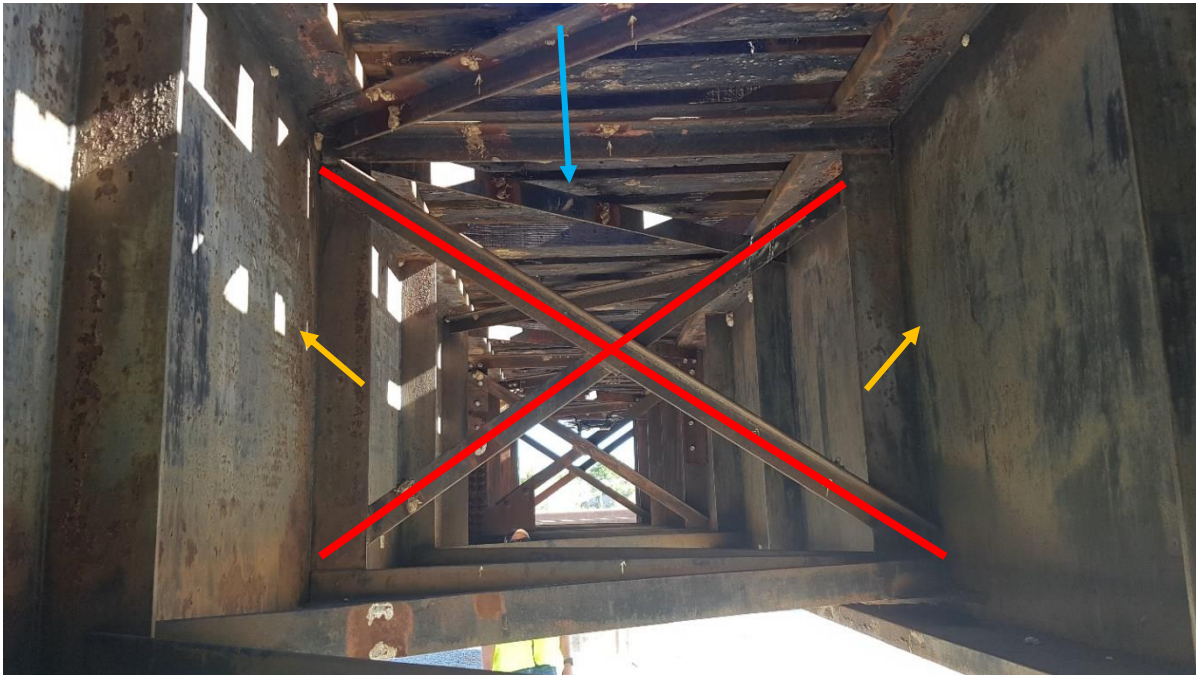
Figure 19 presents a flight test inside a bridge structure (blue) with cross components (red). This situation was portrayed in the truss elements of Obstacle 5, and the closed space on Obstacle 7.

Figure 19 Flight test inside a bridge welded structure at S-BRITE.

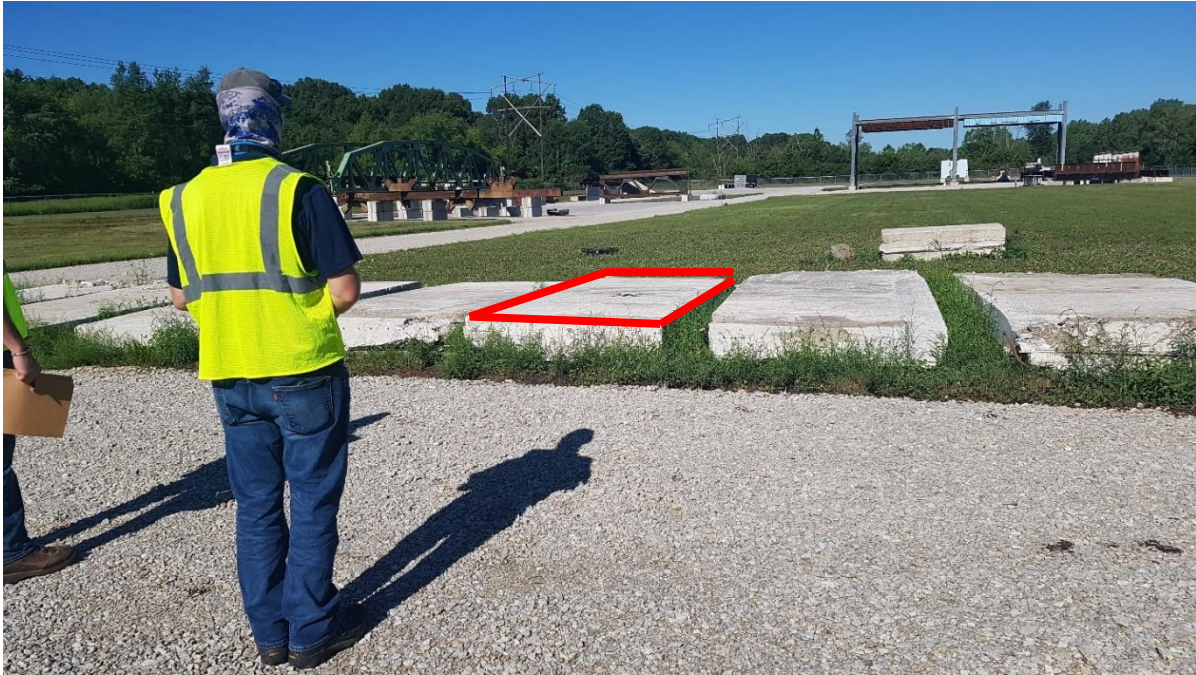
Figure 20 presents inspection in concrete structures (red), portrayed in the floor and faces of Obstacle 4 and Obstacle 6. In addition, the concrete element inside the evaluation chamber presents concrete with exposed rebar.

Figure 20 Inspection in concrete elements at S-BRITE.

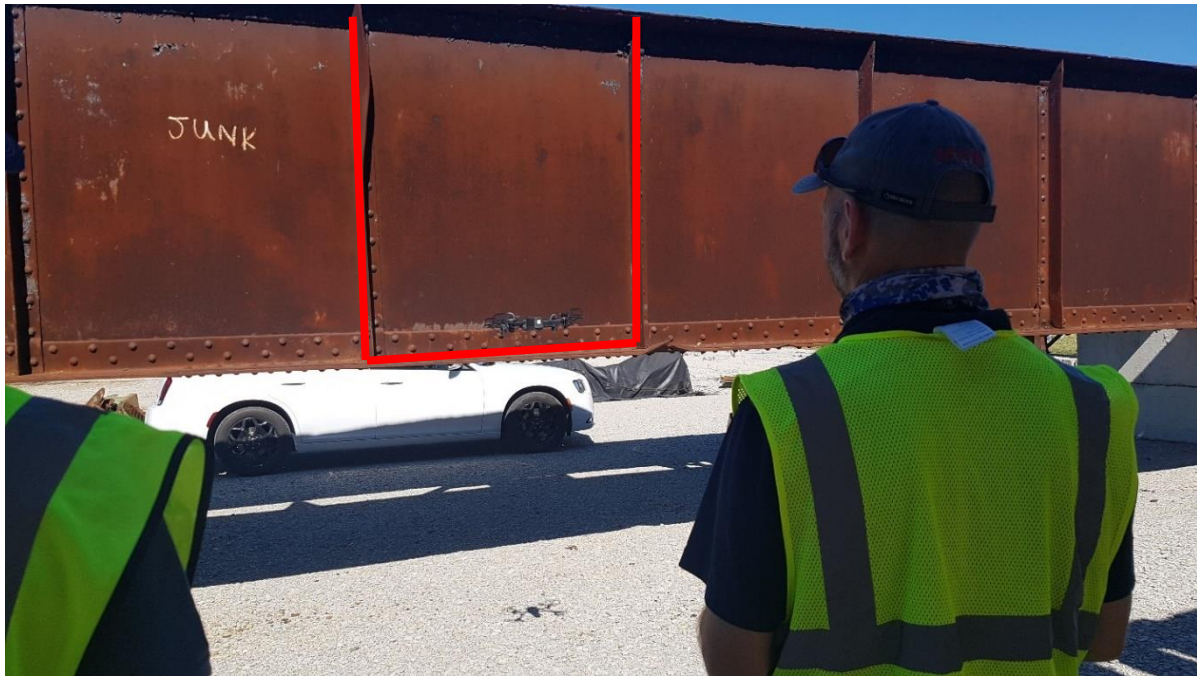
Figure 21 presents inspection in riveted bridge structures (red). This situation is represented by the side faces of Obstacle 4, Obstacle 5, and Obstacle 6.

Figure 21 Inspection of riveted bridge structure at S-BRITE.

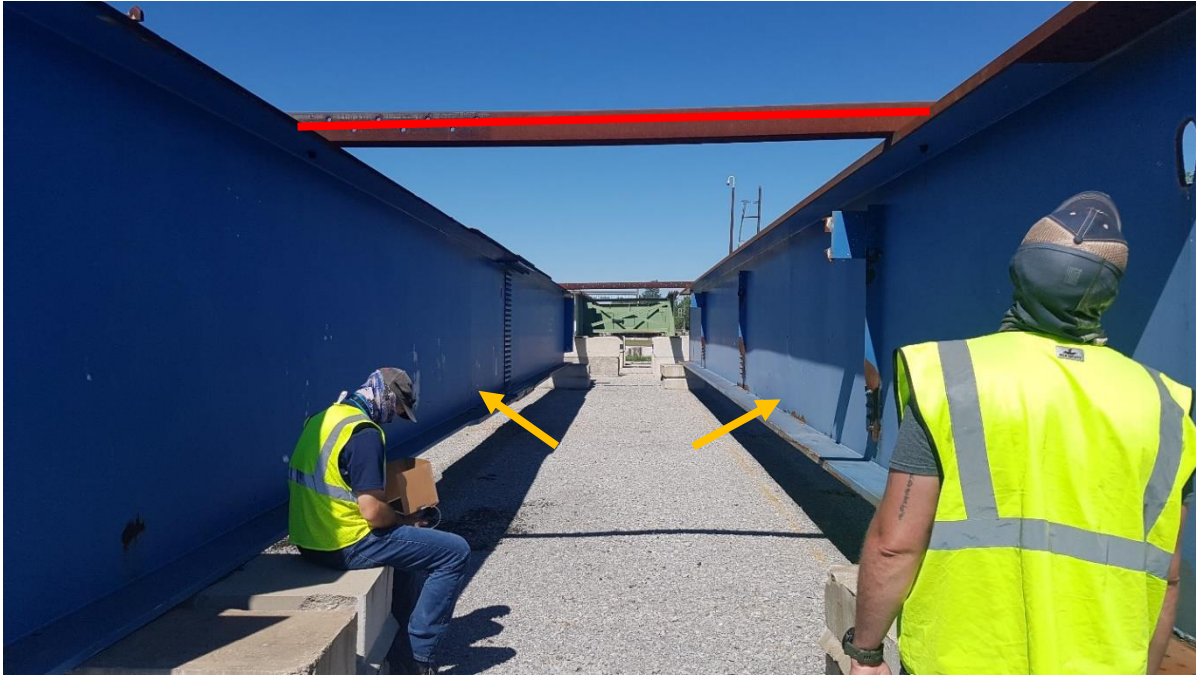
Figure 22 presents inspection in bolted structures and zones in-between steel elements (red and orange). This situation is represented in Obstacle 6, and the tight space of Obstacle 7. Additionally, the steel elements located at the entrance of the evaluation chamber portray girder, steel beams, and rivets.

Figure 22 Inspection of bolted and spaces between steel structures at S-BRITE.

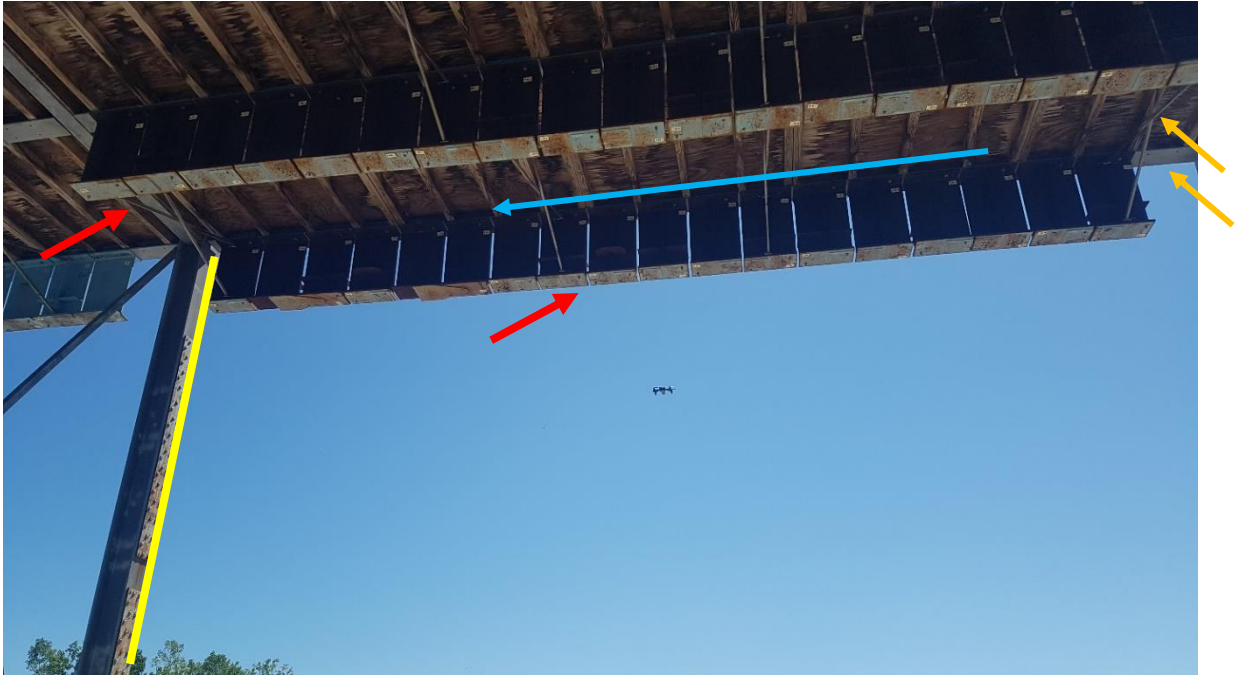
Figure 23 presents inspection in tall structures (yellow) and decks (orange) over bridges. This situation is portrayed in Obstacle 1, Obstacle 2, Obstacle 4, and Obstacle 6. Additionally, girders (red) similar to the ones presented in Figure 23 are located at the entrance of the evaluation chamber for inspection.

Figure 23 Inspection of tall bridges, deck, and other steel elements.

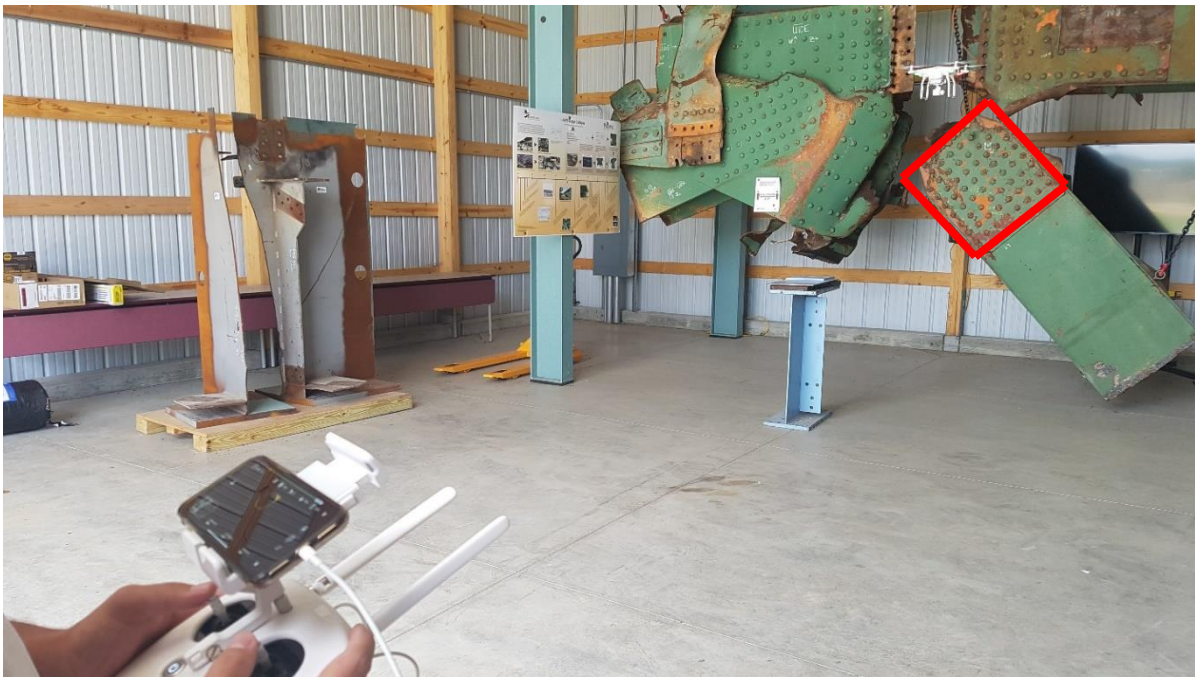
Figure 24 presents inspection on rivetted elements (red) from sections of the I-35W Bridge. Those elements are represented in the steel structures located at the entrance of the evaluation chamber.

Figure 24 Inspection of I-35W Bridge elements at S-BRITE.

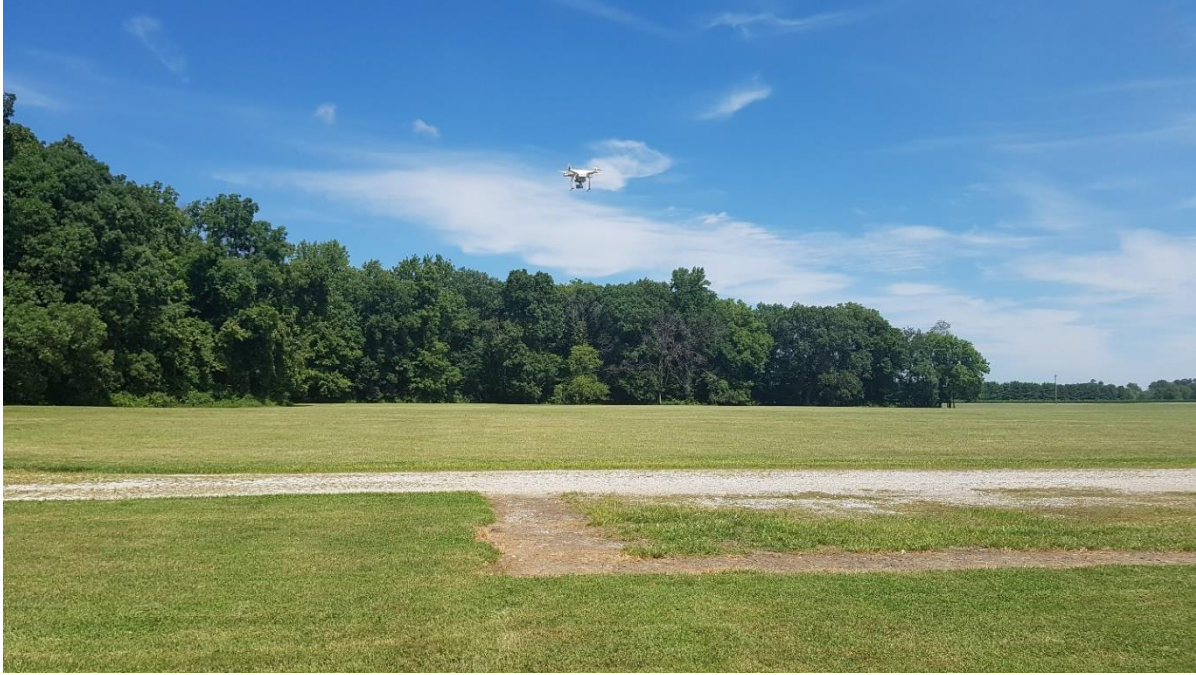
Figure 25 presents UAV inspection in open environments surrounded by vegetation. This situation allowed the author to obtain information from flying in an environment with no structures nearby and provide a comparison when flying close to structures.

Figure 25 UAS flight in an open environment surrounded by tall vegetation.

The first flights were conducted in open environments where surrounding effects are not relevant due to the absence of objects close to the UAV but this situation was important to consider as a comparison point for future flights. The UAVs used in the flights described were DJI Phantom 3 Pro and a DJI Mavic 2 Pro. An example of these situations is presented in Figure 25.

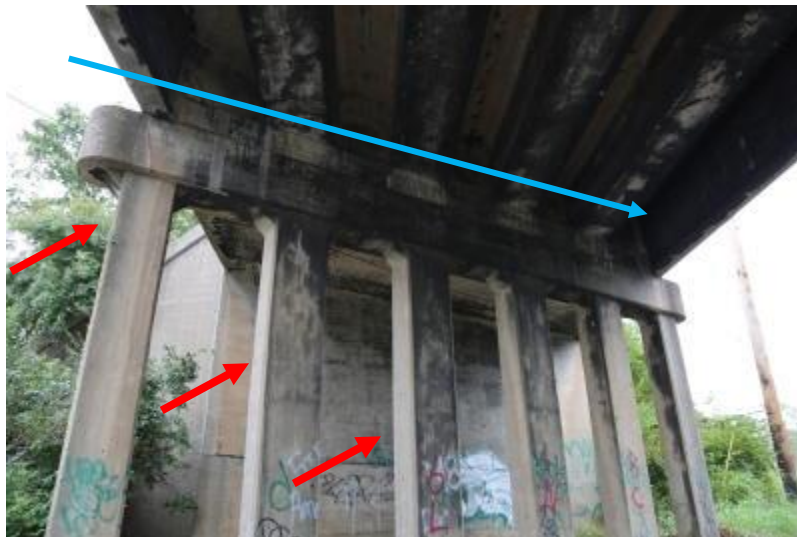
Figure 27 represents one of the bridge structures used to conceive Obstacle 2 and Obstacle 3, covering tall and slender elements in concrete (red).

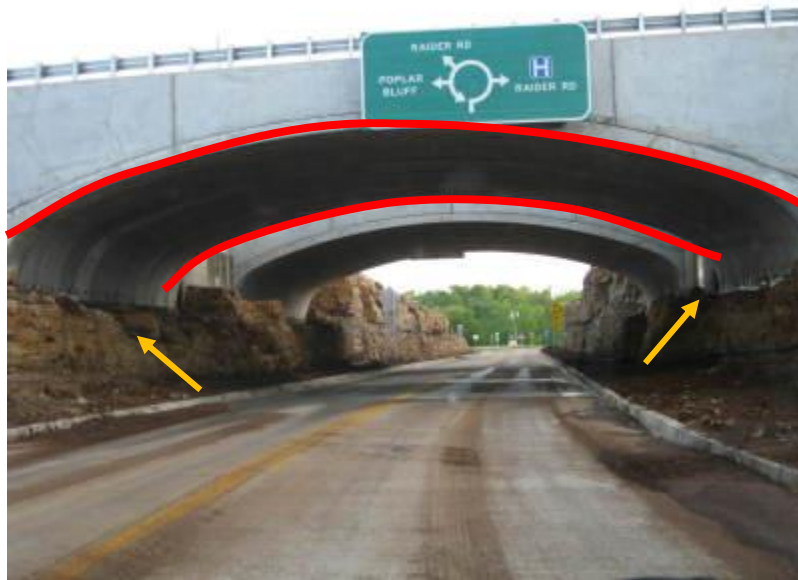
Figure 28 is represented in the roof (red) of Obstacle 6 and the round surfaces of Obstacle 2 and 7.

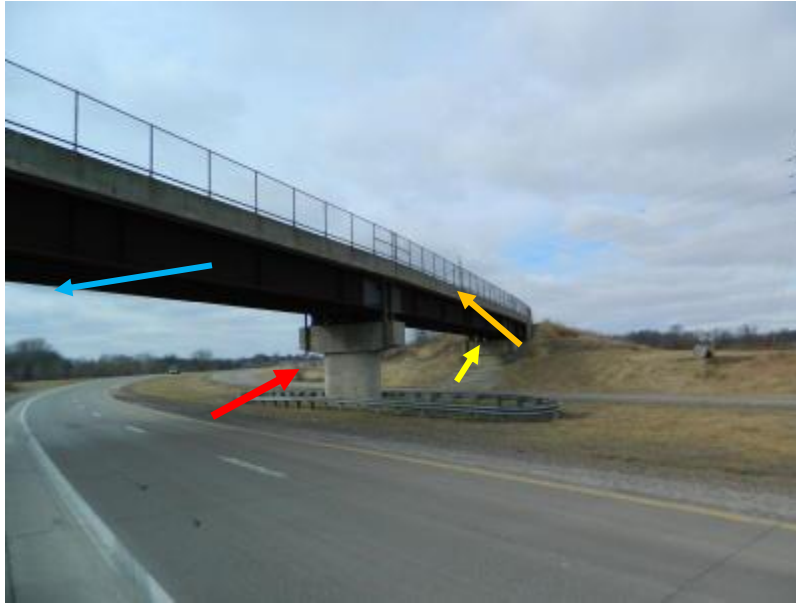
The deck of Figure 30 (orange) is represented in Obstacle 1 and Obstacle 4, the height of the piers (red) in Obstacle 2, and the round shapes (red) and small spaces (yellow) in Obstacle 7. The situation of flying underneath structures (blue) is presented in Obstacle 4 and Obstacle 6.

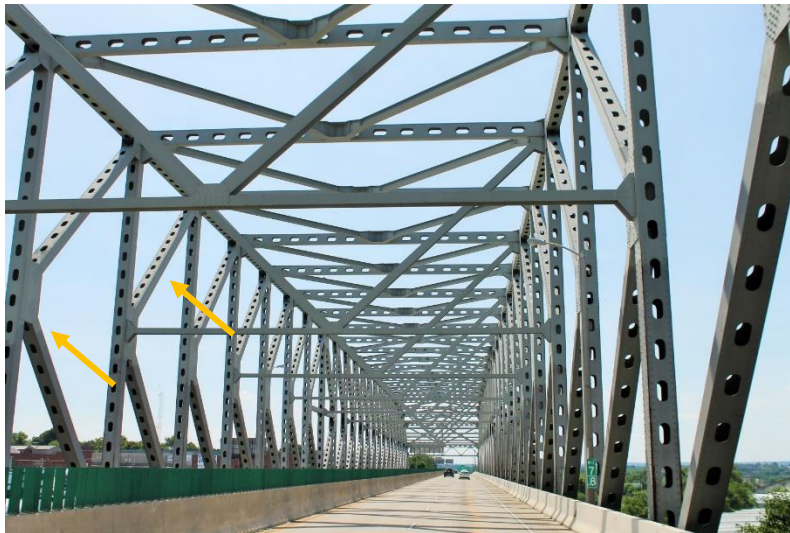
Figure 32 shows a truss bridge, with K bracing (orange) represented in the elements of Obstacle 5.

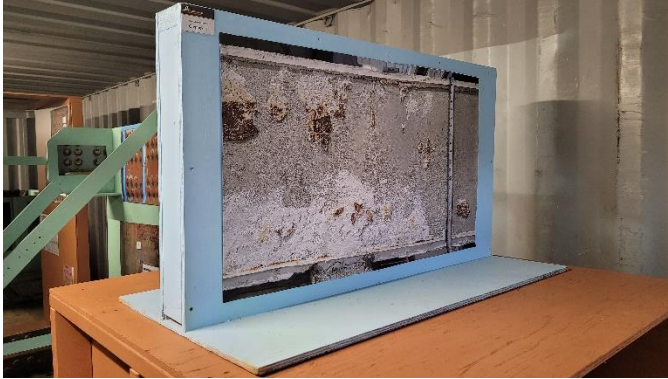
- Width: 3 feet 6 inches.
- Height: 2 feet.
- Depth: 4.5 inches.

Figure 39 3D Illustration and front view of Obstacle 1.

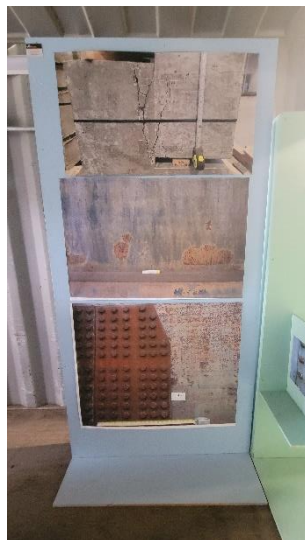
- Width: 3 feet 6 inches.
- Height: 7 feet.
- Depth: 4.5 inches.

Figure 40 3D Illustration and front view of Obstacle 2.

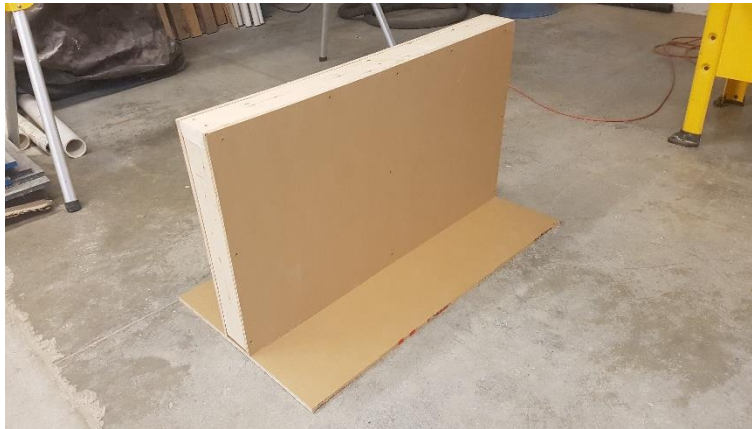
Obstacle 1 is presented in Figure 46.

Figure 46 Obstacle 1 built.

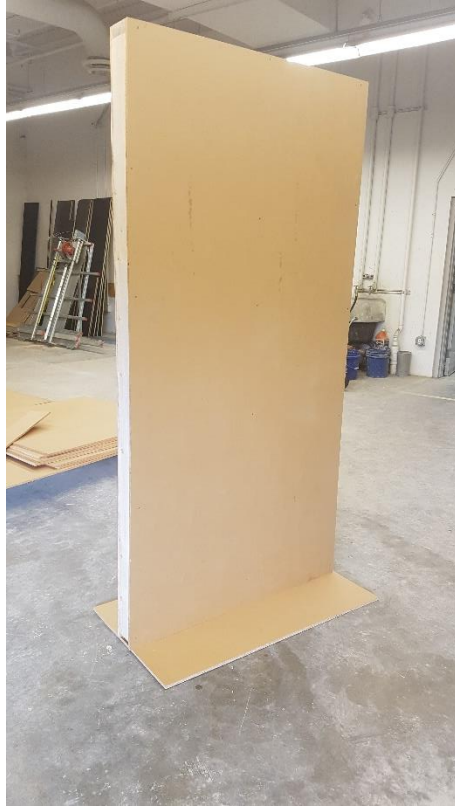
Obstacle 2 is presented in Figure 47.

Figure 47 Obstacle 2 built.

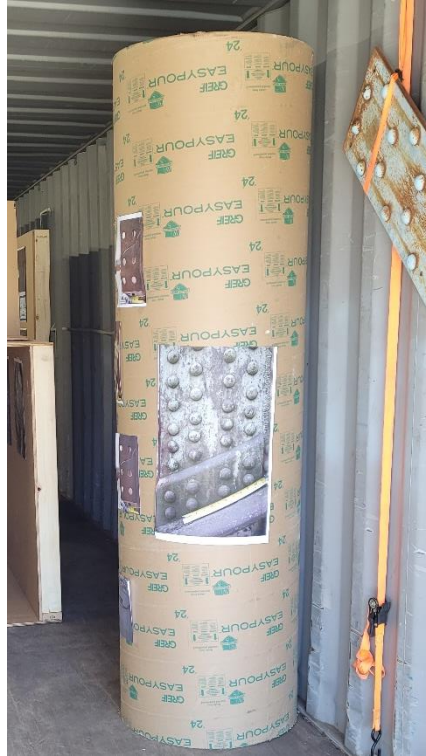
Obstacle 3 is presented in Figure 48.

Figure 48 Obstacle 3 inside the container.

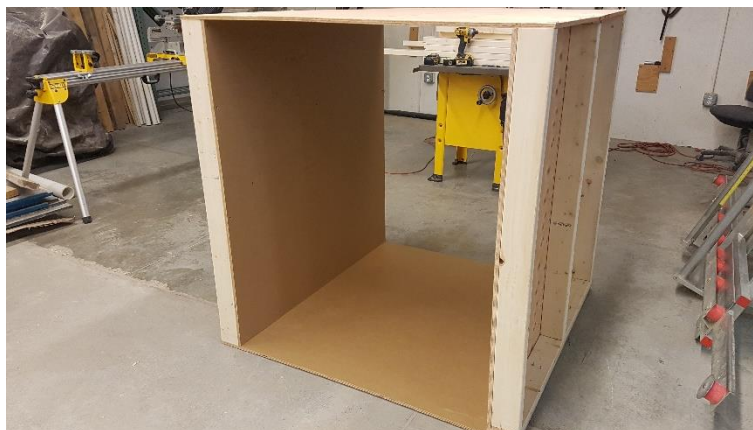
Obstacle 4 is presented in Figure 49.

Figure 49 Obstacle 4 built.

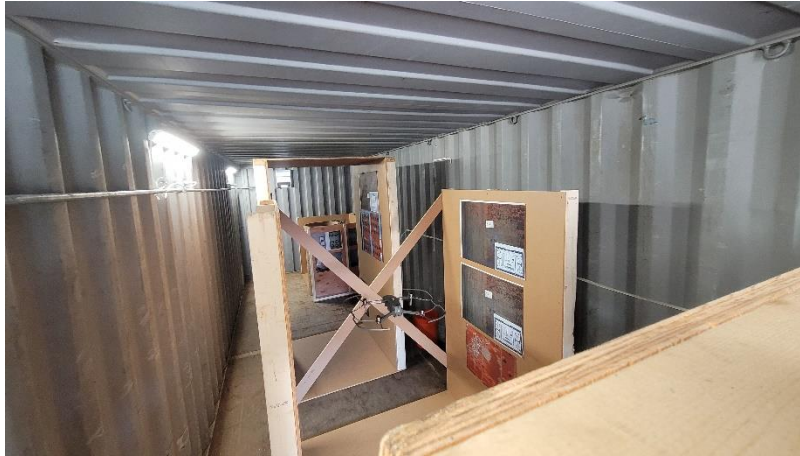
Obstacle 5 is presented in Figure 50.

Figure 50 Obstacle 5 inside the container.

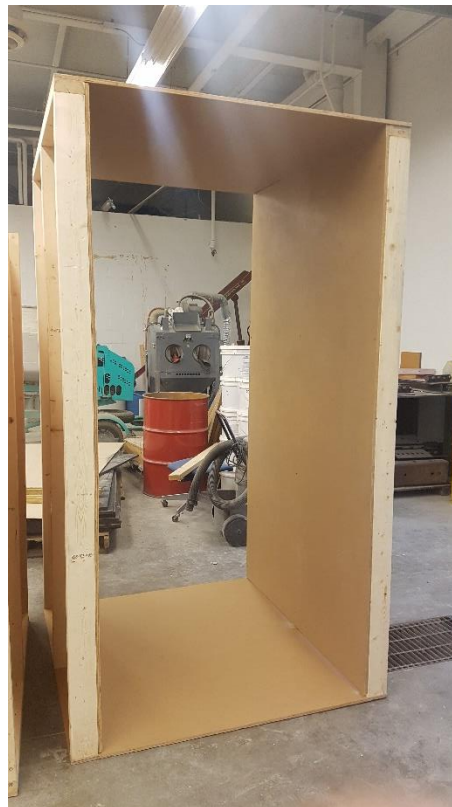
Obstacle 6 is presented in Figure 51.

Figure 51 Obstacle 6 built.

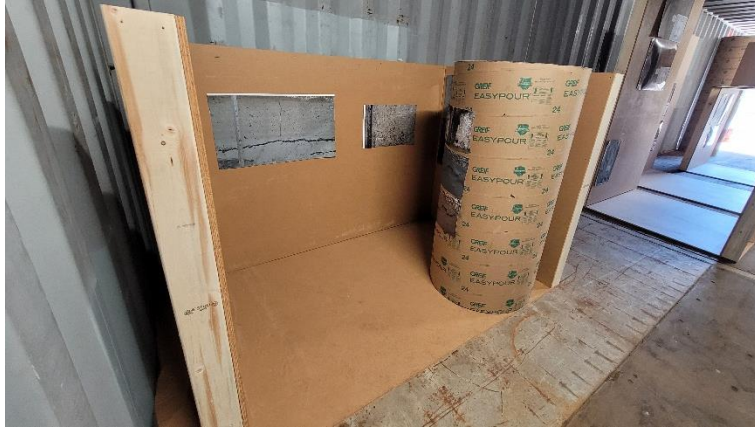
Obstacle 7 is presented in Figure 52.

Figure 52 Obstacle 7 built.

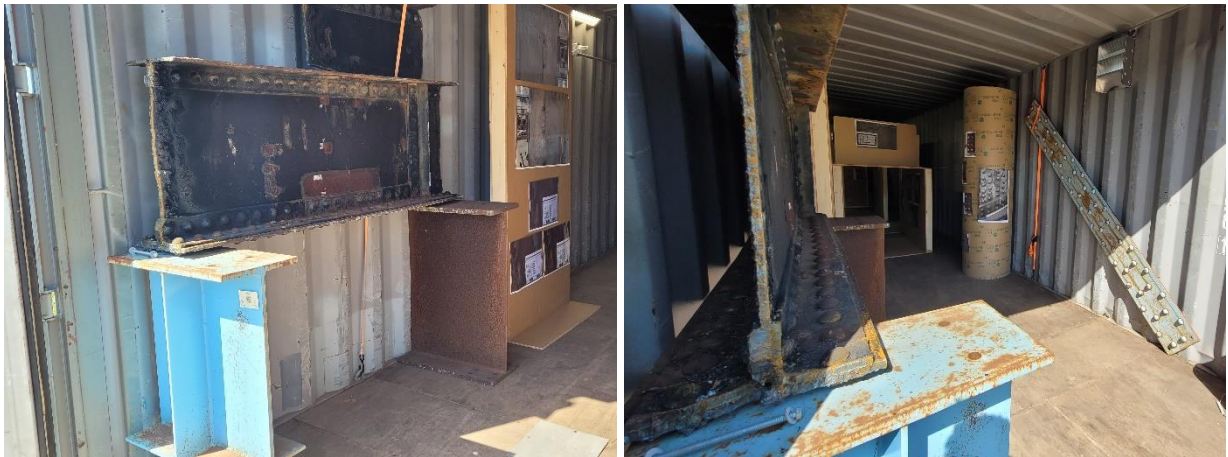
The steel and concrete elements are located inside the evaluation chamber and presented in Figure 53.

Figure 53 Steel elements inside the evaluation chamber.

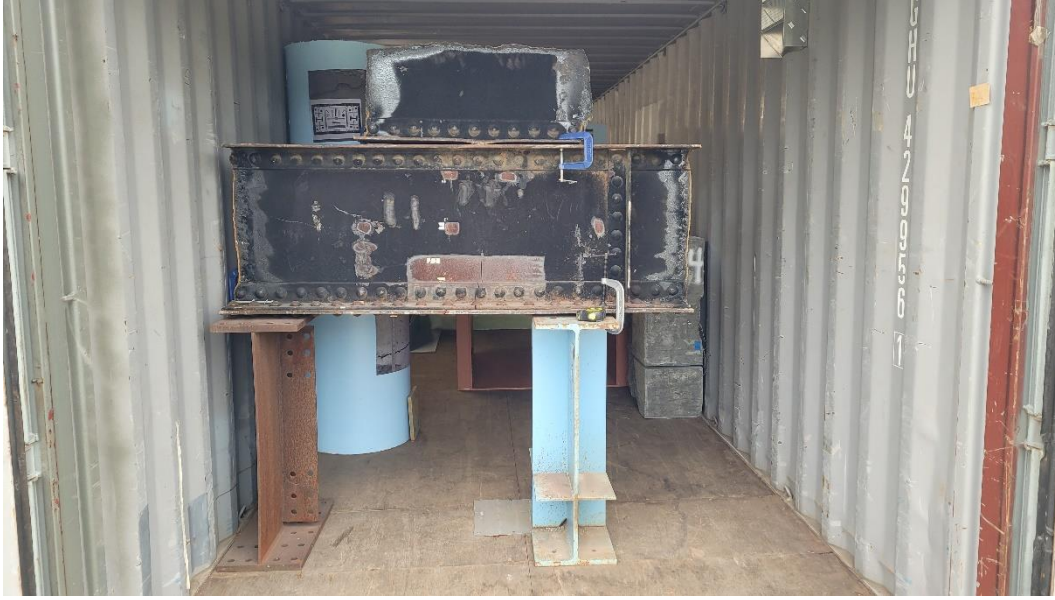
The final arrangement of the evaluation chamber from an outside view is presented in Figure 54.

Figure 54 Final arrangement of the evaluation chamber inside the container from outside view.

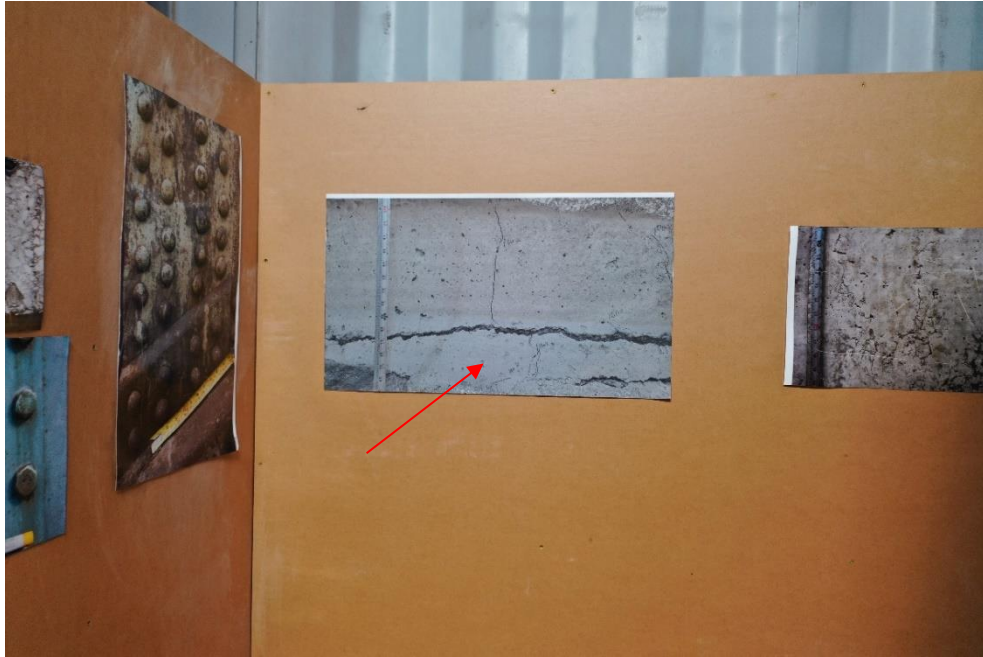
From the table, sky conditions varied from clear sky to overcast, presenting different lighting conditions to the area. To guarantee the replicability of the results, LED lights were installed along the elements and they are turned on during the experiment. When flying along the evaluation chamber, two scenarios were explored: when the doors of the container were opened and when they were closed. Figure 58 presents an image from flight on 04-02-21 (clear sky) with the doors closed. Figure 59 presents an image from flight on 03-01-21 (scattered clouds) with the doors opened. Both images reflect the same visual results with the defect visible and with no loss of quality, pointed with a red arrow in both images. Similar results were observed with other flights in both conditions: container door opened and closed, showing that none of the sky conditions affected the images obtained inside the evaluation chamber.

Figure 58 Image from flight on 04-02-21 (clear sky) with the doors closed from Obstacle 7.

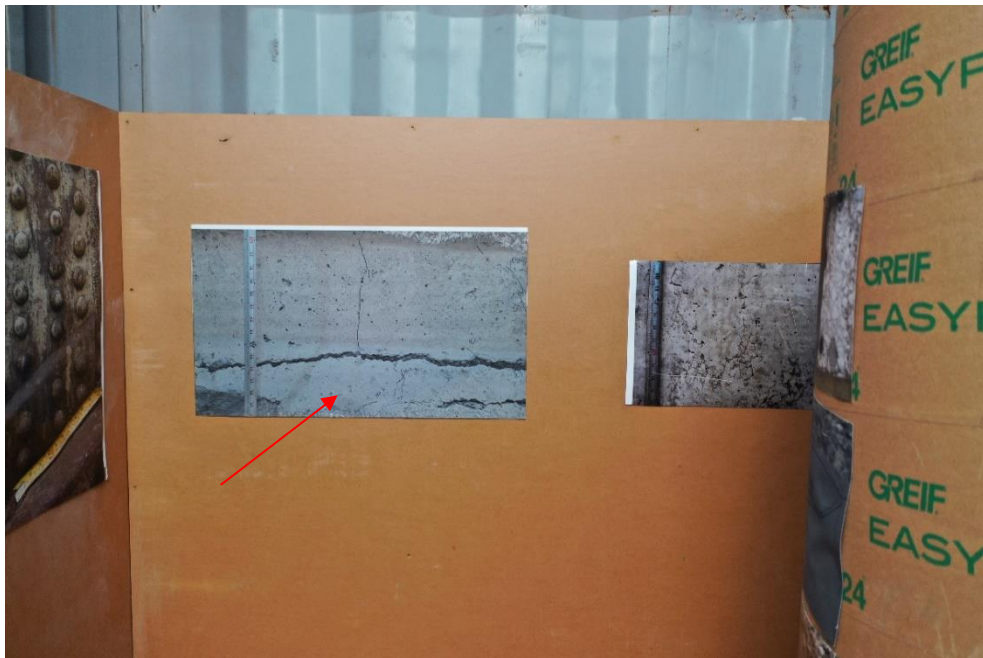
Figure 59 Image from flight on 03-01-21 (scattered clouds) with the doors open from Obstacle 7.

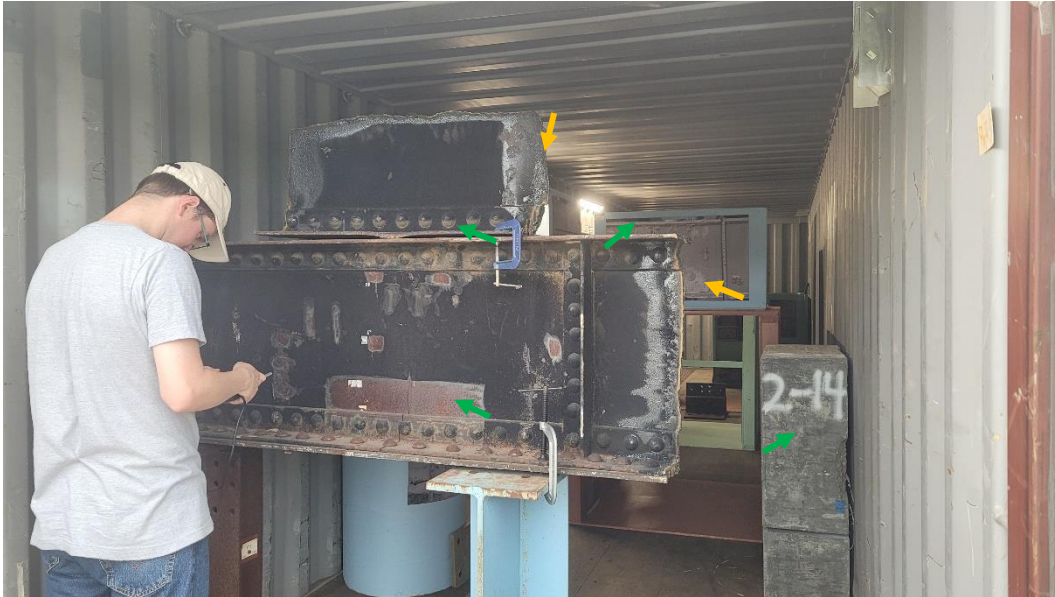
Figure 61 Distribution of Line-of-Sight environment at the entrance of the evaluation chamber

Line of sight is directly available to the pilot in the elements at the start of the evaluation chamber and Obstacle 2, and 3 as observed in Figure 61. With the progress of the test, Obstacles and elements limit the visual range of the pilot, as in a typical bridge inspection. The availability of line of sight is depicted in Figure 60, where the evaluation chamber has been divided by a scale of three colors: green, where the pilot can see the obstacles directly (with their eyes and no need to use any visual information from the controller); yellow, where the pilot can partially see the elements in the evaluation chamber; and red, where the elements are positioned in limited line-of-sight environment, meaning that the pilot will have to rely on the images and video provided in the controller to navigate and perform the inspection of that obstacle. A scale of line-of-sight availability inside the evaluation chamber has been provided at the bottom of Figure 60. This figure was obtained by performing observations at the entrance of the container, by dividing the container in 5 sections and determining an approximate percentage of objects and areas a visual observer is able to see from each section. Later, the percentage in each area was represented by a color obtaining Figure 60.

Figure 61, Figure 62, and Figure 63 provide arrows with three colors: green, yellow, and red, following the same color scale presented in Figure 60. Line of sight is partially available in Obstacle 1, 4, 5 and 6, as presented in Figure 61 and Figure 62. Finally, the goal and location of Obstacle 7 is to fully block line of sight, as presented in Figure 63. The scale on line-of-sight availability provided in Figure 60 and the absence in view of Obstacle 7 in Figure 61 proves that the goal was achieved.

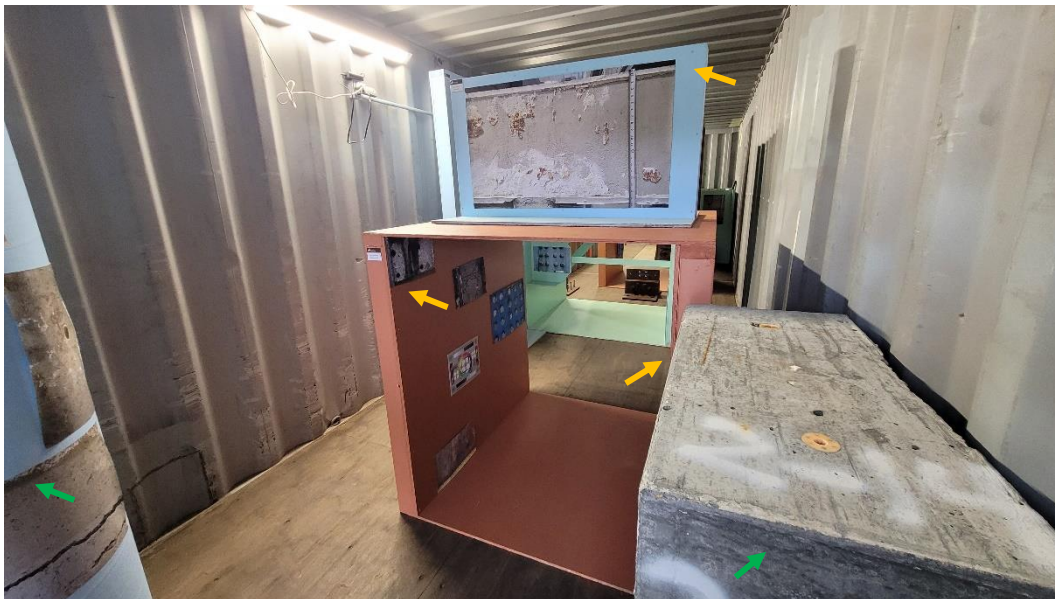
Figure 62 Distribution of Line-of-Sight environment inside the evaluation chamber

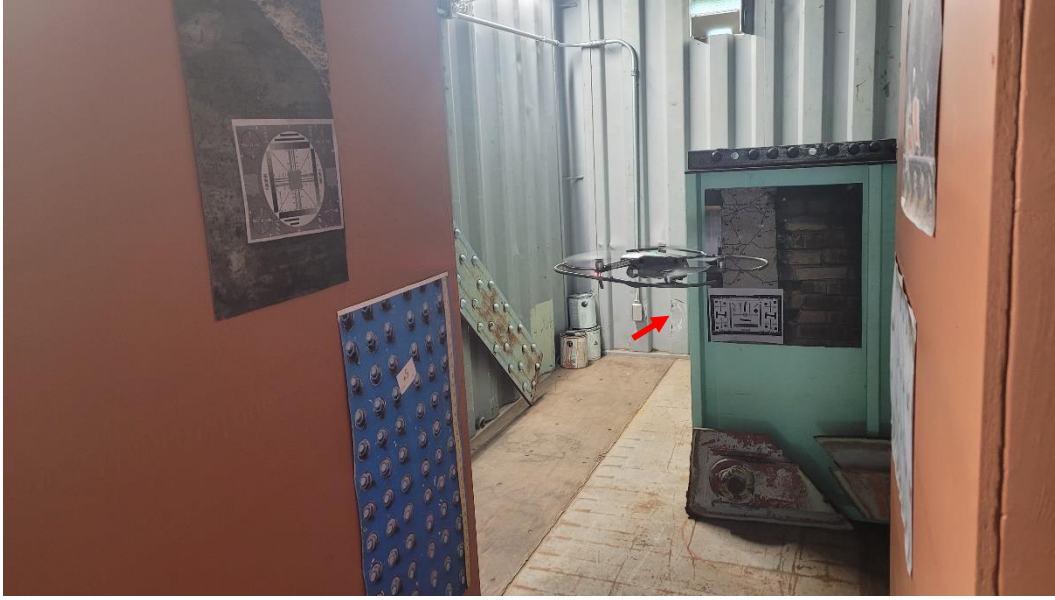
Figure 63 Location of Obstacle 7 blocking line of sight.

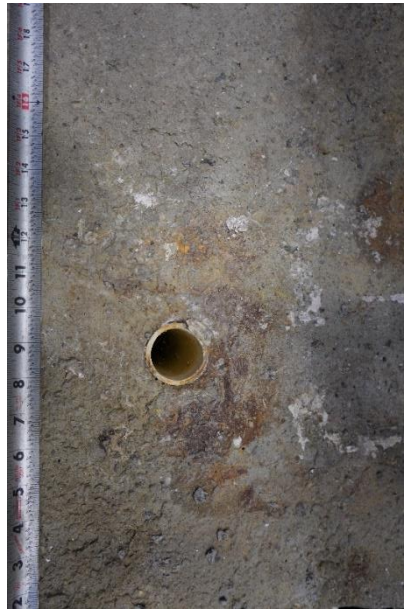
Figure 68 presents the original image inside the evaluation chamber and Figure 69 presents the image obtained during UAS inspection.

Figure 68 Exhibit 5538 of concrete element.

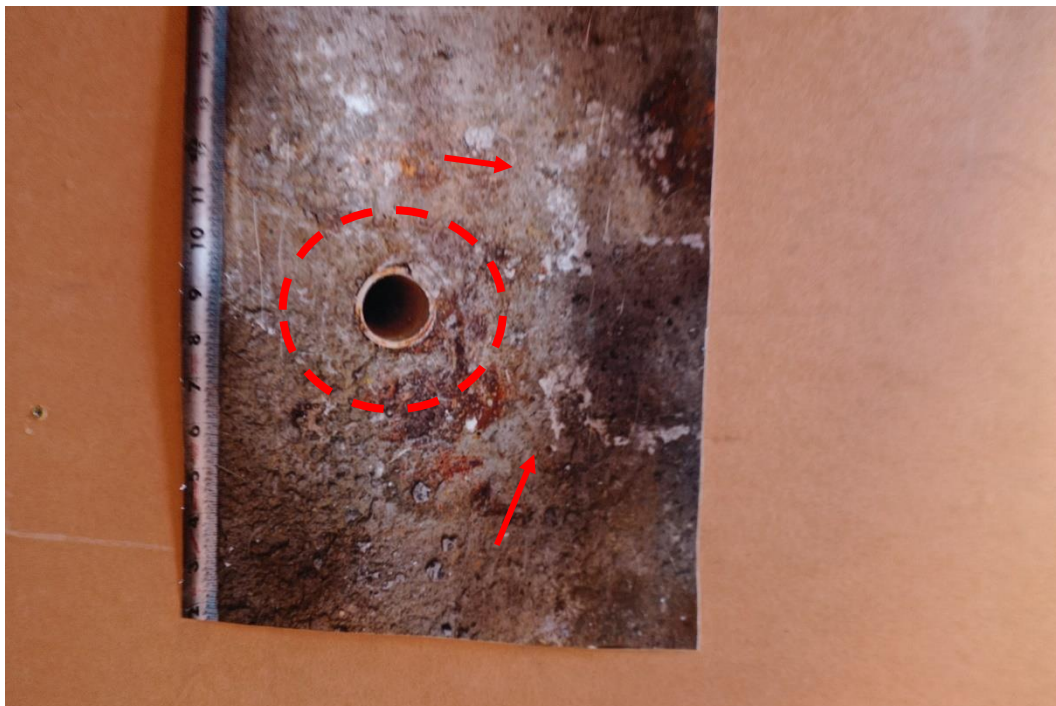
Figure 69 UAS inspection of Exhibit 5538.
