AN UNMANNED AERIAL SYSTEMS EVALUATION CHAMBER FOR BRIDGE INSPECTION

A Thesis

Master of Science in Civil Engineering

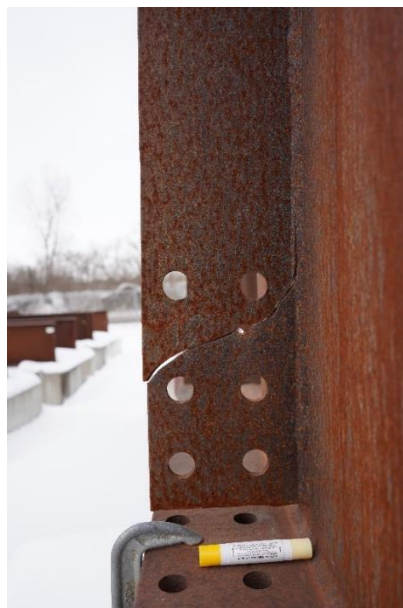
Figure 72 presents the original image inside the evaluation chamber and Figure 73 presents the image obtained during UAS inspection.

Figure 72 Exhibit 5803 of steel element.

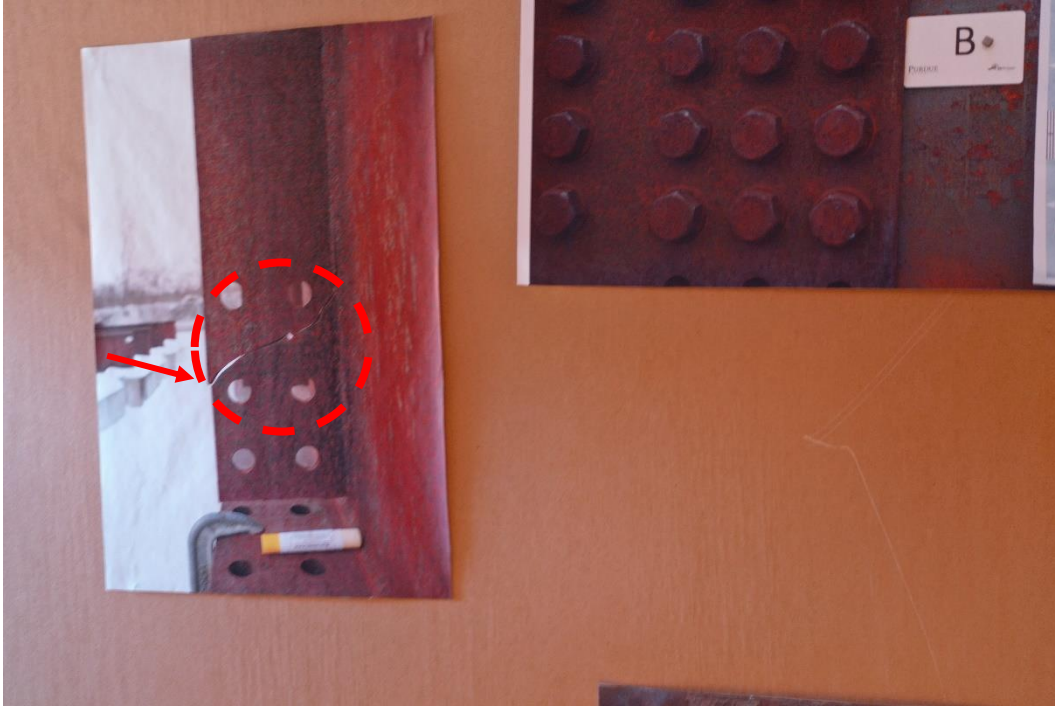
Figure 73 UAS inspection of Exhibit 5803.

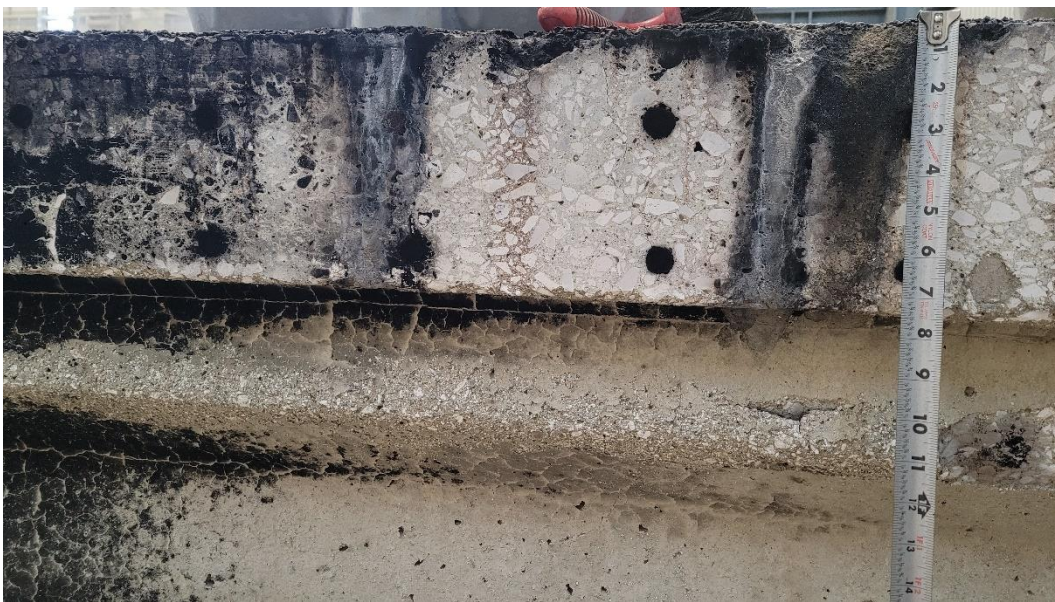
Figure 74 presents the original image inside the evaluation chamber and Figure 75 presents the image obtained during UAS inspection.

Figure 74 Exhibit 1516 of concrete element.

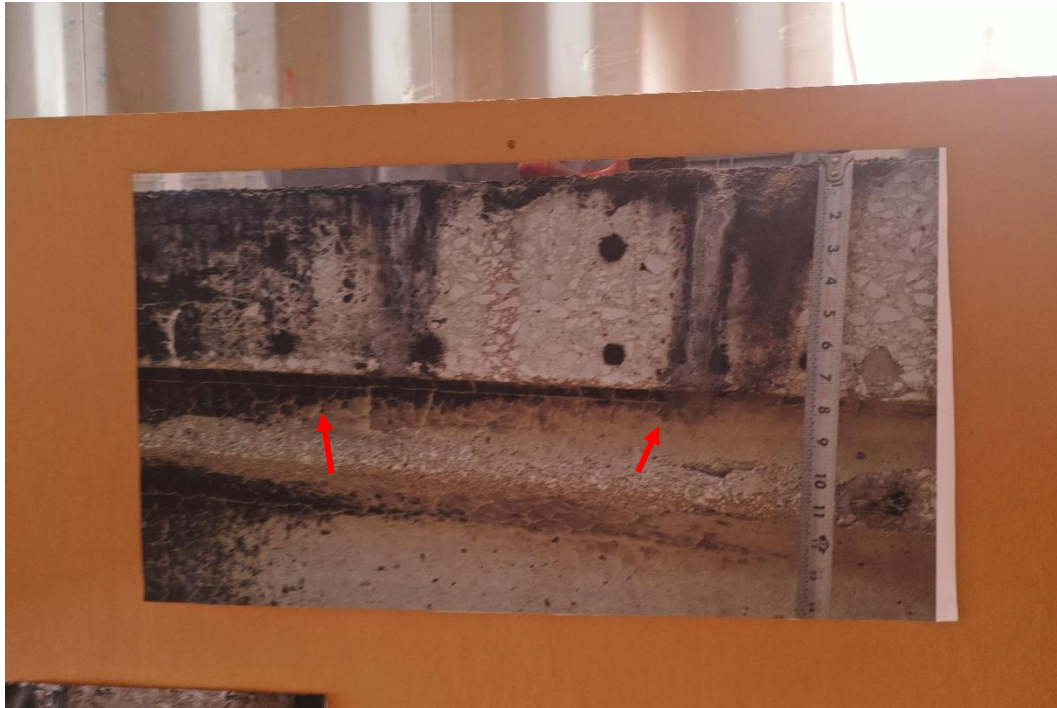
Figure 75 UAS inspection of Exhibit 1516.

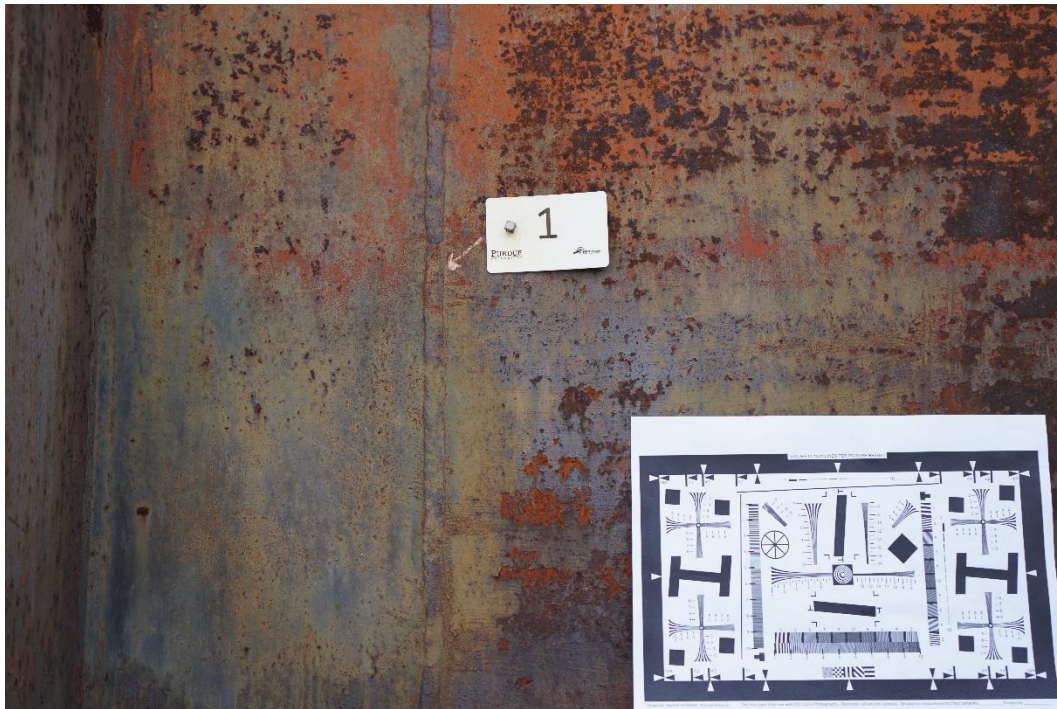
Figure 76 presents the original image inside the evaluation chamber and Figure 77 presents the image obtained during UAS inspection.

Figure 76 Exhibit 5603 of steel element.

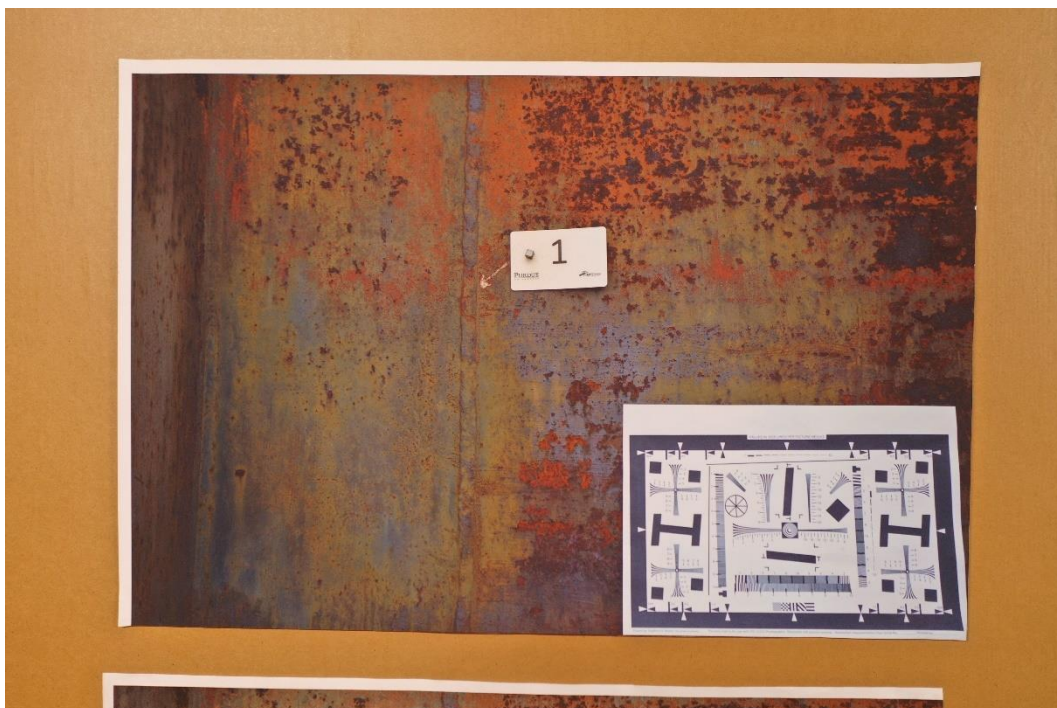
Figure 77 UAS inspection of Exhibit 5603.

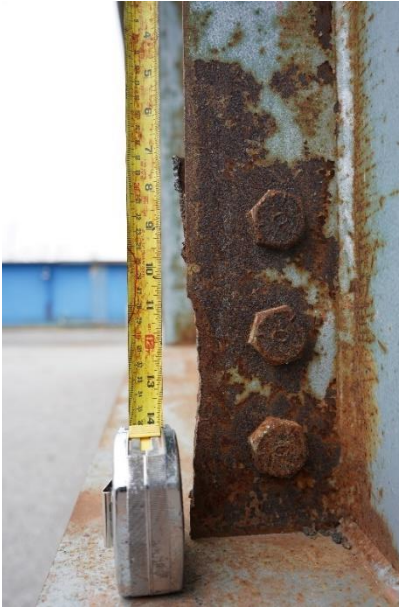
Figure 78 presents the original image inside the evaluation chamber and Figure 79 presents the image obtained during UAS inspection.

Figure 78 Exhibit 5635 of steel element.

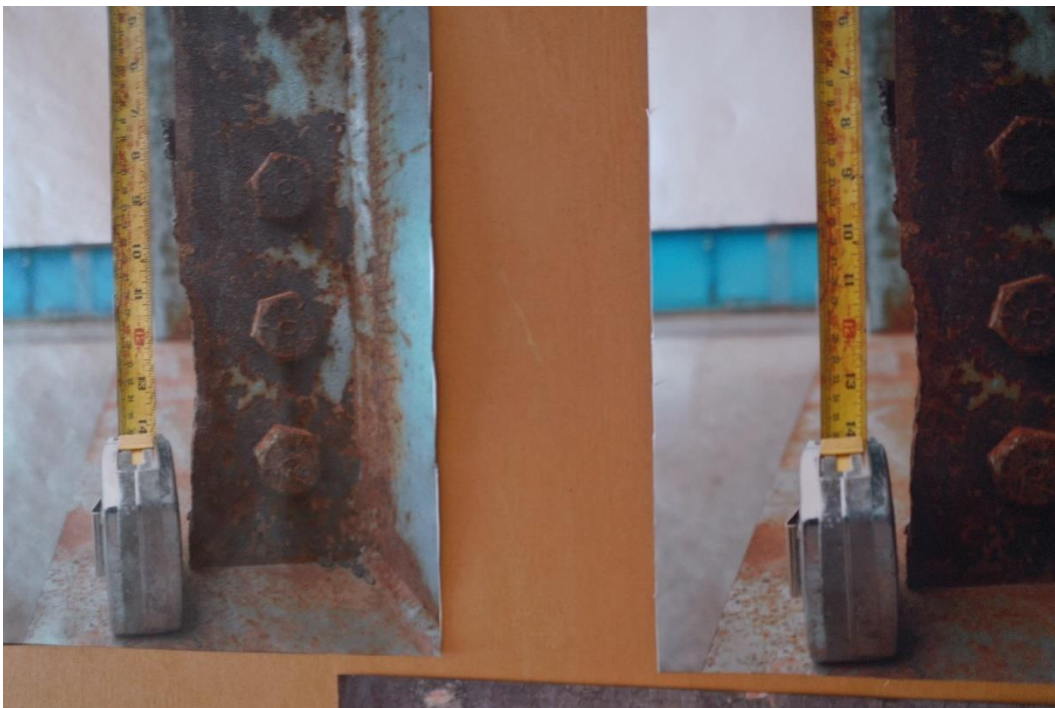
Figure 79 UAS inspection of Exhibit 5635.

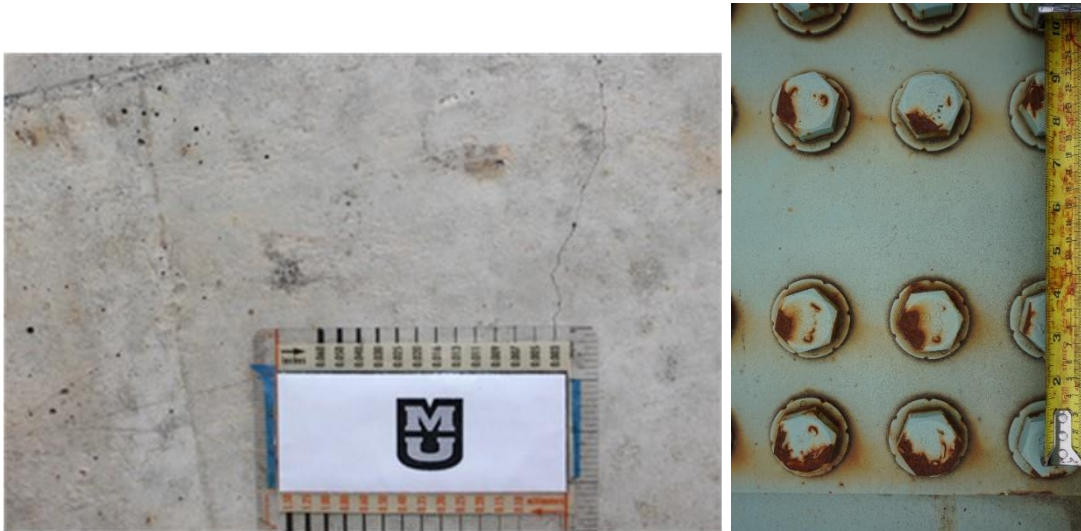
Figure 80 presents the original images inside the evaluation chamber and Figure 81 presents the image obtained during UAS inspection.

Figure 80 Exhibit 0101 (left) of concrete element (American Association of State Highway and Transportation Officials, 2019) and Exhibit 5678 (right) of steel element.

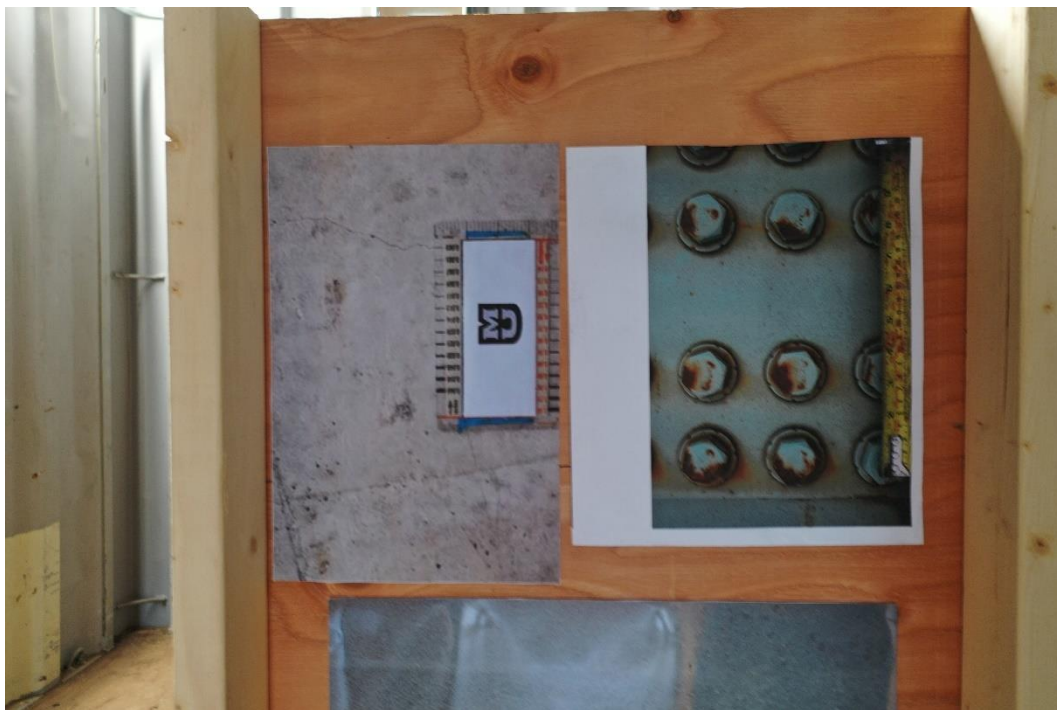
Figure 81 UAS inspection of Exhibit 0101 and 5678.

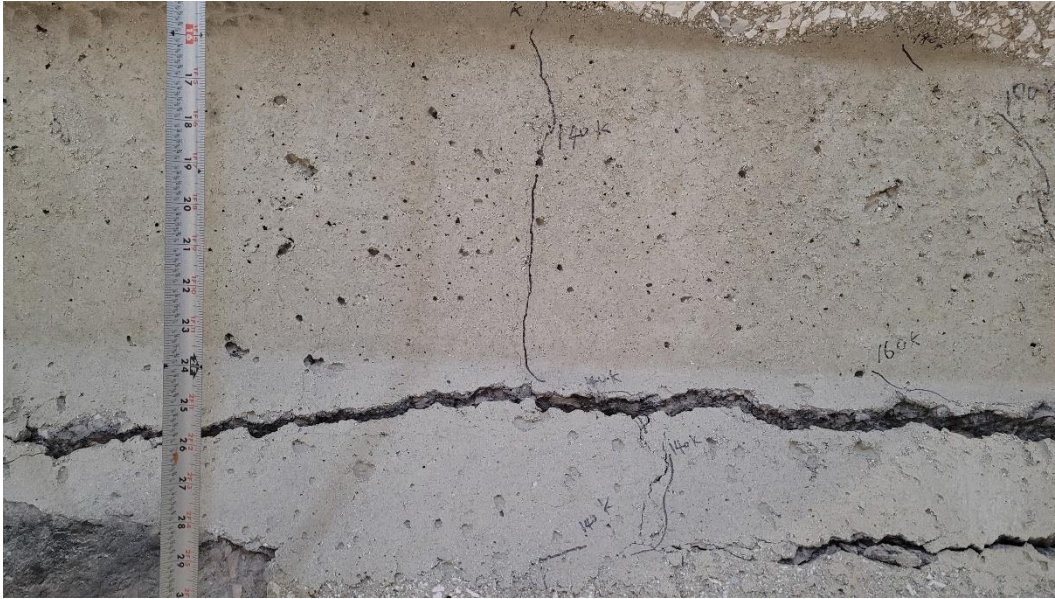
Figure 82 presents the original image inside the evaluation chamber and Figure 83 presents the image obtained during UAS inspection.

Figure 82 Exhibit 1518 of concrete element.

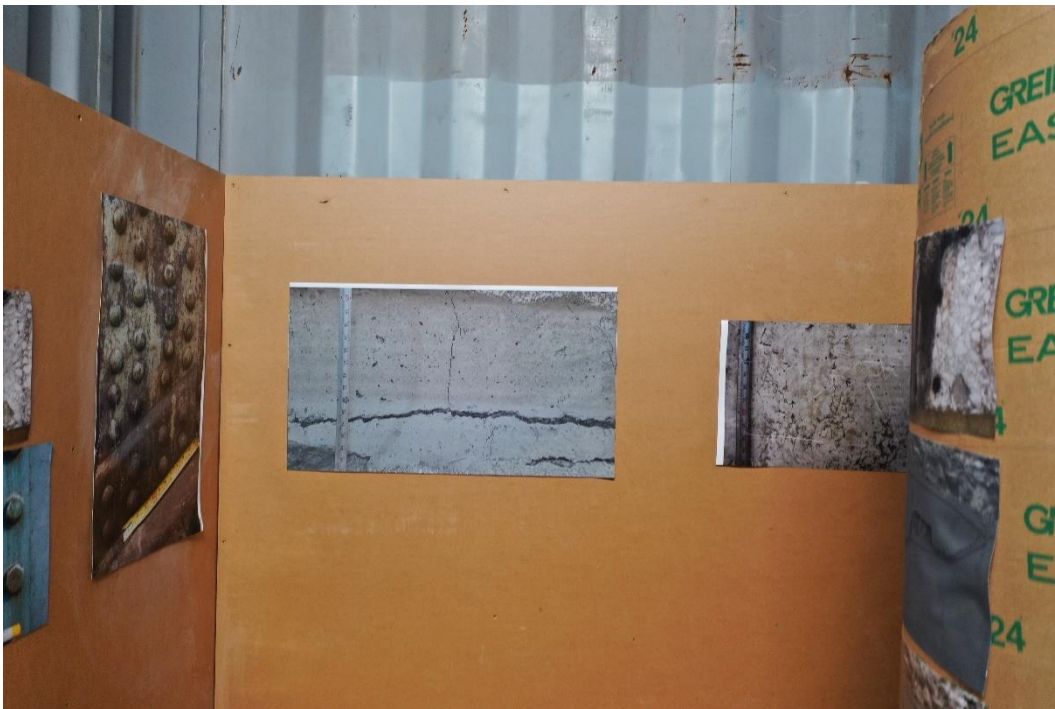
Figure 83 UAS inspection of Exhibit 1518.

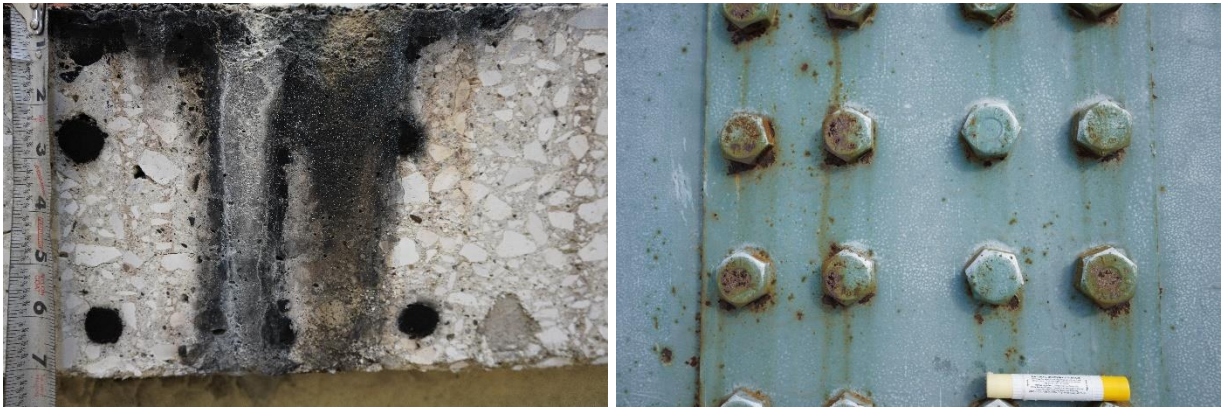
Figure 84 presents the original images inside the evaluation chamber and Figure 85 presents the image obtained during UAS inspection.

Figure 84 Exhibit 5550 (left) of concrete element and Exhibit 5786 (right) of steel element.

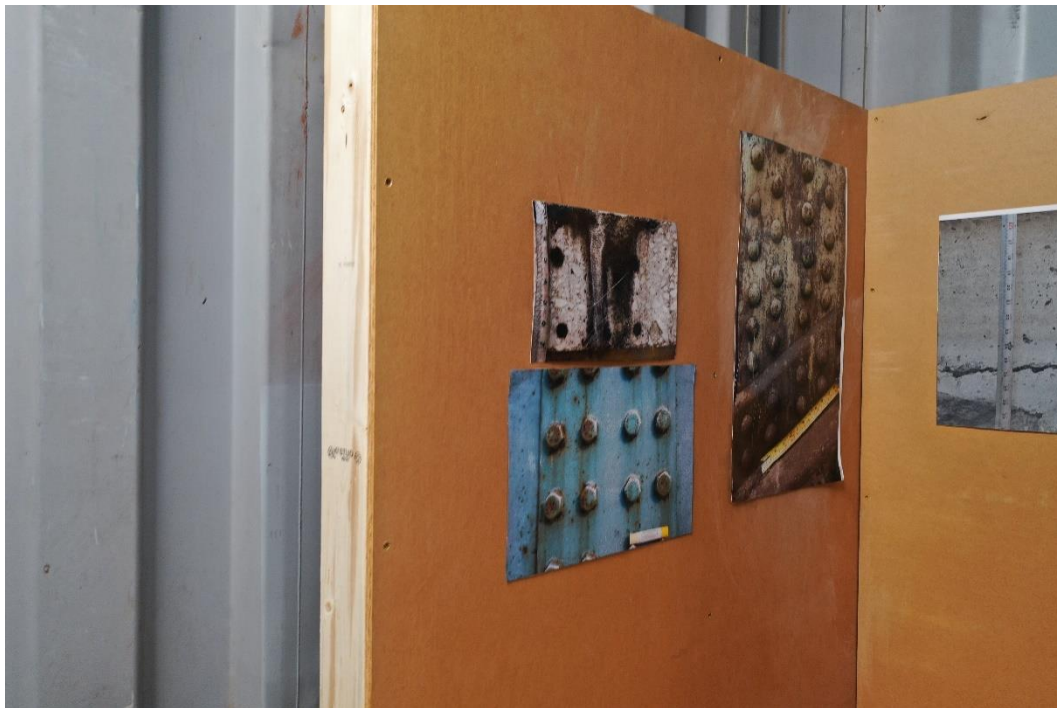
Figure 85 UAS inspection of Exhibit 5550 and 5786.

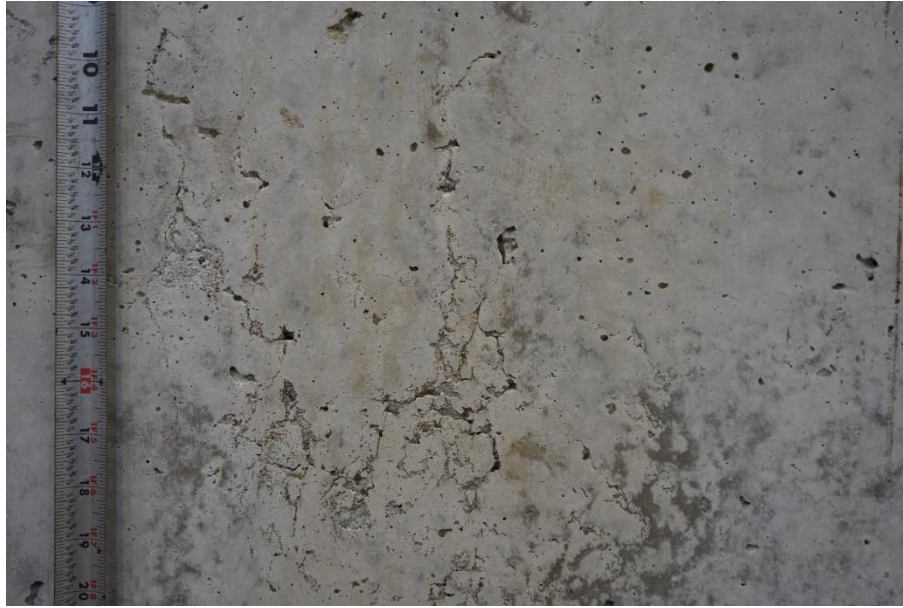
Figure 86 and Figure 87 present the original images inside the evaluation chamber and Figure 88 presents the image obtained during UAS inspection.

Figure 86 Exhibit 5564 of concrete element.

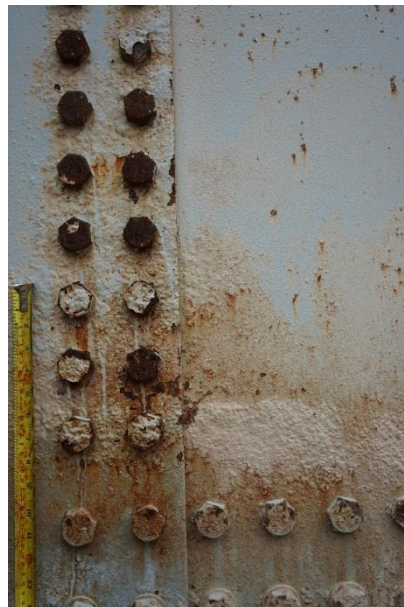
Figure 87 Exhibit 5656 of steel element.

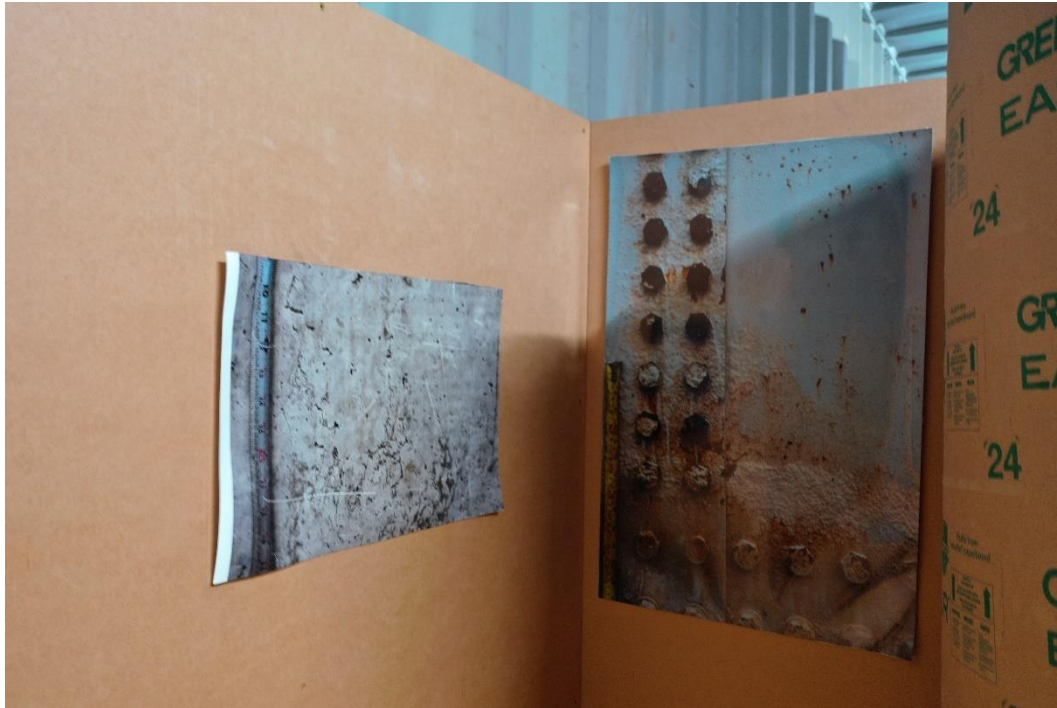
Figure 88 UAS inspection of Exhibit 5564 and 5656.

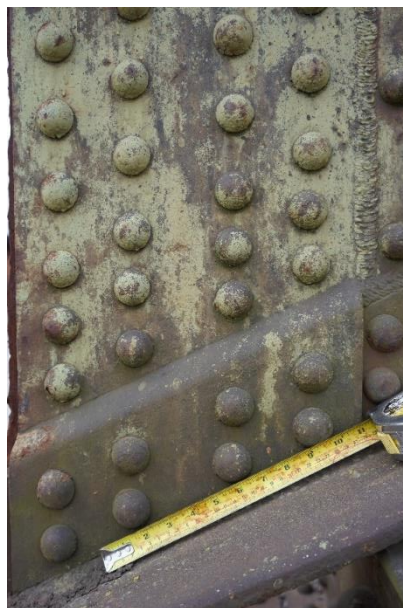
Figure 89 presents the original image inside the evaluation chamber and Figure 90 presents the image obtained during UAS inspection.

Figure 89 Exhibit 5619 of steel element.

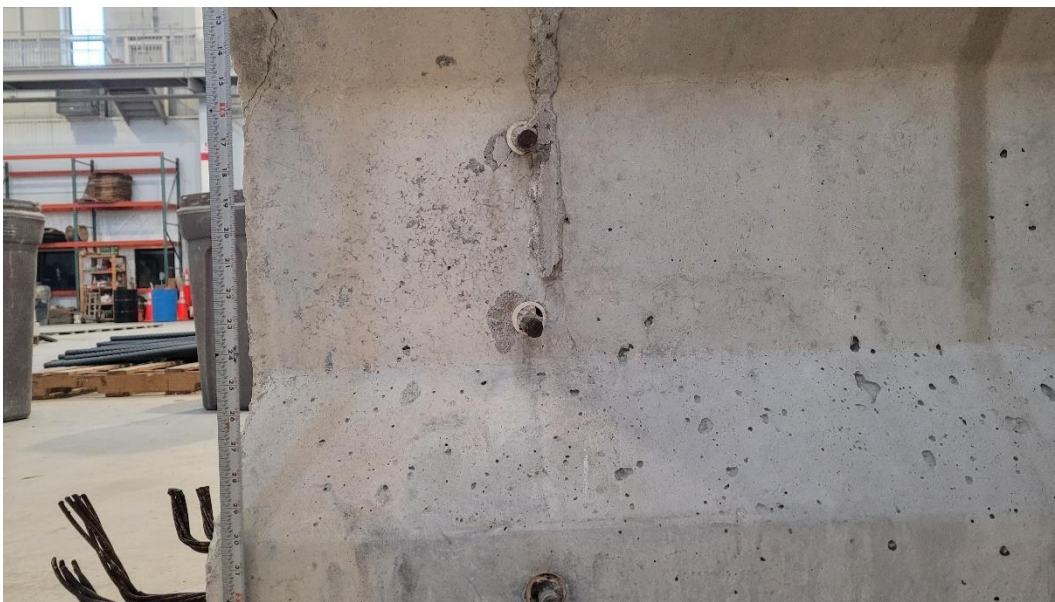
Figure 91 presents the original image inside the evaluation chamber and Figure 92 presents the image obtained during UAS inspection.

Figure 91 Exhibit 1527 of concrete element.

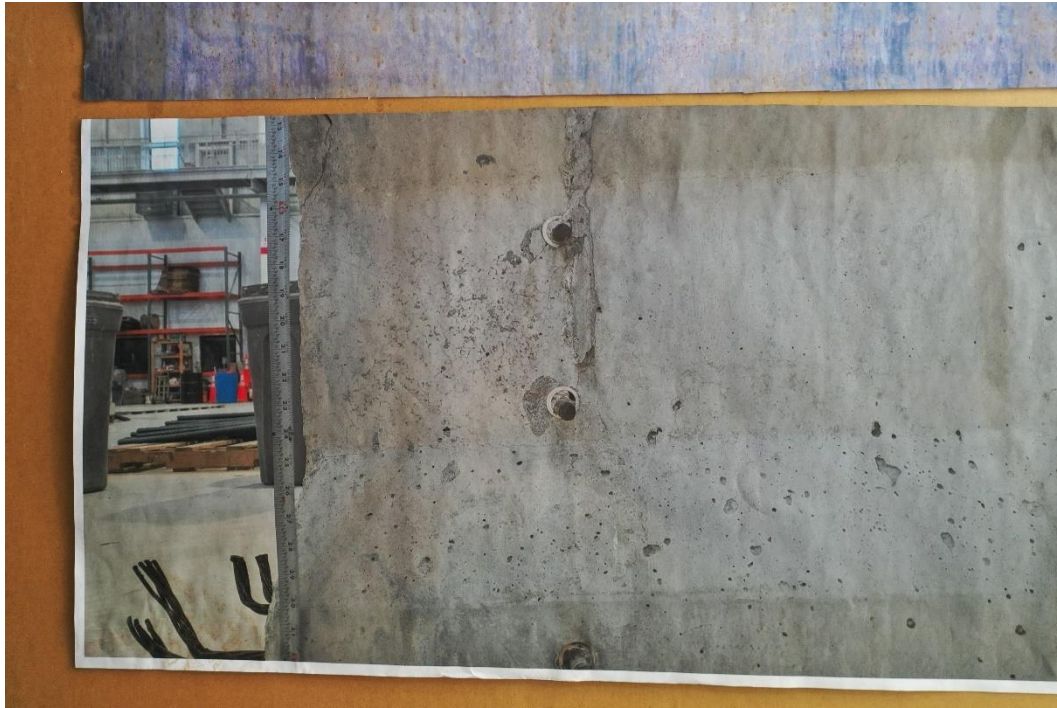
Figure 92 UAS inspection of Exhibit 1527.

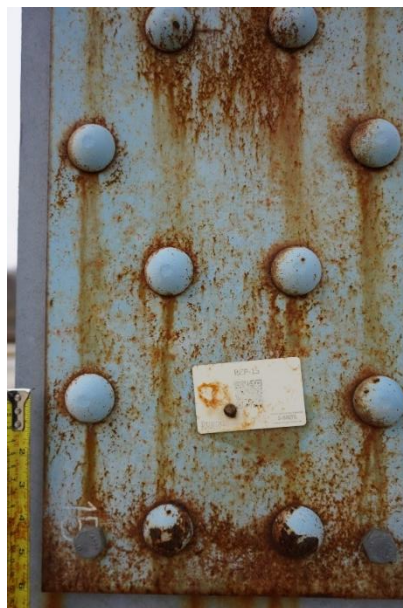
Figure 93 presents the original image inside the evaluation chamber and Figure 94 presents the image obtained during UAS inspection.

Figure 93 Exhibit 5675 of steel element.

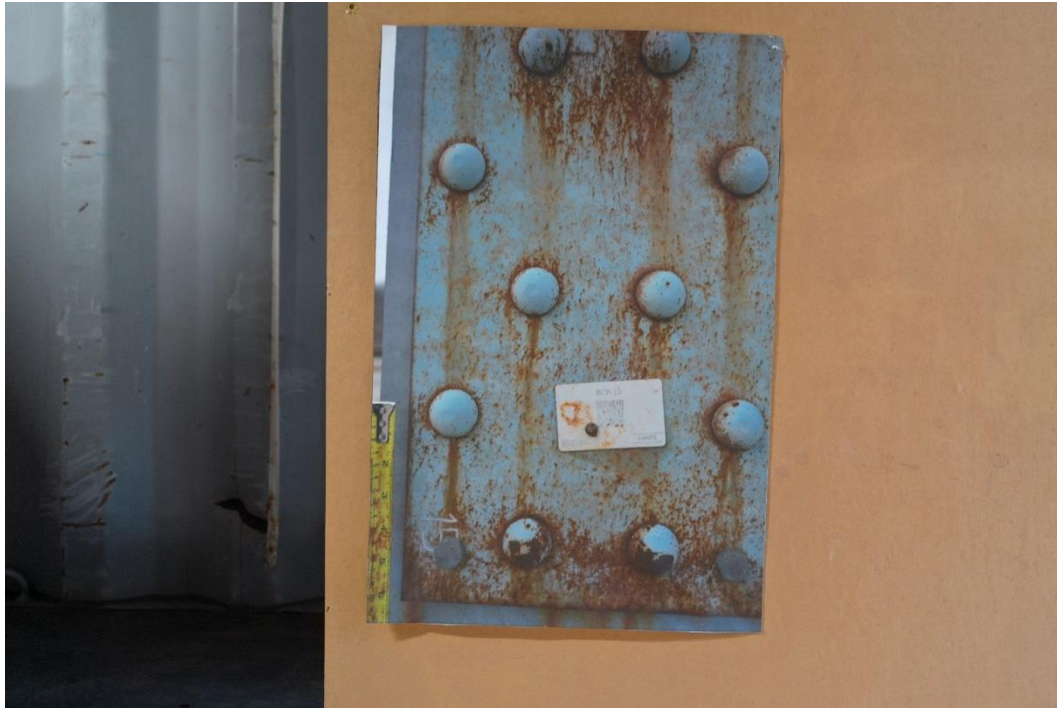
Figure 94 UAS inspection of Exhibit 5675.

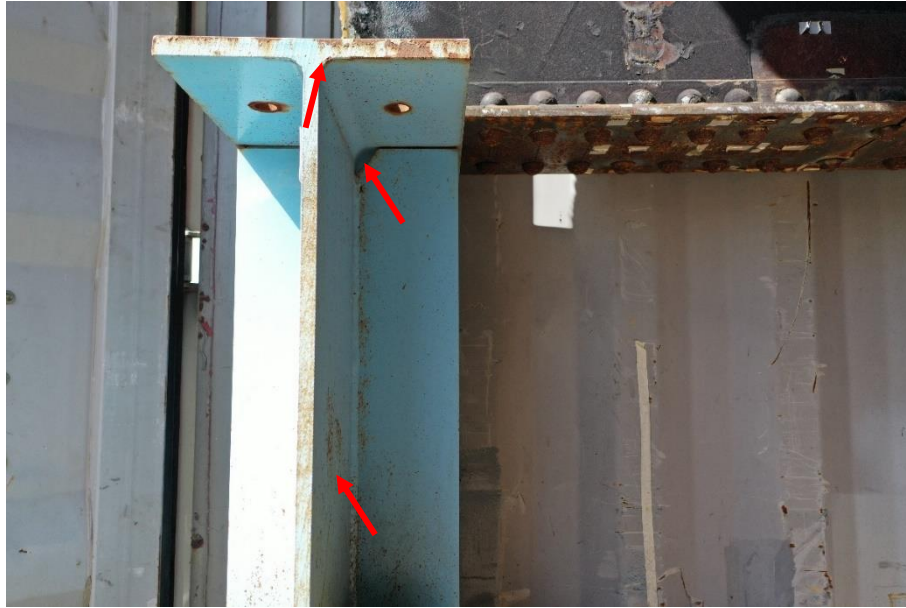
In the next pages, high-quality images are presented for steel elements located inside the container. In Figure 95 and Figure 96, defects are easily located from the images obtained, and the most relevant ones are presented with red arrows.

Figure 95 UAS inspection of steel elements.

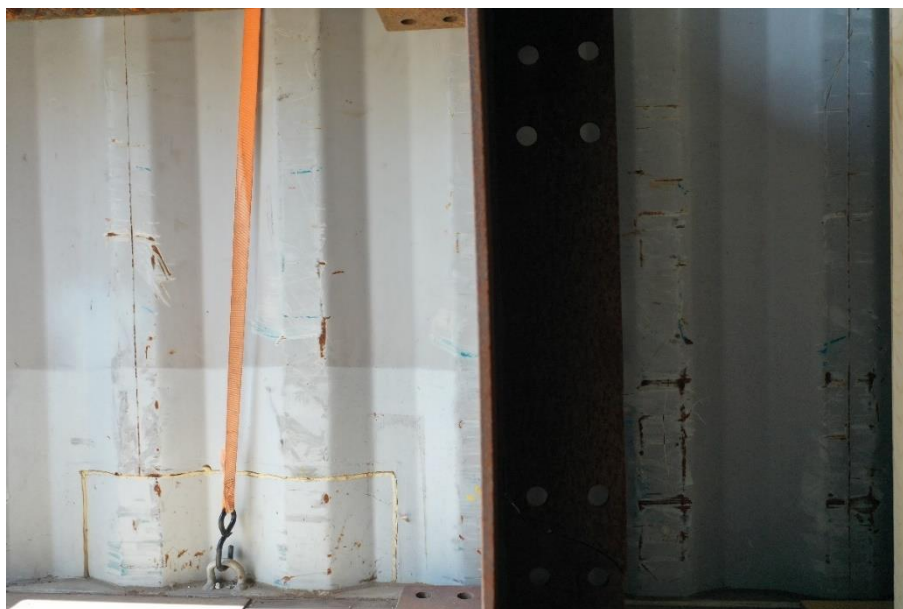
Figure 97 has been overexposed due to the change of lighting from the left side to the right side of the girder. However, information is not lost. With the use of an image editor, contrast has been adjusted to -100, exposure to 100, and shadows to 100, obtaining Figure 98, where a significant defect in terms of size missed in Figure 97 is now visible and presented in red arrows.

Figure 97 UAS inspection of steel elements.

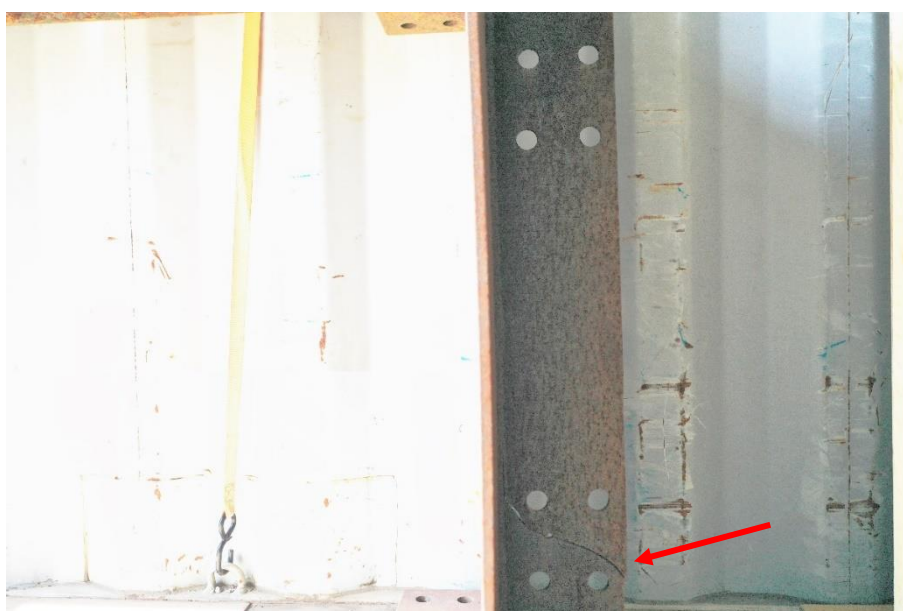
Figure 98 UAS inspection of steel elements, enhancing to see defects hidden by shadows.

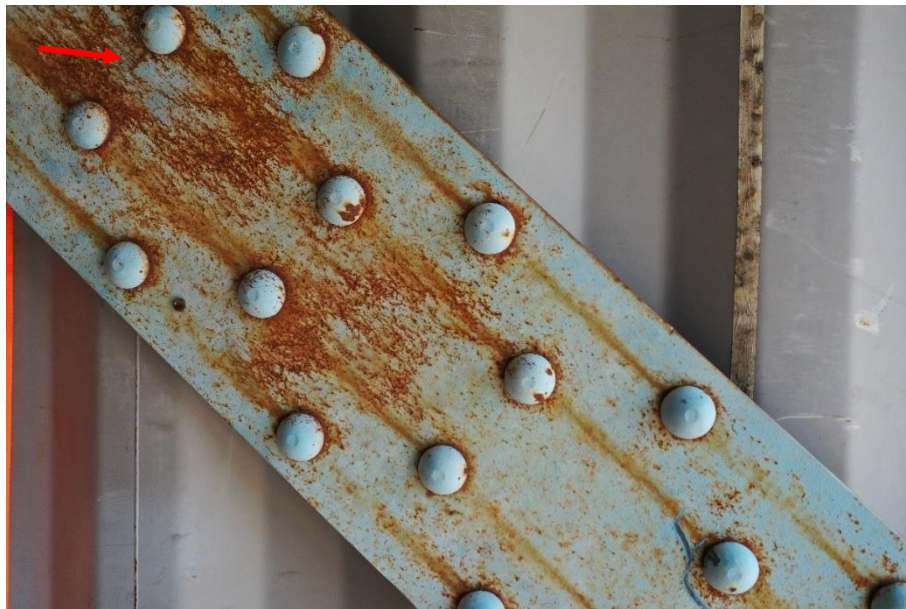
Figure 100 UAS inspection of steel elements.

A crack was identified with the images obtained during inspection in the steel element from Figure 99 and Figure 100, presented with a red arrow in both images.
