**AN EXPERIMENTAL STUDY OF THE RESPONSE OF REINFORCED
CONCRETE FRAMES WITH WOOD PANEL INFILLS TO SIMULATED
EARTHQUAKES**

A Thesis

Master of Science in Civil Engineering

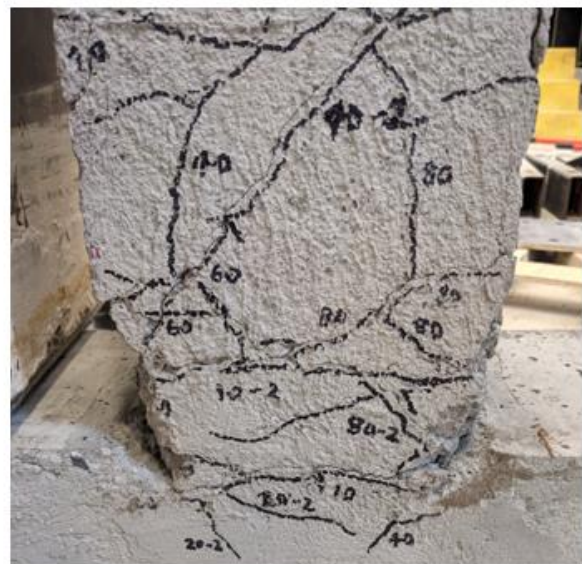
(c) South Column West Face – Base

Figure 2-11: Inherited Condition of Frame 1 Columns

Frame 1 had undergone 56 in-plane and 22 out-of-plane runs and had a 3/8" residual in-plane drift towards the South prior to its first test series with wood infill. Spalling was most severe at column bases and was concentrated below the location of the first external post-tensioning

device, 3" above the joint (Figure 2-11). All columns had large flexural cracks both at the joint face and approximately away 3" from the joint face. Smaller flexural cracks at mid-height of the columns had formed. Local crumbling of concrete often occurred beneath contact surfaces of external post-tensioned clamps. Flexural cracks were no wider than 0.005". In-plane inclined shear cracks of widths between 0.01" and 0.075" were present near column ends.

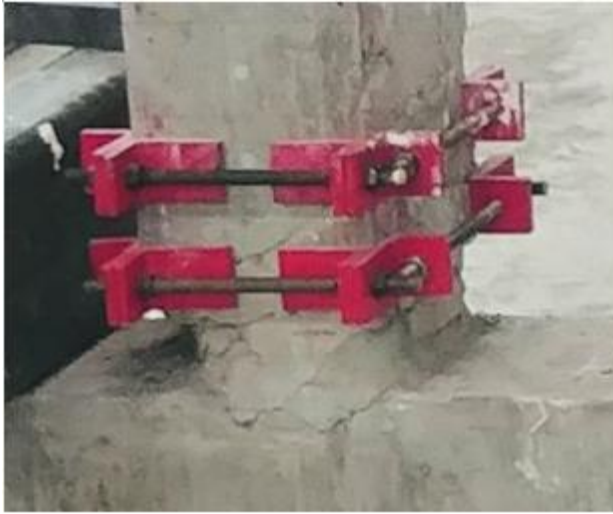
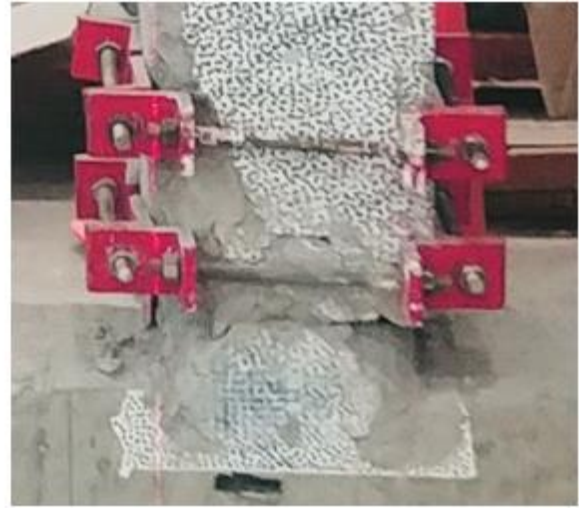
(a) North Column Base – West Face

(b) South Column Base- West Face

Figure 2-12: Inherited Condition of Frame 2 Column Base¹

¹ The bottom post-tensioned clamp had been prior to each photograph to better display spalling at the column bases.

Frame 2 had undergone 97 in-plane and 0 out-of-plane runs and had a 1/8" residual in-plane drift towards the South prior to its first test with wood infill. Severe flexural cracking had occurred at each column-joint face. Concrete spalling at column bases was more severe than in Frame 1 and reached up to the location of the third external post-tensioning device, 9" above the joint (Figure 2-12). Longitudinal reinforcement was exposed in the south column but had not buckled. Inclined cracks on the south column, east face, were as large as 0.1". Thin flexural cracks near column mid-height were present. Figure 2-13 shows the extent of spalled column concrete and a photograph of the mortar repairs performed prior to Series F2-C-4PB.

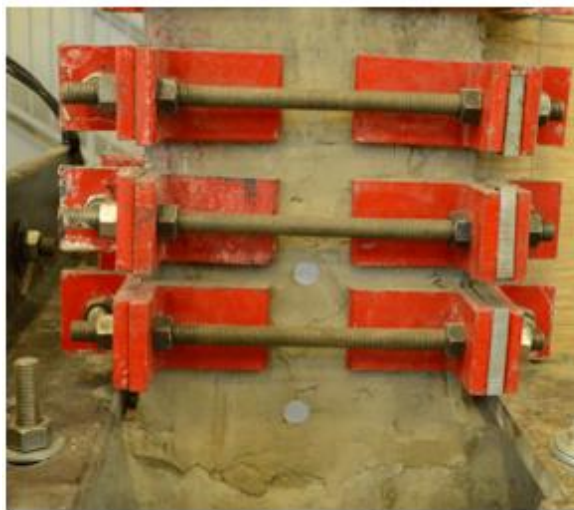
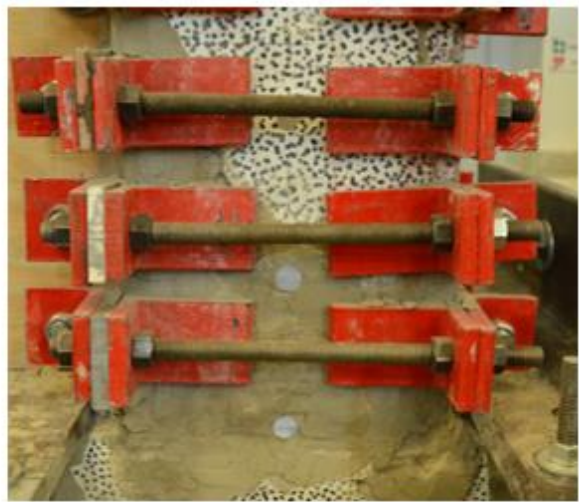
(a) North Column Base – West Face

(b) South Column Base- West Face

Figure 2-13: Mortar Repaired Frame 2 Column Base²

² Image taken prior to series F2-C-4PB. Mortar repairs were performed prior to all non “-R” series

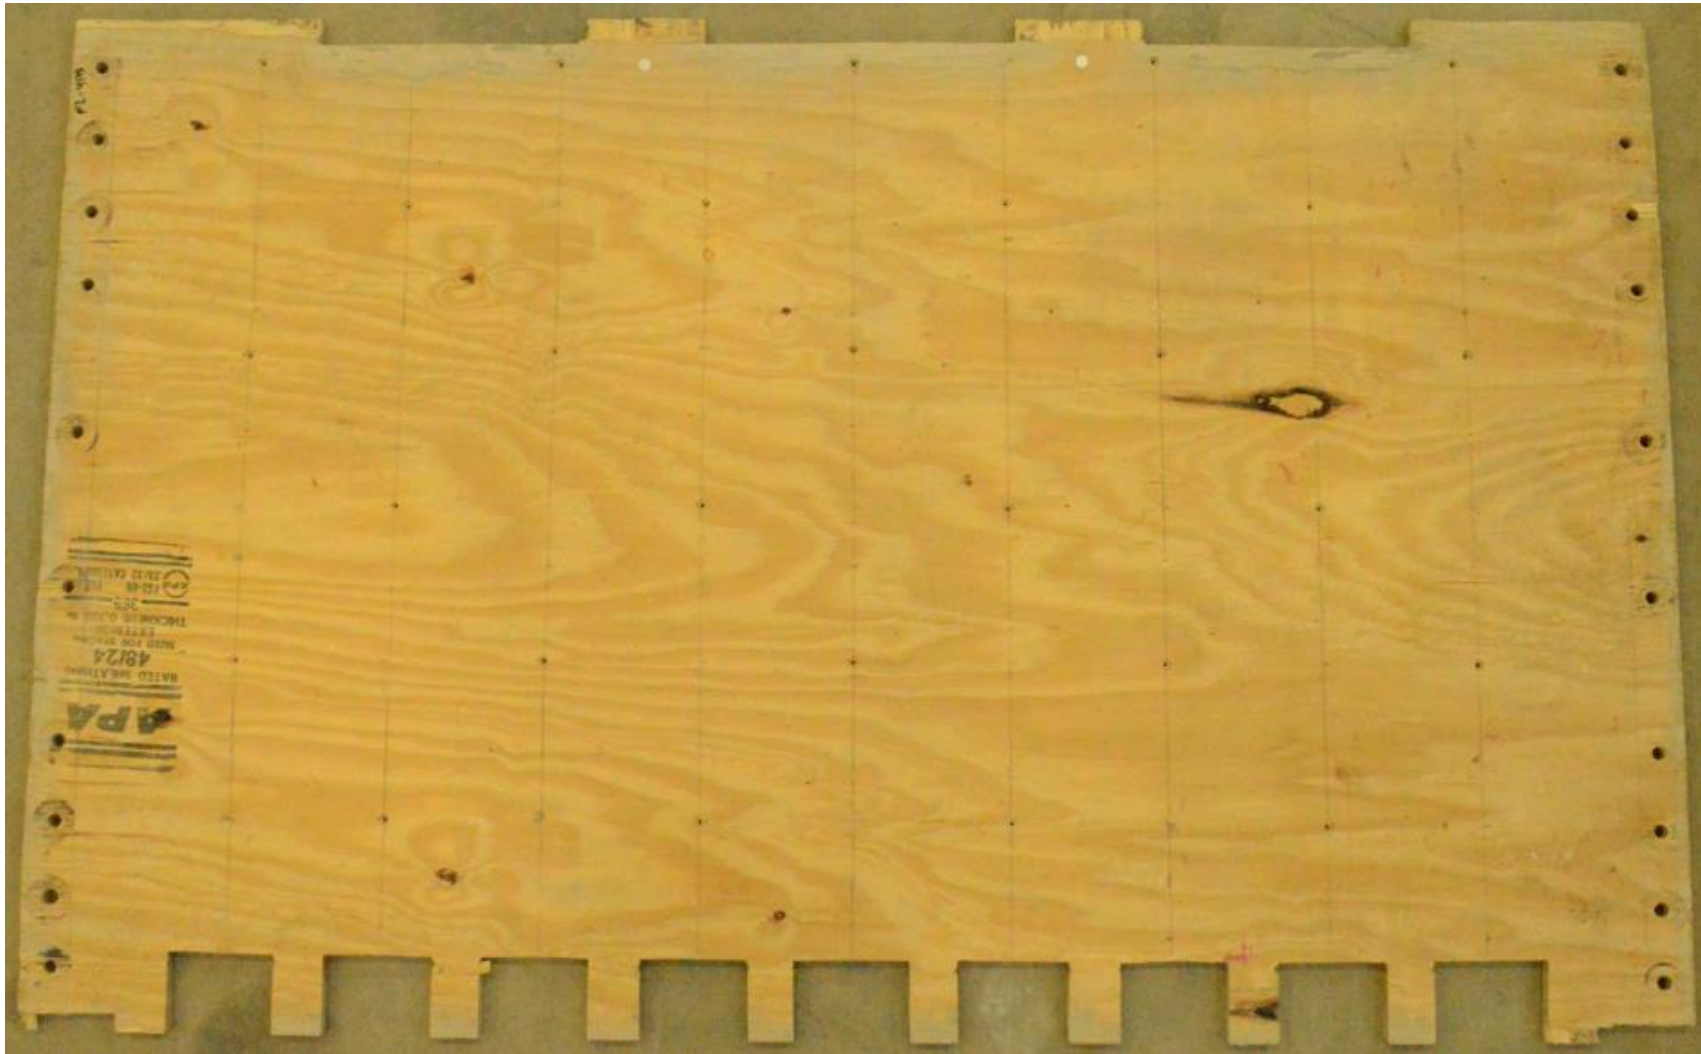
Figure 2-28: Wood Infill Photograph¹

¹Displaying the western-most panel in the 4PB infill of used series F2-C-4PB. Damaged at some edges. Vertical pencil lines denote lamination screw gridlines

The single 64"x40" rectangular bay within Frames 1 and 2 was filled by lateral-load participating plywood infills. Wood infills were constructed in 1PB (0.70" net thickness, 1-panel), 2PB (1.41", 2-panel), and 4PB (2.81", 4-panel) thicknesses. Edge gaps between infill and frame were a maximum of 1/4" wide, depending on the uneven geometry of the damaged column concrete. Edge gap width was precisely monitored during construction due to the sensitivity of infilled frame response to edge gap (Fiorato et al., 1970). In Series F2-C-4PB, mortar was pushed into edge gaps and cured for 14 days to form the bearing edge-joint. In all other test series, wooden shims were driven from alternating sides by hammer and glued to form the edge-joint.

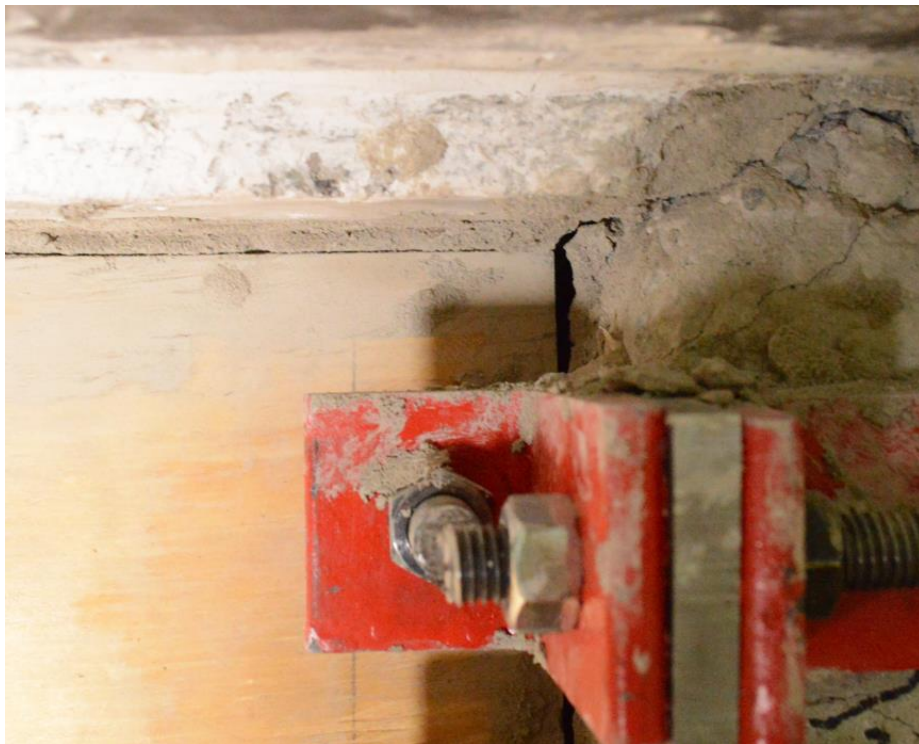
Figure 3-7: Mortar Edge-Joint after Deterioration during Series F2-C-4PB

During the first 60% motion, all mortar in the bearing edge-joint crumbled within 6" of the corners (Figure 3-7). Mortar used to repair the columns had spalled off the column bases. Rotations in columns were concentrated at the flexural cracks near the column top and bottom joint faces. Rotations also concentrated at flexural cracks approximately 3" below the top joint face (marked in Figure 3-8 and Figure 3-9). Damage to the infill was limited to a 5" single-ply split at the top of the infill (Figure 3-10). During the 80% motions the peak drift was 0.75" north (1.5%) and the peak lateral force was 44 kips.

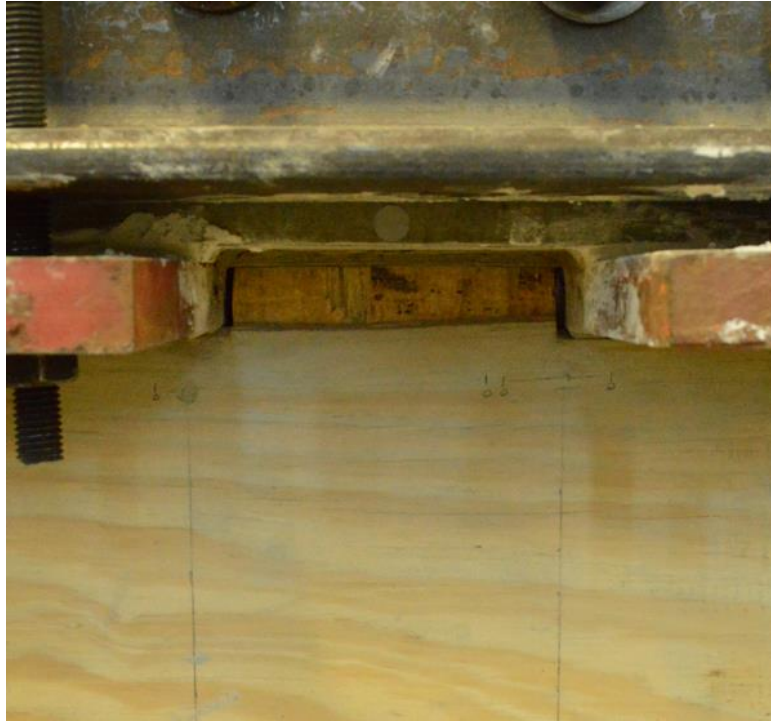
Figure 3-10: Single-ply Splitting at Infill Top, Western Face after Run 104 of Frame 2, Series F2-C-4PB

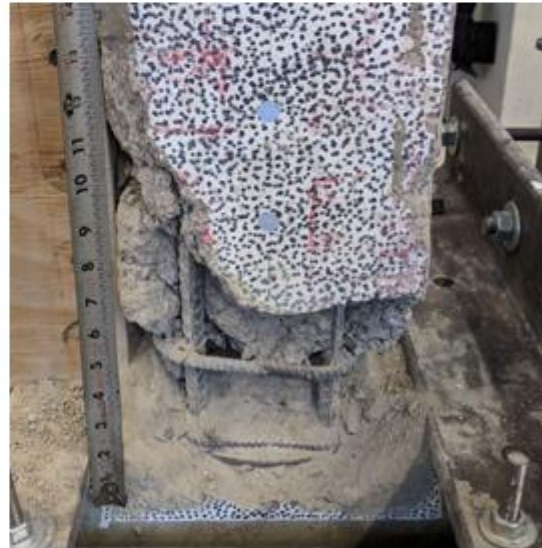
(d) South Column without Clamps

Figure 3-12: Column West-face Base Concrete Spalling after Series F2-C-4PB

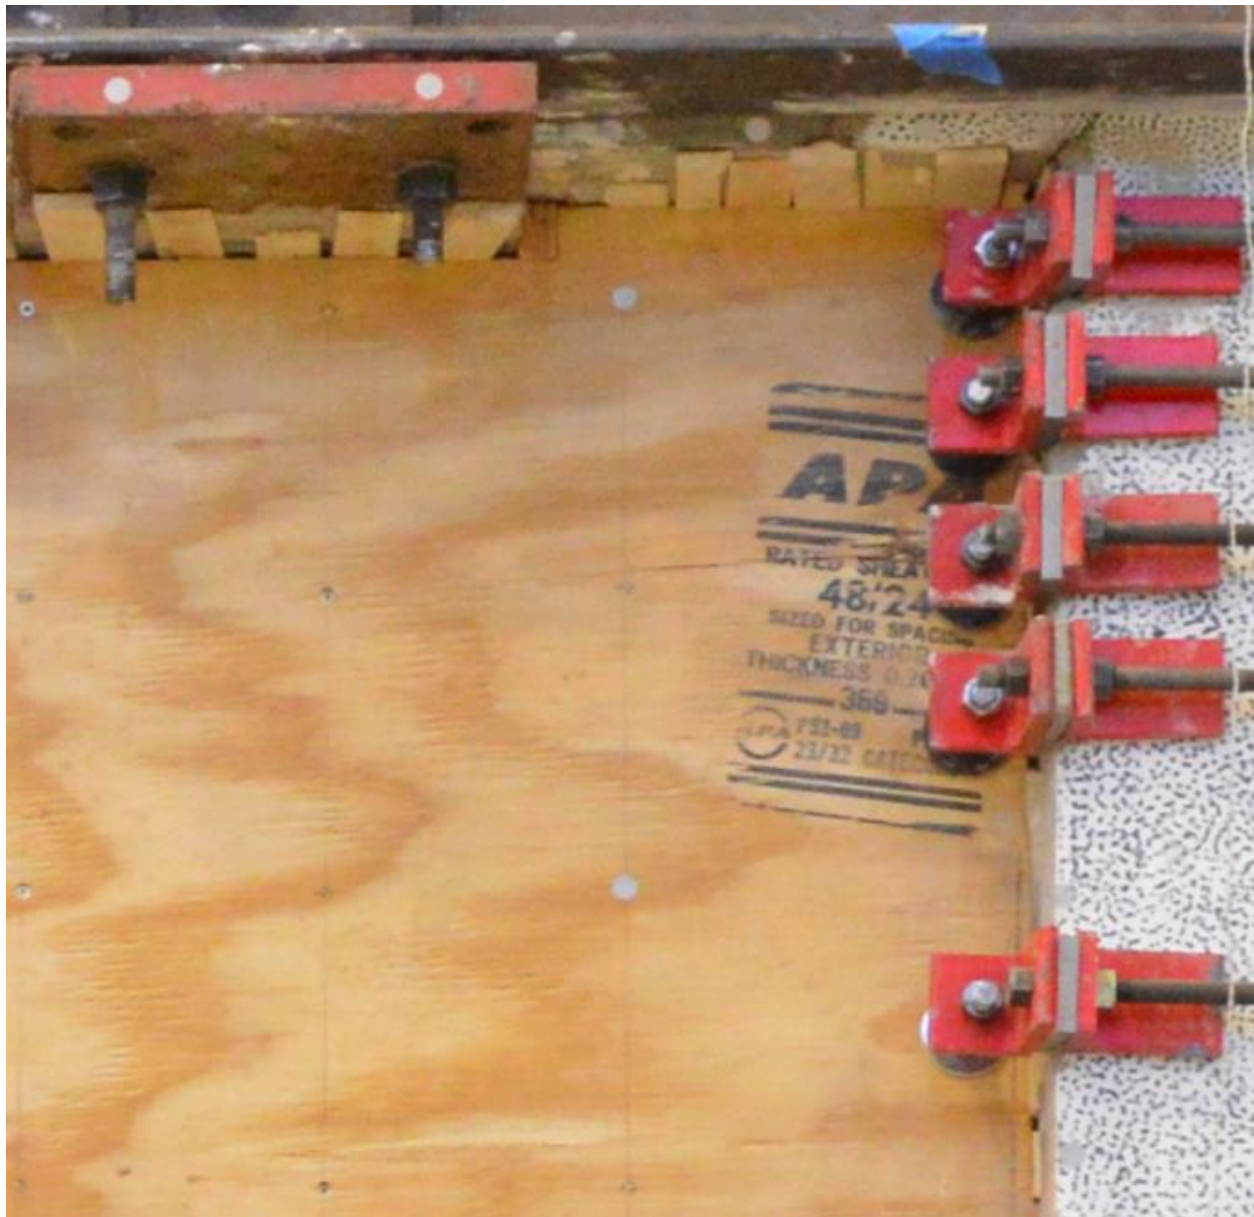
Figure 3-13: Shim Filled Edge Gap, Series F1-C-2PB

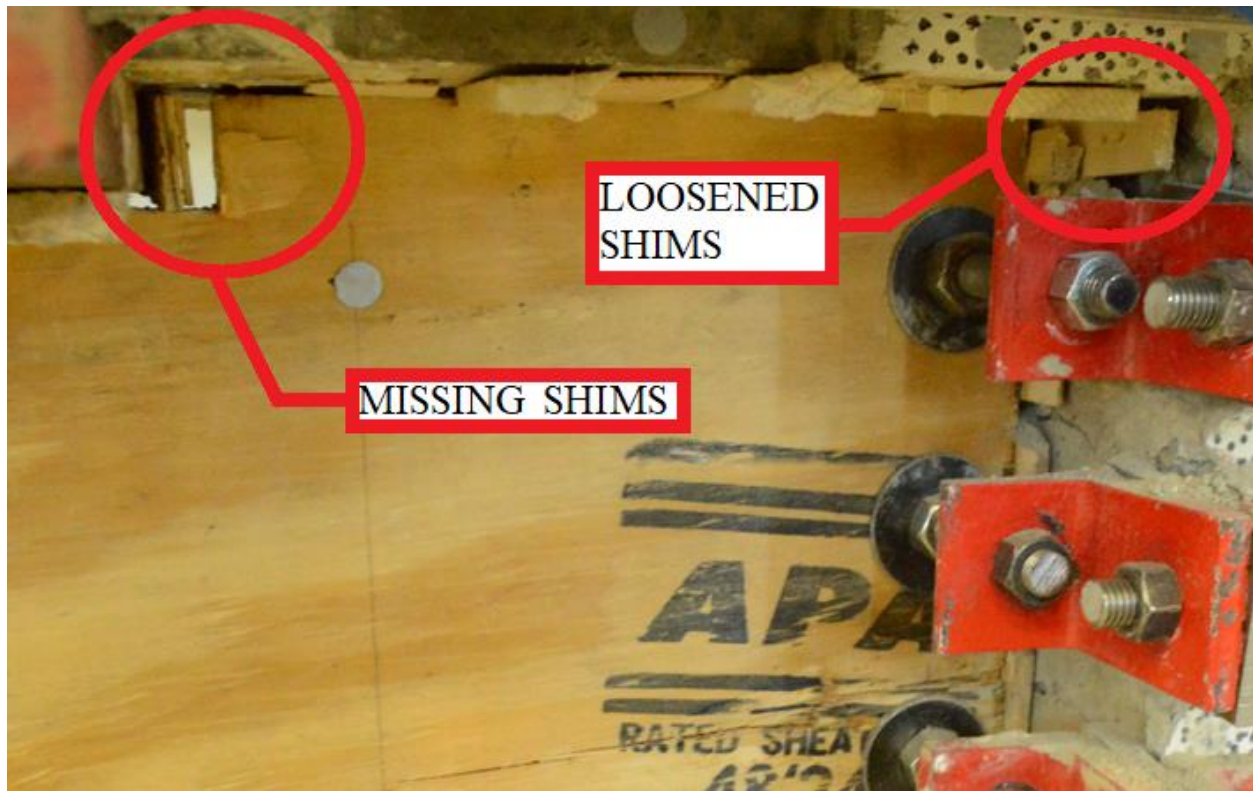
Figure 3-15: Deterioration of Shim Edge-Joint after Frame 1 Run 86, Series F1-C-2PB

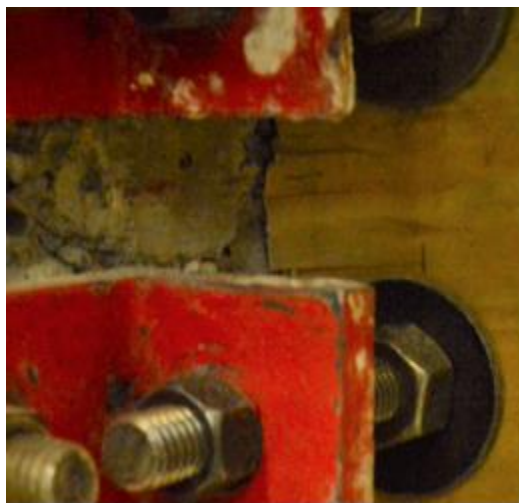
(b) East face, South Column Top

Figure 3-16: Edge Crushing of Infill, Series F1-C-2PB

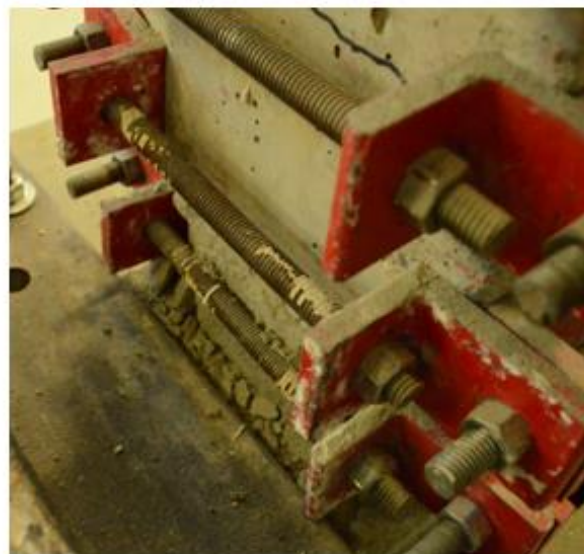
(a) South Column Base East Face
Repaired condition

(b) South Column Base East Face
condition after Run 89

(c) South Column Base South Face
Repair Mortar Spalling after Run 89

Figure 3-17: Column Base Mortar Crumbling, Series F1-C-2PB

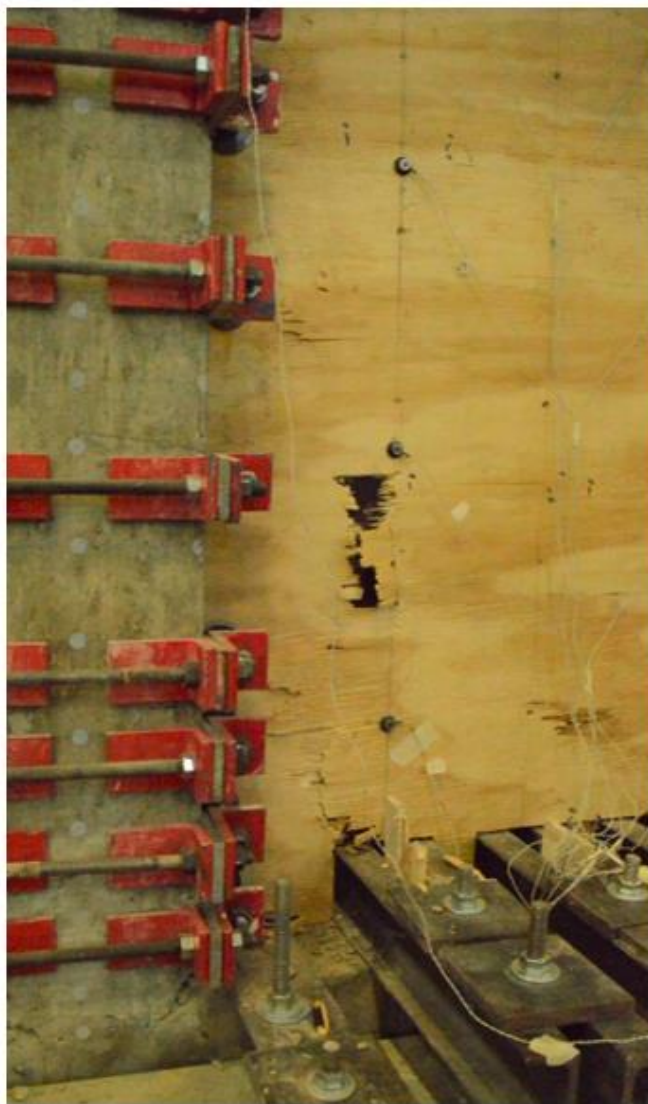
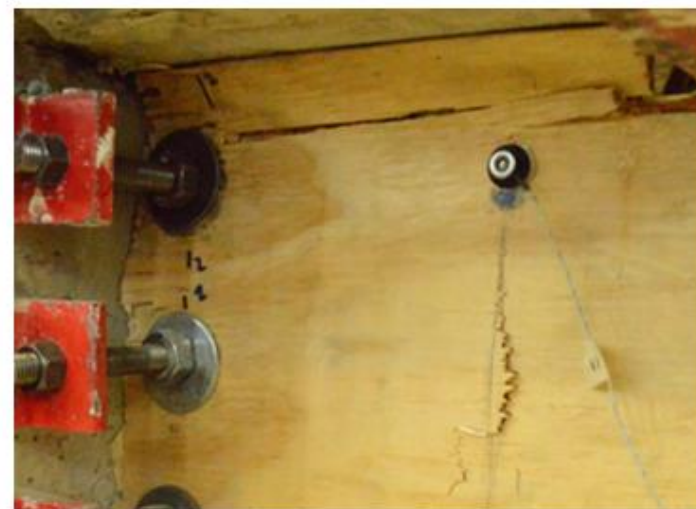
(a) North Edge Splitting, West Face

(b) South Edge Splitting, West Face Bottom

(c) North Edge Crushing, West Face Top

Figure 3-20: Infill Damage after Frame 1 Run 107, Series F1-C-1PB

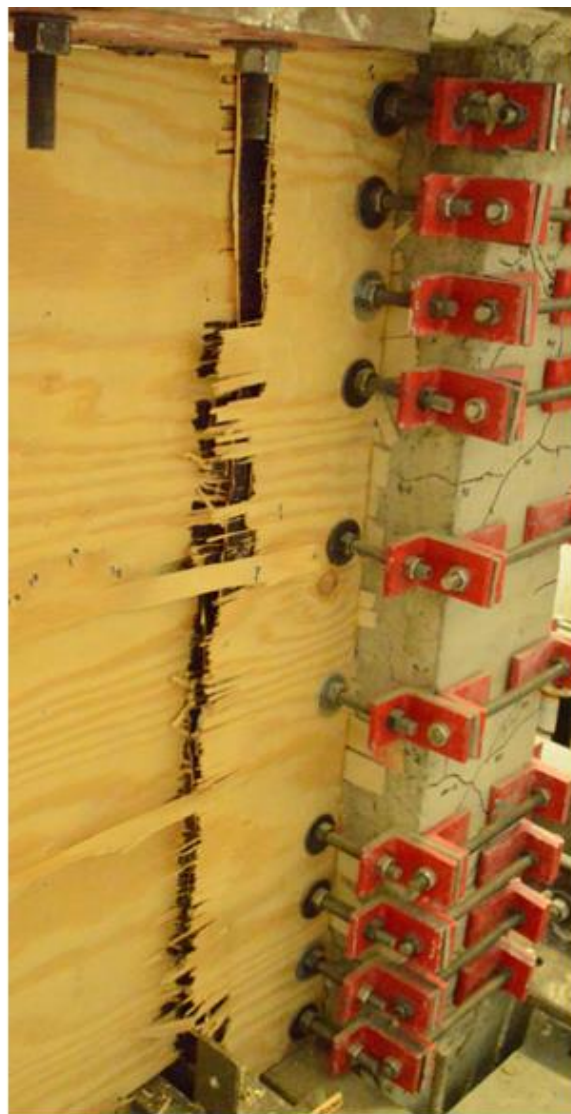
(a) Full-Thickness Failure, North Edge West Face

(b) Full-thickness Failure, North Edge East Face

Figure 3-22: Infill Failure after Frame 1 Run 108, Series F1-C-1PB

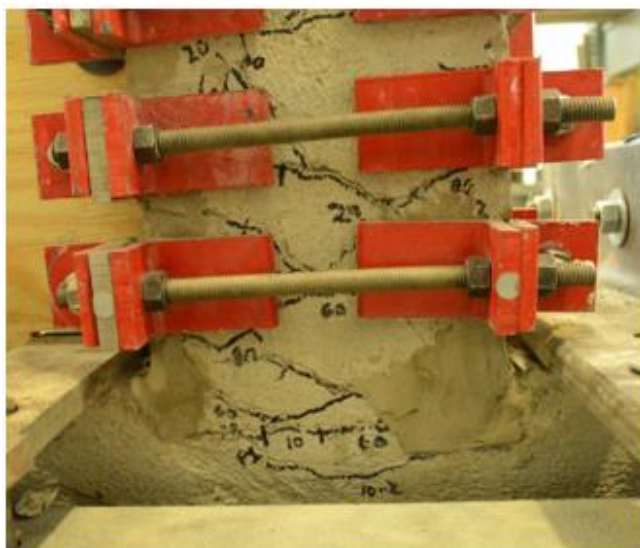
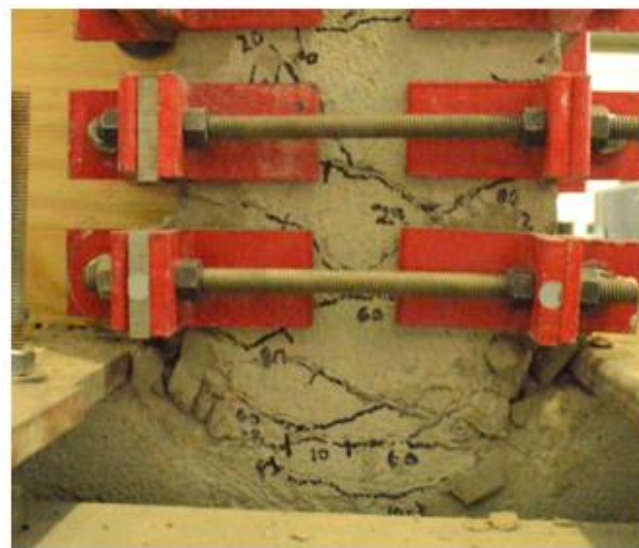
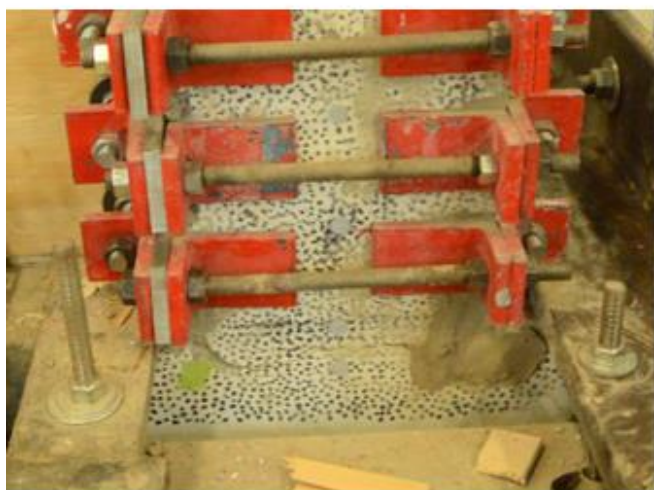
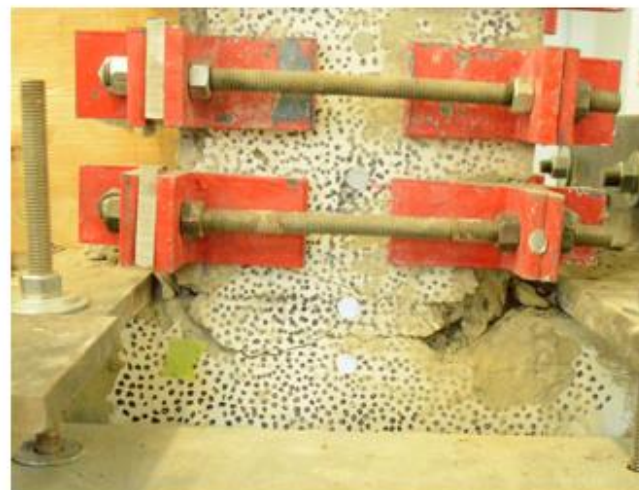
(a) North Column East Face, Repaired

(c) North Column East Face after Frame 1 Run 108

(b) South Column West Face, Repaired

(d) South Column West Face after Frame 1 Run 108

Figure 3-23: Column Base Damage after Series F1-C-1PB

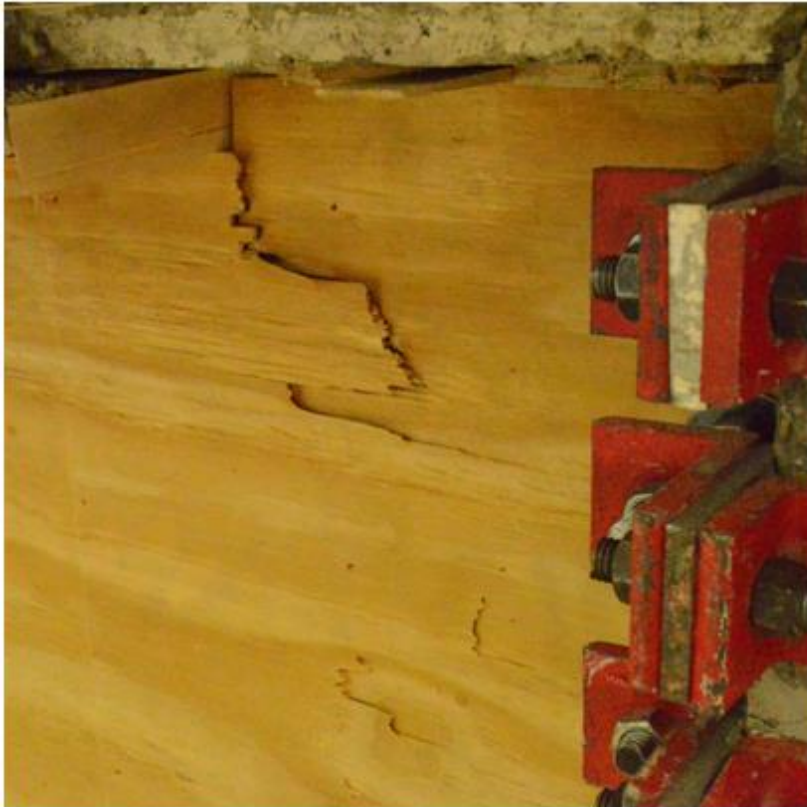
(a) East Face

(b) West Face

Figure 3-39: Infill Damage after Frame 2 Run 148, Series F2-R-C-1PB

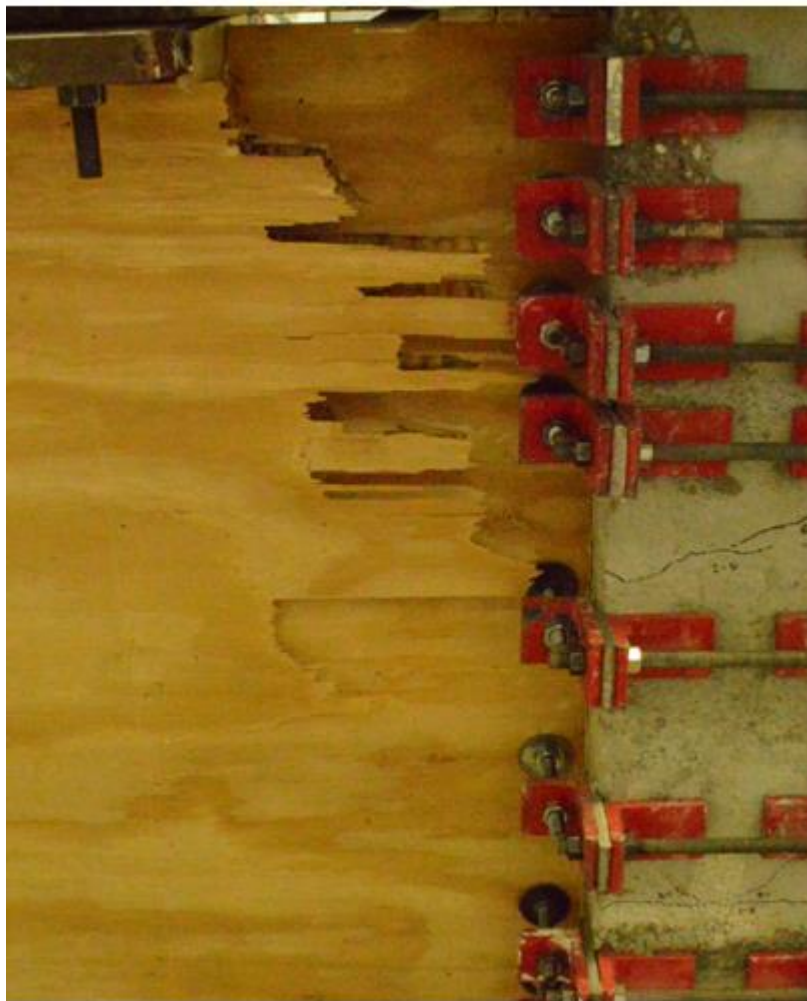
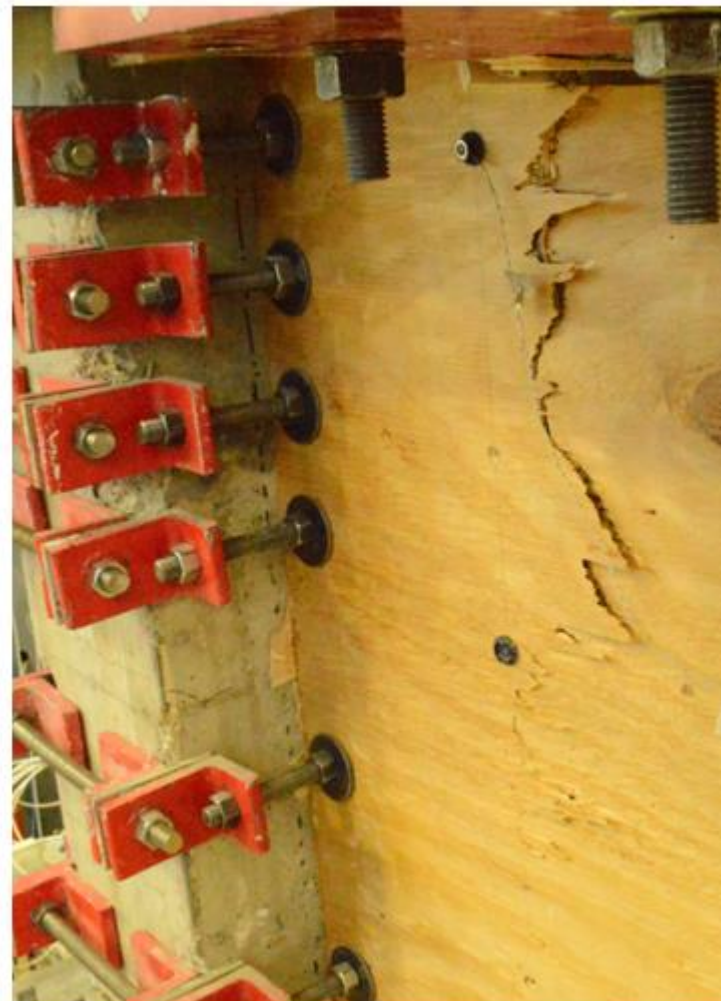
(a) East Face

(b) West Face

Figure 3-41: Infill Failure after Frame 2 Run 149, Series F2-R-C-1PB

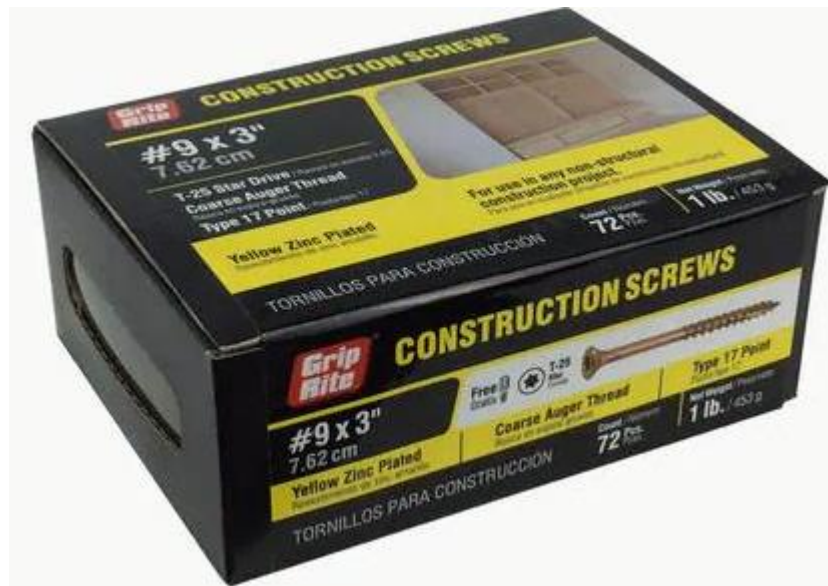
Figure A-7: #9 x 3" GripRite Construction Screws

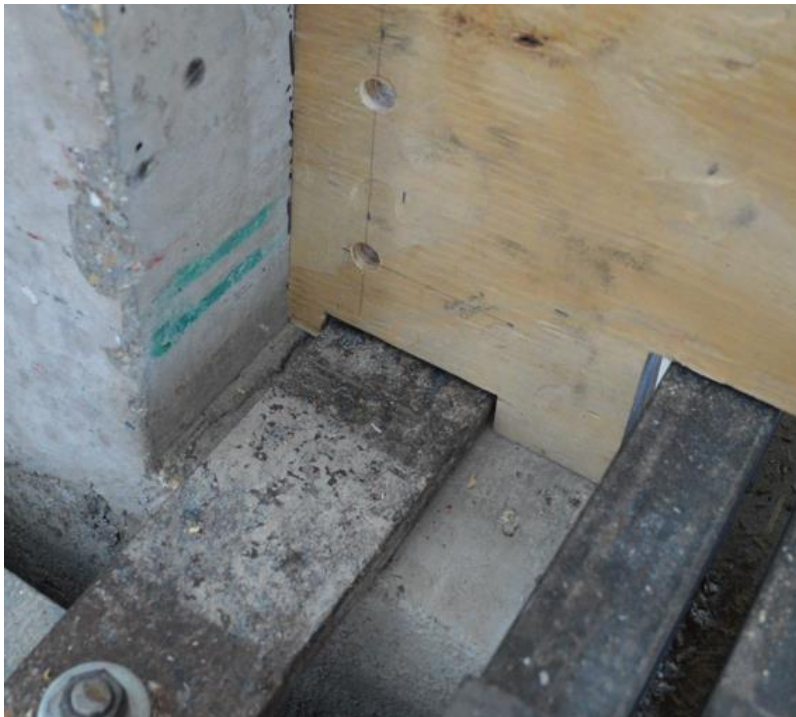
Figure A-12: Typical Infill Corner Cutout

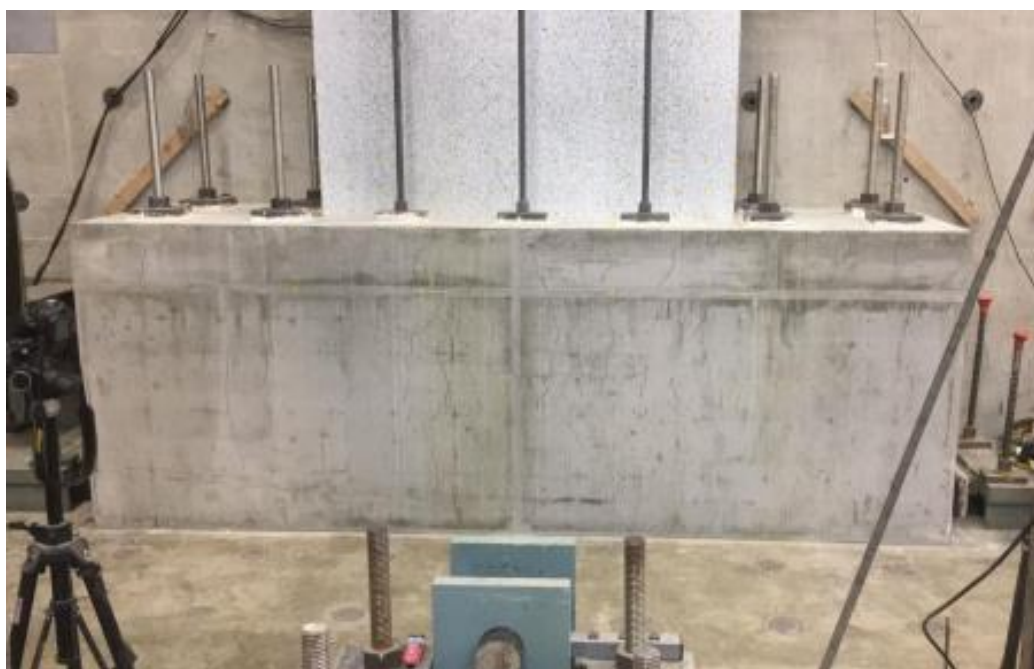
Figure A-14: Reinforced Concrete Block (External Suspended Mass) as a Foundation Block
Constructed by Pollalis (2021)

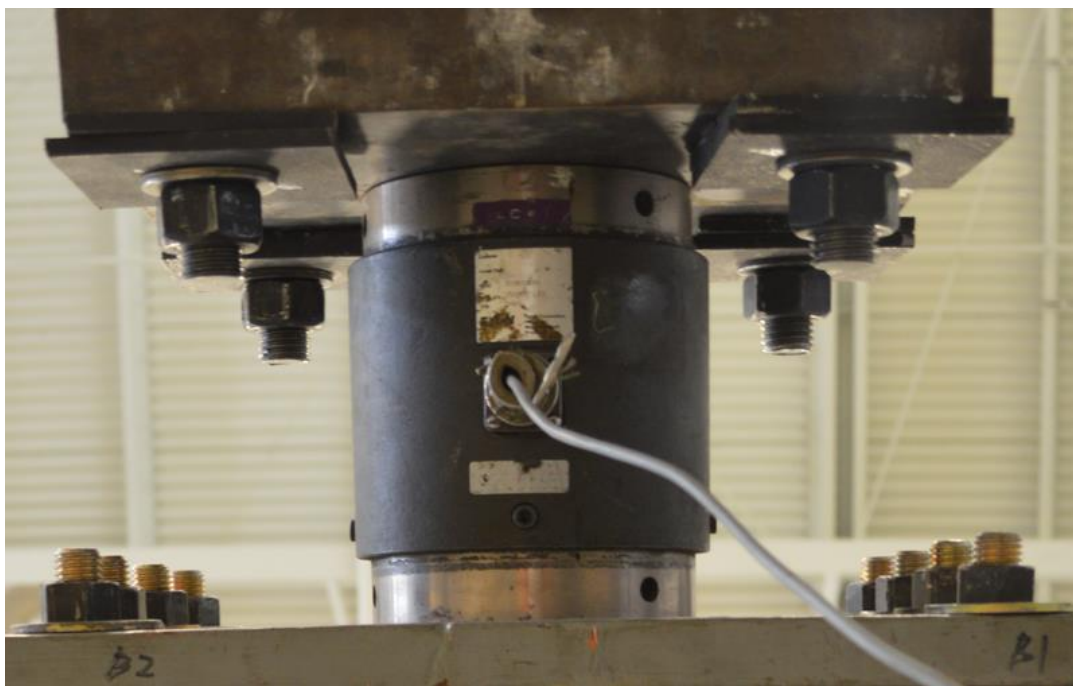
Figure B-4: Lebow 3156-100K Load Cell
