POST-FIRE ASSESSMENT OF CONCRETE IN BRIDGE DECKS

A Thesis

Master of Science in Civil Engineering

August 2019

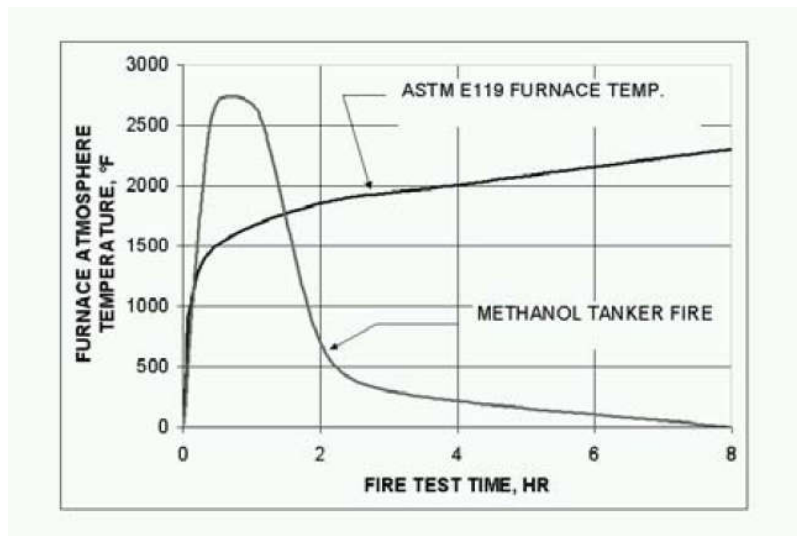
Figure 2-1. Temperature vs. Time for ASTM E119 Furnace and Methanol Tanker Fire (Stoddard, 2014)

In 2002, a railroad tanker collided on a prestressed girder bridge and caused a fire under the bridge, and the incident was inspected by the Washington State Department of Transportation (WSDOT), and reported by Stoddard (2004). About 30,000 gallons of methanol was consumed during the fire. The flame temperature of the fire was estimated to be around 3000°F (1649°C). This study also showed the comparison of temperature vs. time curves between furnace test according to ASTM E119 and methanol tanker fire, as shown in Figure 2-1, which indicates that although methanol fire can cause higher temperature compared to furnace heating, the duration of high temperature period is shorter than the duration of elevated temperature period in the furnace tests. According to Stoddard (2004), it is likely that the temperature of the bottom of the girders reached to almost 2700°F (1482°C) after only 30 minutes.

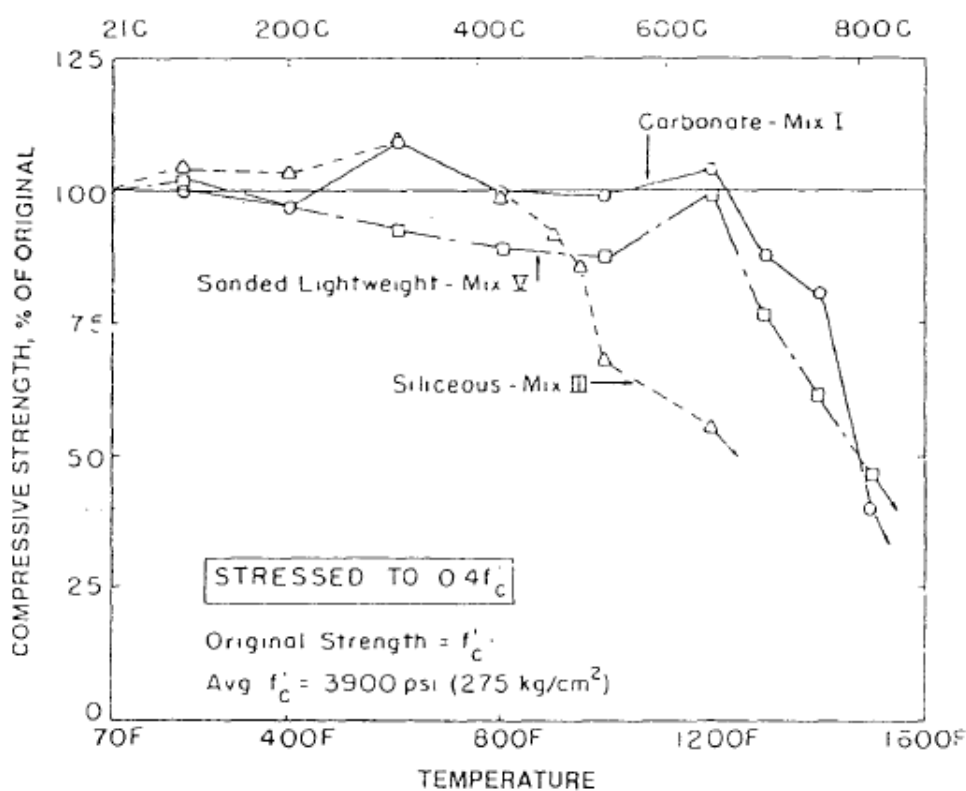
Figure 2-3. Compressive Strength of Concrete at High Temperatures (Griffin and Beavis, 1992)

Siliceous aggregates include silicon dioxide. For siliceous aggregates, they do not undergo any chemical changes within the temperature range of fire tests. Figure 2-3 also shows the change of compressive strength at elevated temperature for concrete using different types of aggregate. As shown in Figure 2-3, the strength of concrete with all types of aggregates starts to reduce when temperature reaches to about 800 °F (about 400 °C), which is also the temperature that calcium hydroxide (CH) in concrete decomposes.

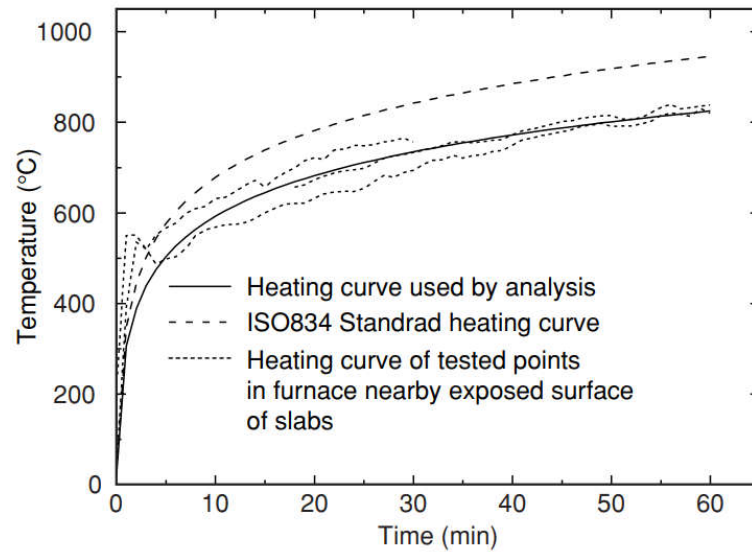
Figure 2-5. Surface Temperature Compared with ISO 834 Standard Heating Curve (Zheng, 2008)

The results from Zheng (2008) is shown in Figure 2-5. From the figure, it is found that the tested temperature curve from thermocouples that were located near the exposed slab surfaces (short dashed line) was slightly lower than ISO 834 standard fire temperature (long dashed line), during the furnace test. This tested temperature measurements will be compared with the temperature measurements from this project tests in the future chapters.

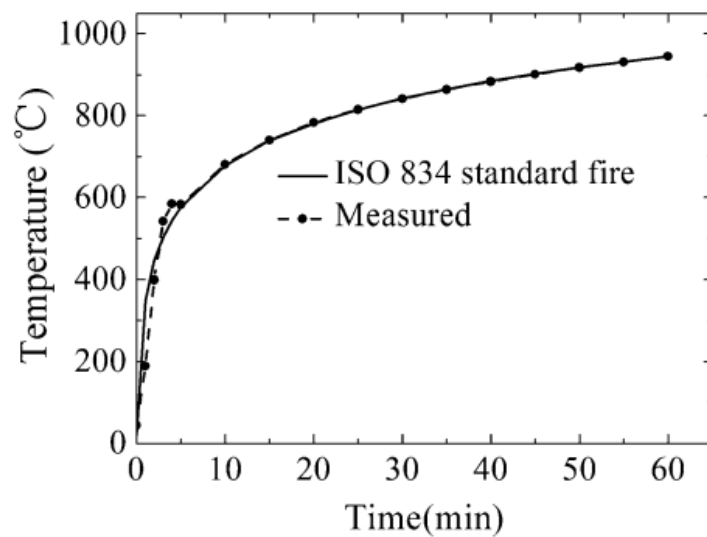
Figure 2-6. Measured Temperature in the Furnace during Fire Tests (Hou, 2014)

Hou (2014) has also conducted a series of fire experiments using furnace as heating equipment. The heating chamber of the furnace with dimension of 3 m by 4 m by 2.46 m was used as heating equipment, and eight oil burners are located inside the furnace in order to provide thermal energy. Thermocouples were distributed throughout the chamber to measure furnace temperature during the test. Figure 2-6 shows the comparison of temperature measurement from thermocouples attached at the furnace with ISO 834 standard fire curve. The temperature results from the furnace test verified that using furnace to simulate fire event can provide very similar air temperature compared to standard fire temperature curve. The surface temperature results from Hou (2014) will also be discussed and compared with the experimental results from this project in the future chapters.

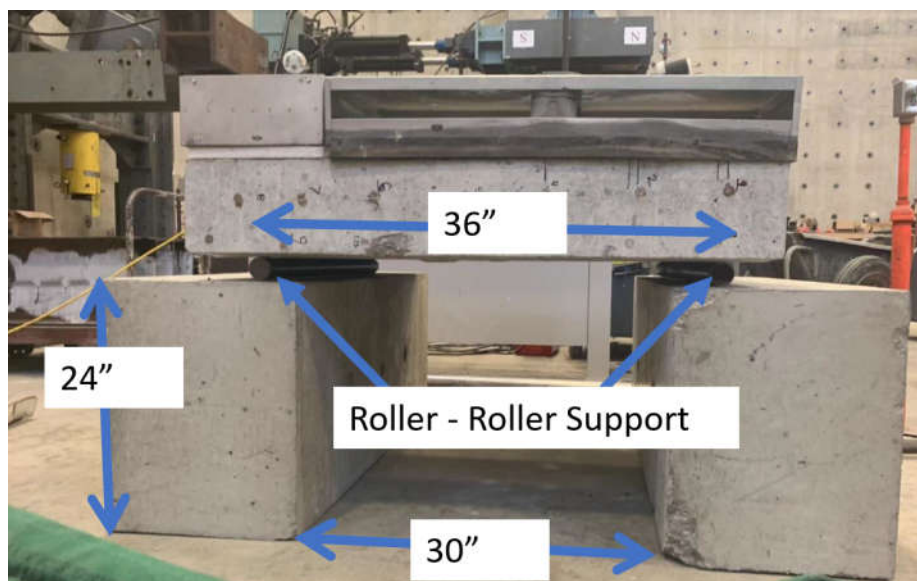
Figure 3-1. Test Setup for Heating Experiment

Two concrete deck specimens were tested for 40 minutes and 80 minutes of heating following the ISO-834 heating time-temperature curve. All deck specimens have the dimension of 48 in. by 48 in. with thickness of 8 in. The deck specimen was supported on rollers with 3 ft distance in between to allow free expansion in horizontal direction and provide supports in vertical direction. The rollers were 6 in. away from each end of the deck. The roller support system was placed on two 2 ft high concrete blocks to allow the instrumentation to be placed under the deck. The test setup is shown in Figure 3-1.

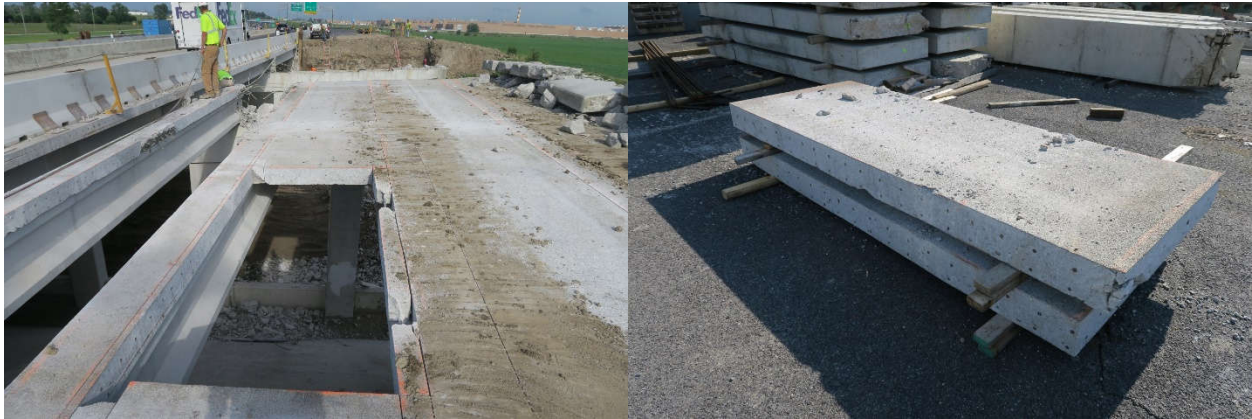
Figure 3-3. Original Deck Sections Removed from I-469

All test specimens were collected from I-469 bridge over Feighner Road, a bridge located near Fort Wayne, Indiana, whose service history was more than 30 years. Deck sections were selected from the green area shown in Figure 3-2. The deck sections were then transported to Bowen Laboratory for testing. As shown in Figure 3-3, two pieces of deck sections with

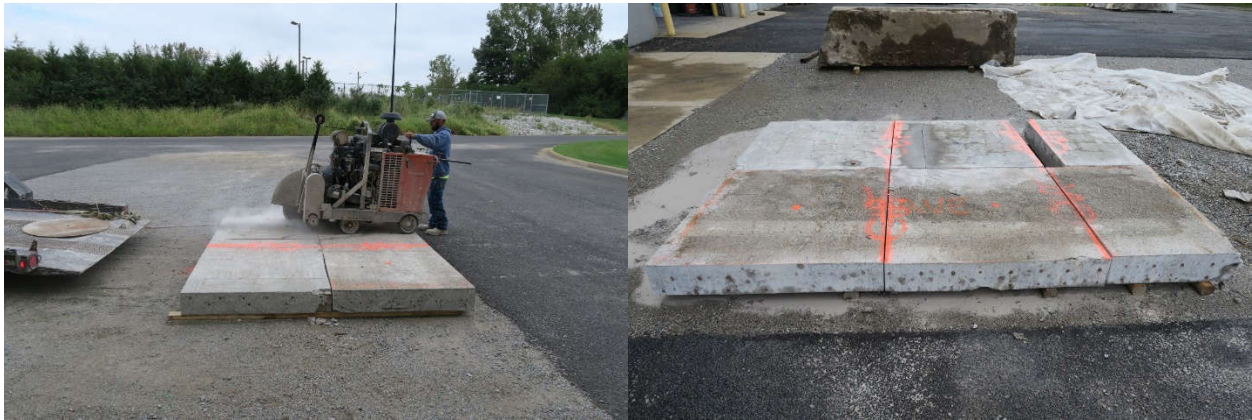
Figure 3-4. Deck Specimens Cut from the Original Deck Sections

After deck sections were transported to Bowen Laboratory, each section was cut into two deck specimens for testing, as shown in Figure 3-4. In total, four deck specimens with dimensions of 48 in. by 48 in. were cut from the original sections.

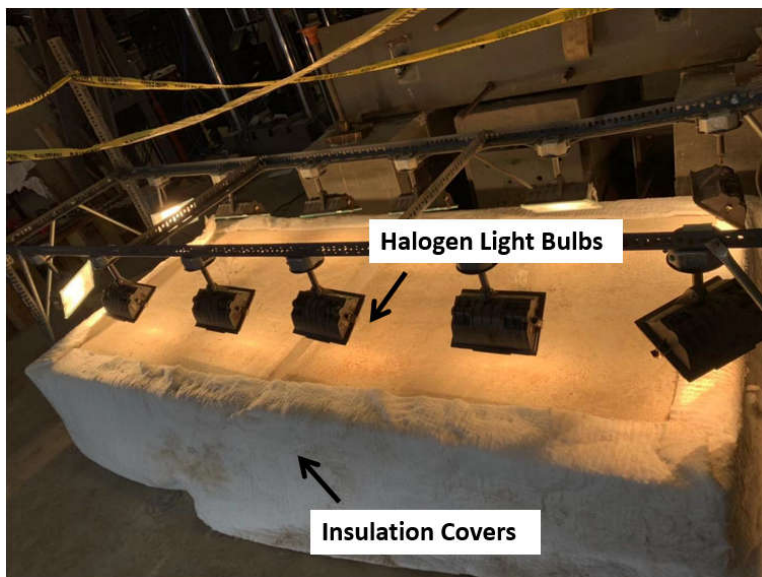
Figure 3-5. Halogen Lamp System

All deck specimens were placed under the halogen lamp drying system for two weeks in order to evaporate excessive surface moisture from the specimens. The halogen lamps drying system were located about 6 in. above the deck specimens to ensure that the concrete surface temperature does not exceed around 140°F (60°C); such temperature is high enough to evaporate surface moisture and dry out the specimen, but it will not remove the chemically bonded water from various hydrated phases present in hardened concrete. The halogen lamps drying system is shown in Figure 3-5.

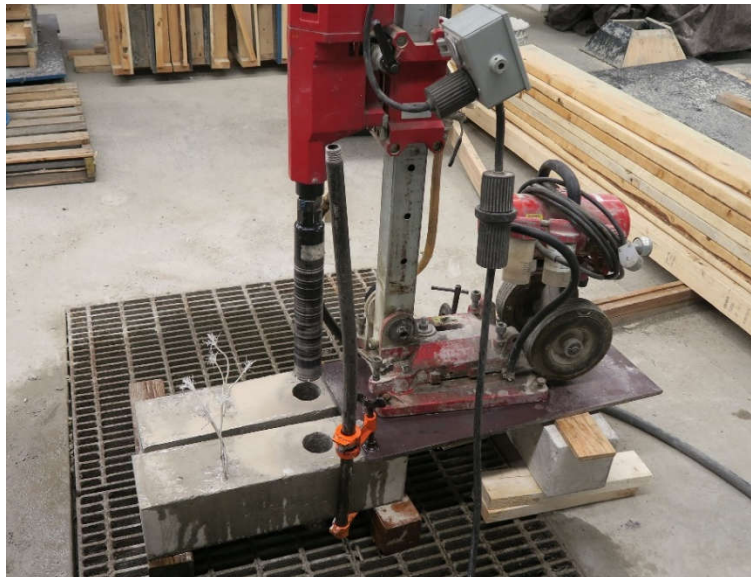
Figure 3-7. Drilling Process after the Curing Process of Small Beam

During the casting process, one set (Set A) of thermocouple trees was installed before casting, as shown in Figure 3-6. After the beam had been cured for a week, a 2 in. diameter hole was drilled to insert another set (Set B) of thermocouples, as shown in Figure 3-7 and Figure 3-8.

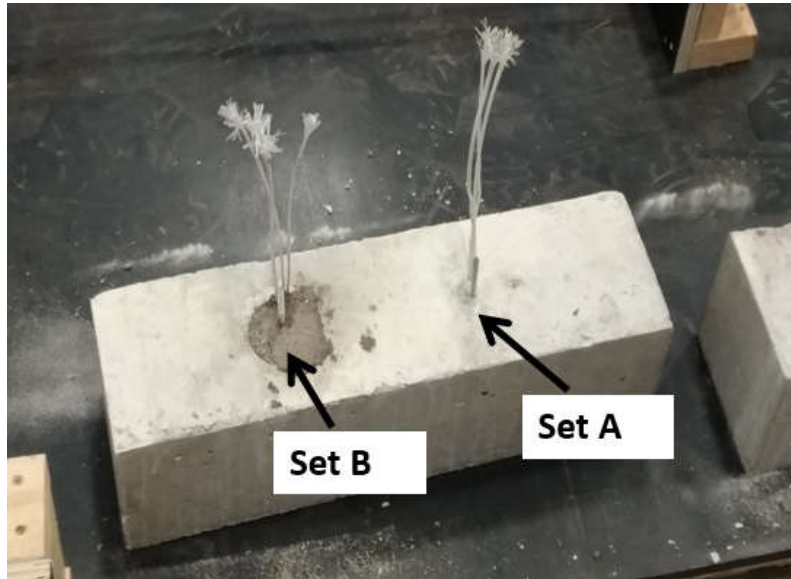
Figure 3-8. Installation of Thermocouple Tree after Casting

Once both sets of thermocouple trees were installed, packaged concrete mix was filled in the hole and cured for another week. Then the small beam was oven dried for one week with the heating temperature controlled by the oven, as shown in Figure 3-9. The oven temperature was set to 140°F (60°C) in order to evaporate the excessive surface moisture but not to break the chemically bonded water inside concrete inside the concrete. Two surface thermocouples were also installed for measuring the surface temperature.

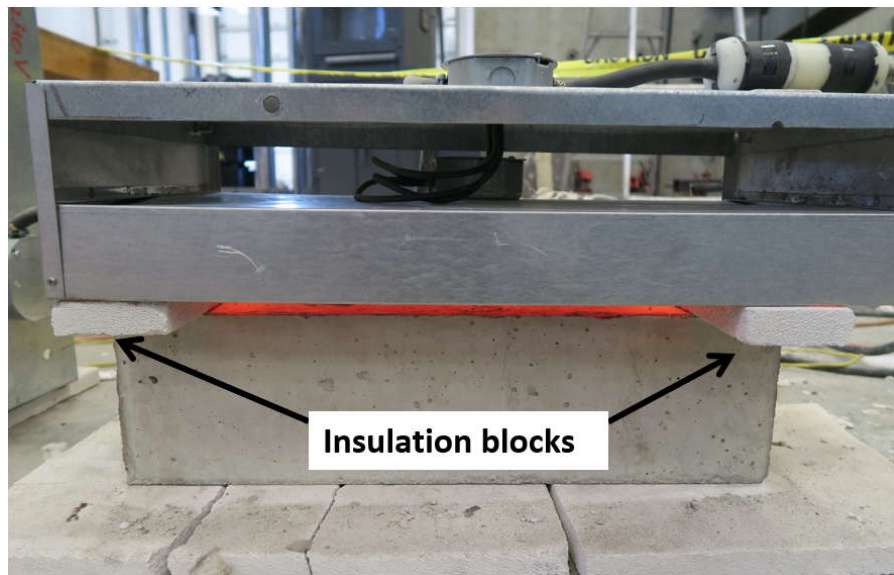
Figure 3-10. Preliminary Test Setup

Once the small beam was placed in the oven for a week, it was ready for heating experiment. The experiment was set up as shown in Figure 3-10. Insulation blocks were put on top of the small beam to avoid heater from coming into direct contact with concrete surface.

The small beam was heated for 100 minutes. The surface temperature reached approximately 1300°F (704°C). results for preliminary test will be presented in the next chapter. Surface temperature was also monitored using handheld non-contact temperature indicator during experiment, as shown in Figure 3-11.

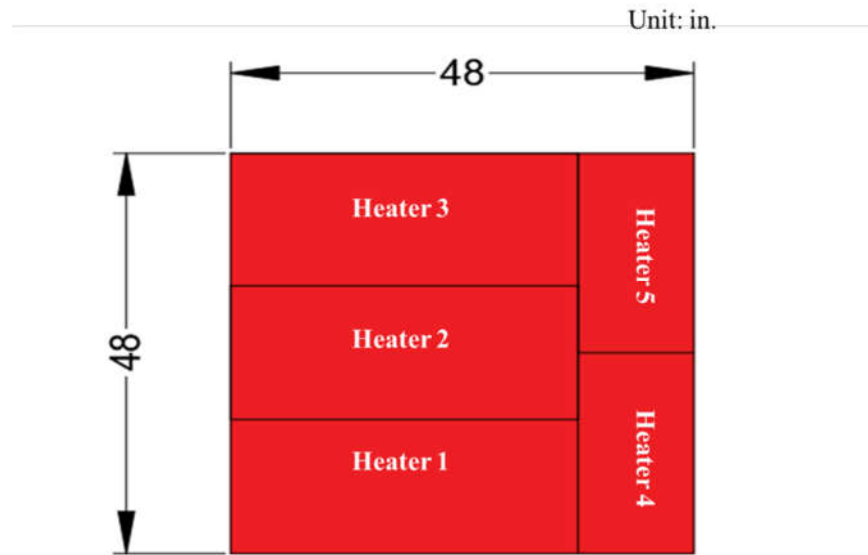
Figure 3-12. Layout of Ceramic Heaters for Heating System

High-temperature ceramic-fiber radiant heaters were used to heat the deck specimens. Five ceramic heaters were placed above the deck, including three 36 in. by 16 in. heaters (Heater 1 to Heater 3) and two 24 in. by 12 in. heaters (Heater 4 and Heater 5), as shown in Figure 3-12. The ceramic-fiber radiant heaters were produced by Watlow Electric Manufacturing Company.

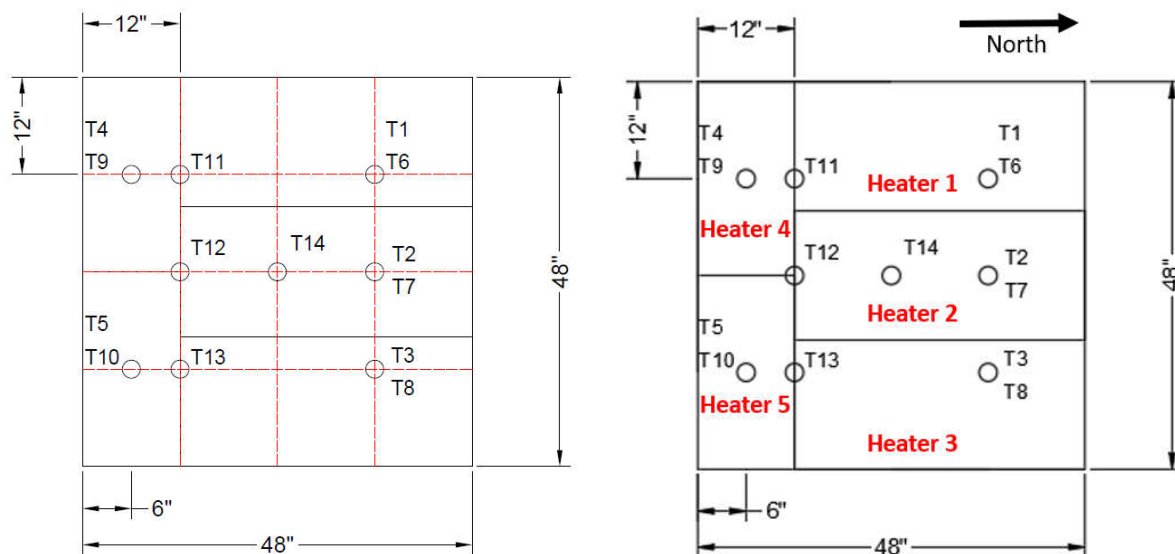
Figure 3-13. Layout of Surface Thermocouples

In order to provide the temperature measurements throughout the surface area, thermocouples were placed at exposed surfaces of the deck at locations that are 1 ft away from the edge, at the center of the deck specimen, at the center of the heaters, and at the gaps between each heater, respectively, as shown in Figure 3-13. In total, 14 surface thermocouples were installed on each deck specimen, with one redundant thermocouple under each heater to make sure that the heater temperatures could be controlled and recorded.

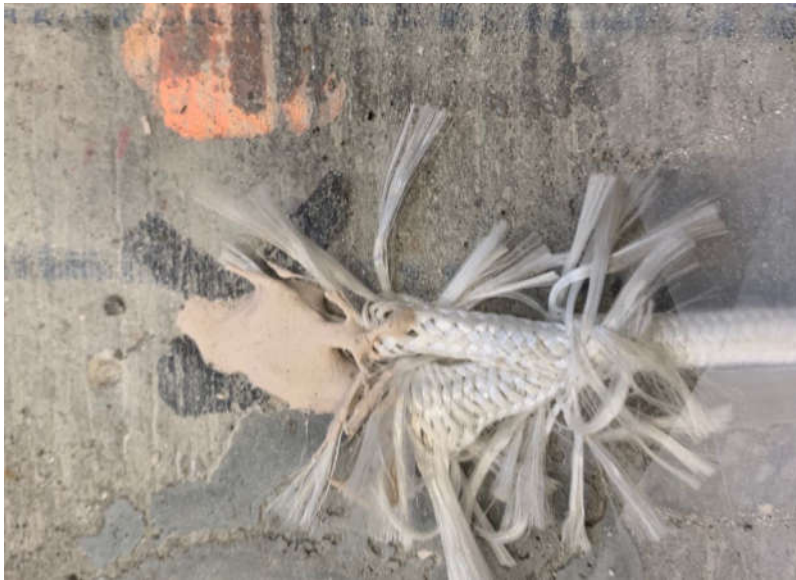
Figure 3-14. Surface Thermocouple Covered by High Temperature Cement

In order to allow thermocouples to measure surface temperature properly, a small hole with about 0.5 in. depth was drilled to place each surface thermocouple. The surface thermocouple was placed inside the hole with the measuring point attached on the surface of specimen. High temperature cement manufactured by Omega was used to fill the hole, fix the position of thermocouple, and prevent the thermocouple from direct contact with the air. An example of how the high temperature cement covers the surface thermocouple is shown in Figure 3-14.

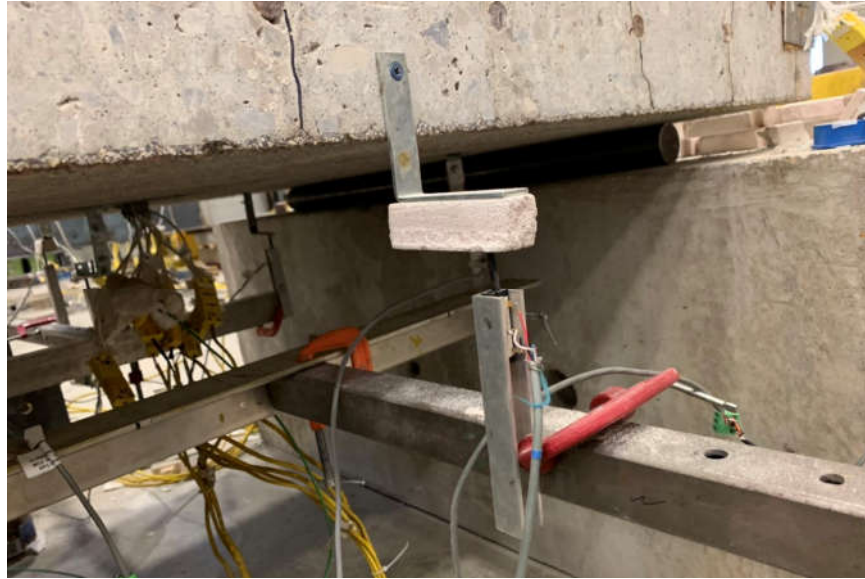
Figure 3-17. Example of Protection of Displacement Transducers

Small S-shaped hooks were fixed to the bottom surface of the deck specimen using concrete screws. Displacement transducers were placed inside aluminum angle brackets and attached to a steel frame so that they were located at the destined location for accurate measurement. Displacement transducers were in contact with the S-shaped hooks in order to measure the vertical displacements of the deck specimen. To protect the displacement transducers from the heat during the experiment, the displacement transducers were insulated by insulation block attached under the L brackets, as shown in Figure 3-17.

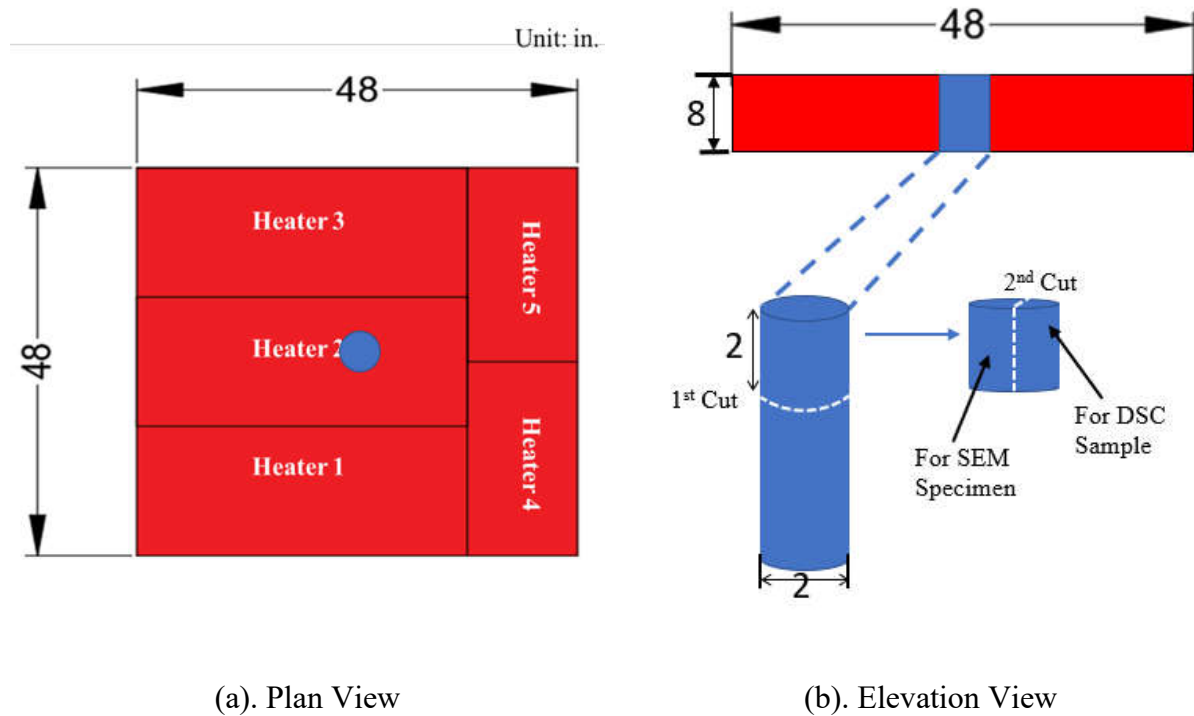
Figure 3-18. Location of Material Analysis Samples at Deck Specimen

All samples used in material analysis were collected from a core that was taken from the deck specimens before and after heating. The cored sample had the diameter of 2 in. and height of 8 in. As shown in Figure 3-18, the cores were removed from locations near the center of the specimen and close to the thermocouple tree so that the material analysis results can be correlated with the through-depth temperature profiles of the concrete.

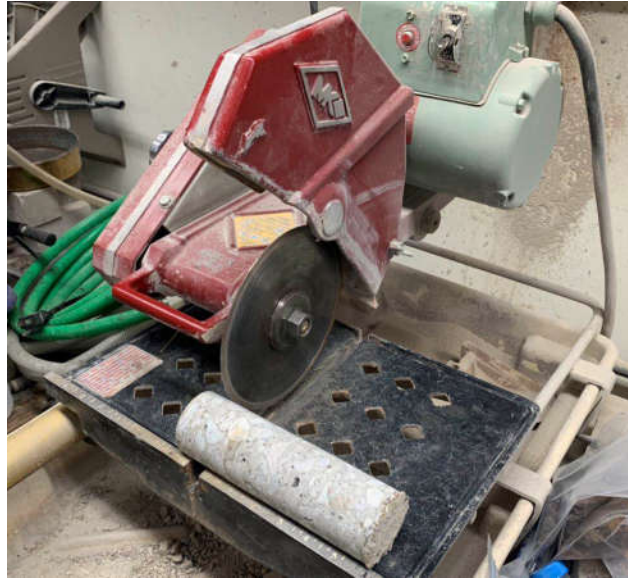
Figure 3-19. Cutting Process of SEM Specimen Preparation

shown in Figure 3-19. The sample cut from the core will be referred as the SEM specimen in the following sections.

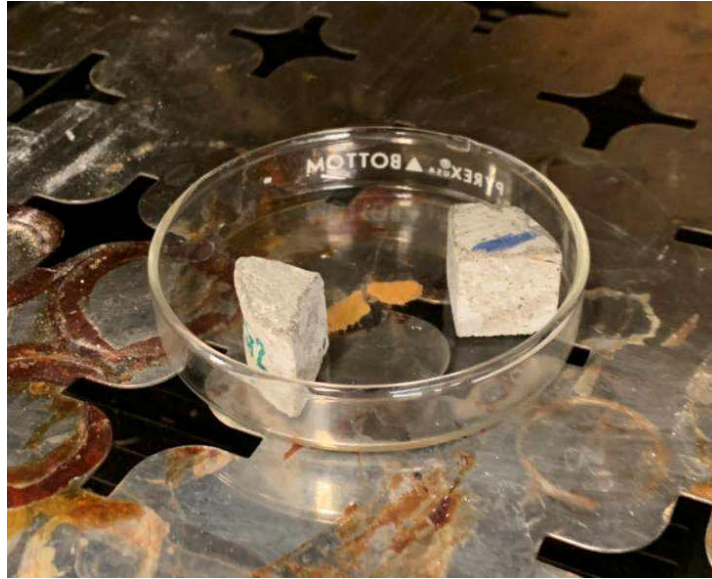
Figure 3-20. Oven Dry Process of SEM Specimen Preparation

After the SEM specimen was cut into proper size for observation, it was oven dried under around 95°F (35°C) for three days to reduce the moisture inside the sample, as shown in Figure 3-20.

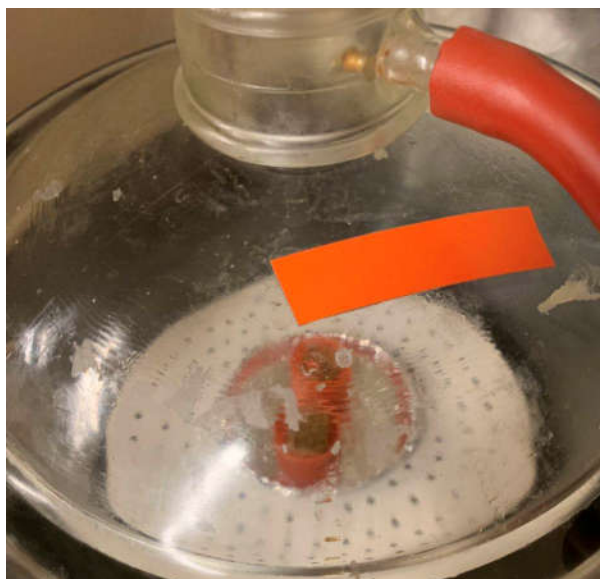
Figure 3-22. Vacuum Process for SEM Specimen Preparation

After the SEM specimen was taken from the oven, the epoxy mounting was prepared for the SEM specimen, as shown in Figure 3-21. As shown in Figure 3-21, the solutions include: ERL – 4221, D.E.R. 736 Epoxy Resin, Nonenyl Succinic Anhydride, and Dimethylaminoethanol. The mixture was poured into the plastic molds, in which the SEM specimen was placed with the tested cross section facing top. To make sure no air was entrapped in the mixture, the SEM specimen was placed in the vacuum overnight, as shown in Figure 3-22. On the next day, the SEM specimen was taken out from the vacuum then put in the oven for 149°F (65°C) for approximately 8 hours to let the epoxy harden, as shown in Figure 3-23.

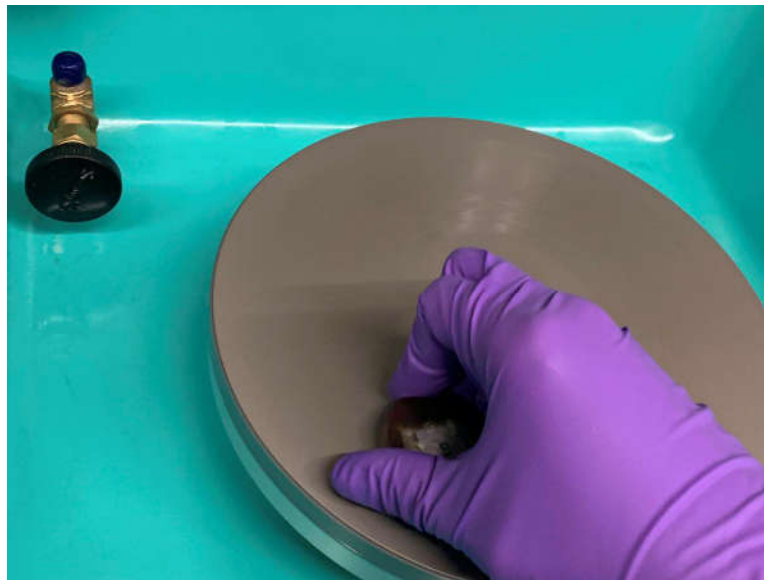
Figure 3-25. Lapping Process for SEM Specimen Preparation

During the lapping process, the SEM specimen was placed on three lapping plates respectively with rotation at low speed to remove the subsurface damage on the specimen surface caused by sawing process. Three lapping plates are with the grit size of $45\mu\text{m}$, $30\mu\text{m}$, and $15\mu\text{m}$ respectively, and the plates were placed in the order from $45\mu\text{m}$ to $15\mu\text{m}$. To produce smooth surface finish, one specimen needed to be polished for four directions, with 30 seconds for each direction, for twice for each lapping plate. The lapping process is shown in Figure 3-25.

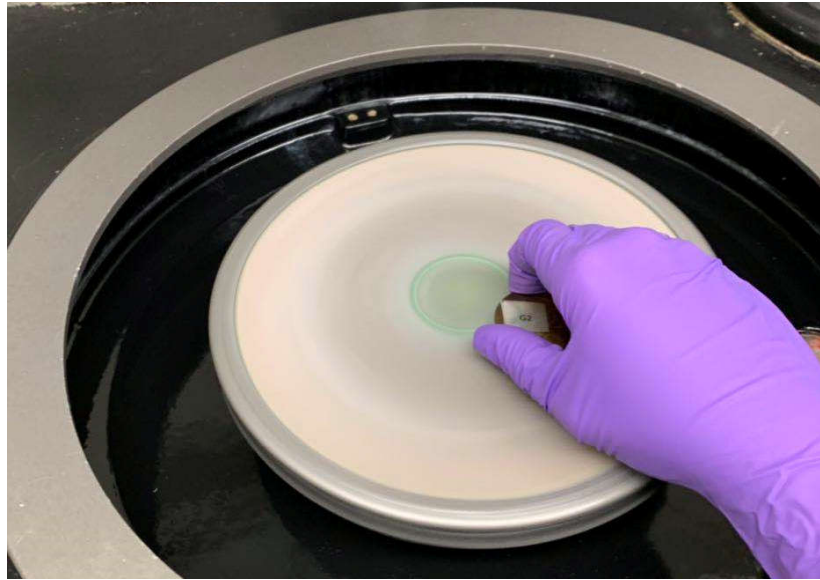
Figure 3-26. Polishing Process for SEM Specimen Preparation

four directions in total, and the polish cloth was placed in the order from $9\mu\text{m}$ to $0.25\mu\text{m}$. After polishing process, the surface of SEM specimen was scratch-free, specular, and ready for observation under microscope. The polishing process is shown in Figure 3-26.

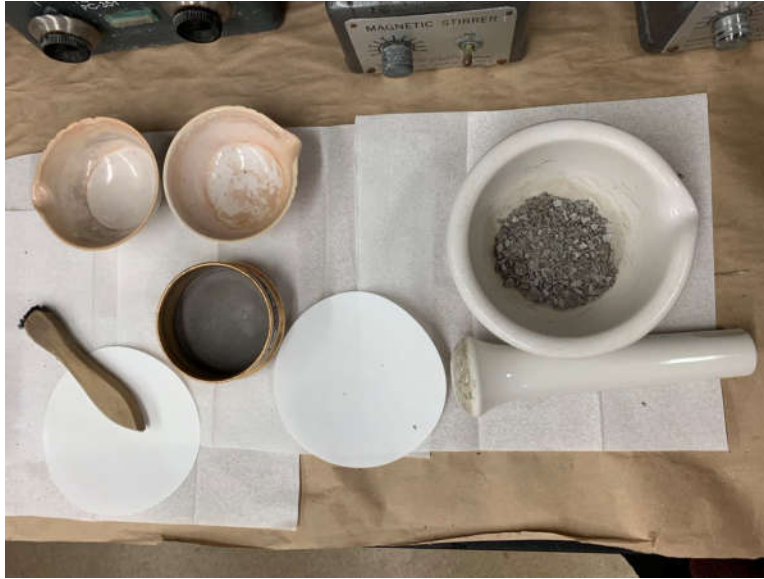
Figure 3-27. Grinding Process for DSC Sample Preparation

To prepare DSC samples, a small piece of concrete was achieved from the concrete core drilled from the deck specimen both before and after heating. Then the small piece of concrete specimen was grinded into powder using mortar and pestle while removing coarse aggregate during the grinding process, since DSC only needs to analyze the change of phases for the content inside the cement paste. The grinding process is shown in Figure 3-27.

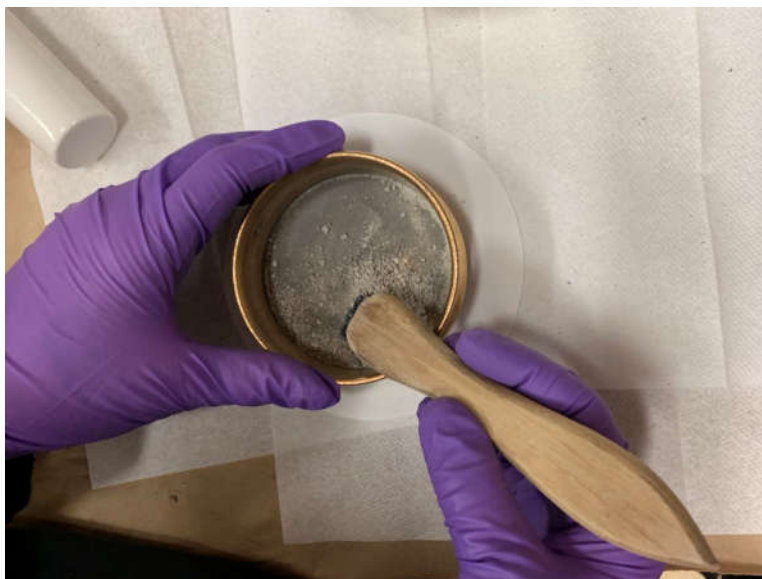
Figure 3-28. Sieving Process for DSC Sample Preparation

After the concrete piece was grinded into powder, the powder was required to pass #200 sieve to make sure it is fine enough for DSC analysis. The grinding and sieving process were repeated until the volume of fine powder accumulated to enough amount for analysis. The fine powder will be referred as DSC sample in following sections. The sieving process is shown in Figure 3-28.

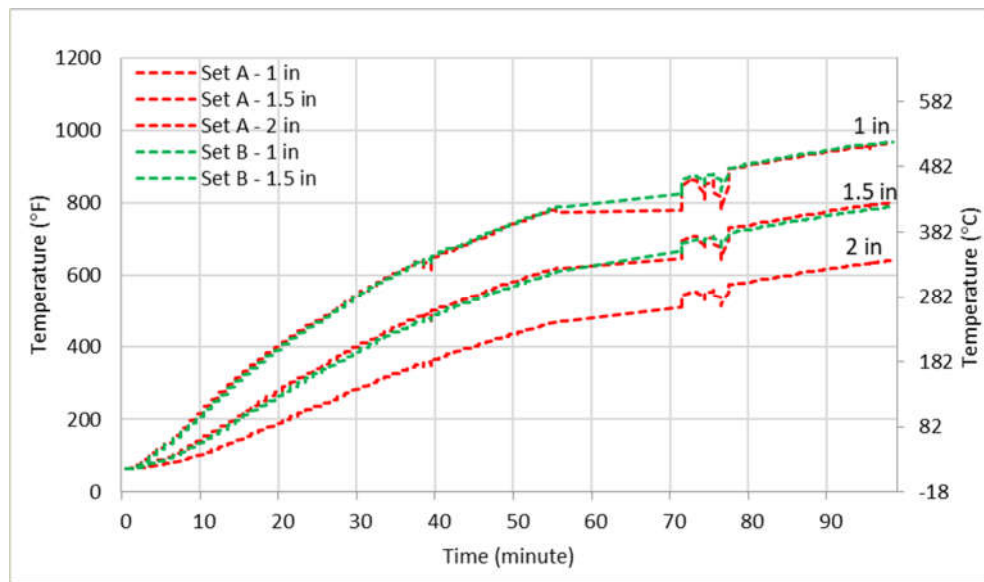
Figure 4-1. Temperature Profile Results

Figure 4-1 shows the temperature histories measured by both sets (A and B) of thermocouple trees in the small beam specimen at corresponding depths. It is evident that the temperature histories for Set A and Set B are very similar and comparable. Thus, the through depth temperatures can be measured accurately using thermocouple trees that installed either before or after casting.

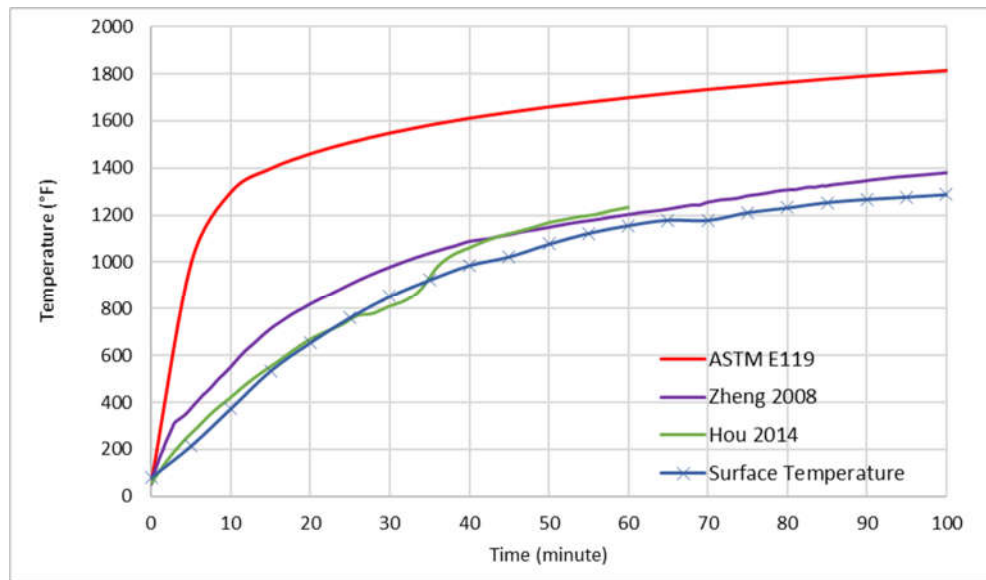
Figure 4-2. Surface Temperature Compared with Standard Fire Tests

concrete surface temperature-time curves measured in standard furnace tests and reported in the literature. As shown in Figure 4-2, the surface temperature-time curves from the preliminary test were comparable to the concrete surface temperature-time curves from standard furnace tests reported in the literature by various researchers (Zheng 2008, Hou 2014, Rodrigues 2014). Thus, the high-temperature ceramic fiber radiant heaters used in the tests were able to simulate the heating associated with ISO-834 standard fire tests.

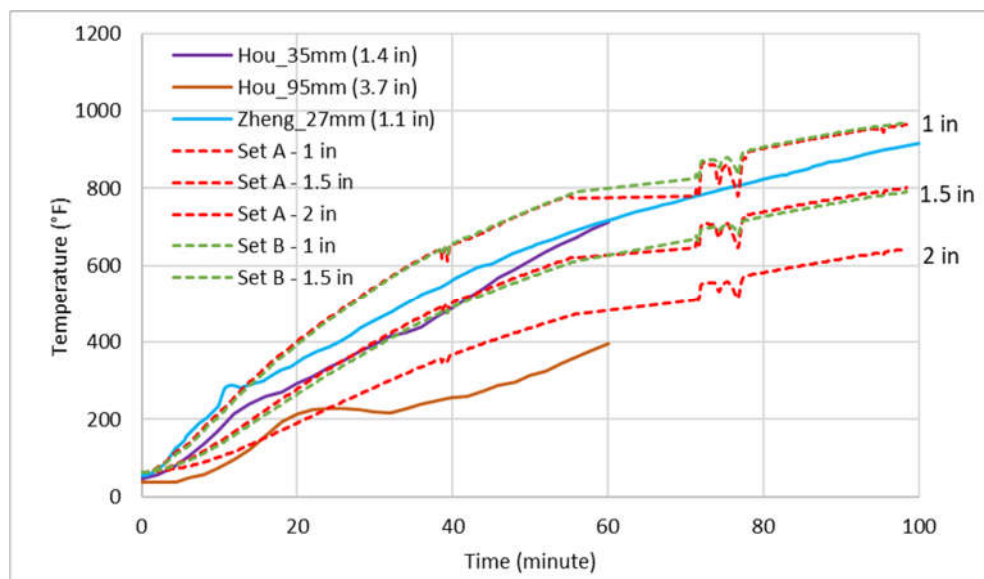
Figure 4-3. Through Depth Temperature Compared with Previous Research

Figure 4-3 compares the temperature-time histories from both sets of thermocouple trees with those reported by previous researchers. As shown, the temperature histories from the preliminary heating test compare reasonably with the temperature histories measured and reported within the concrete thickness by other researchers. This further verifies the heating approach and the temperatures measured by thermocouple trees installed before and after casting concrete.

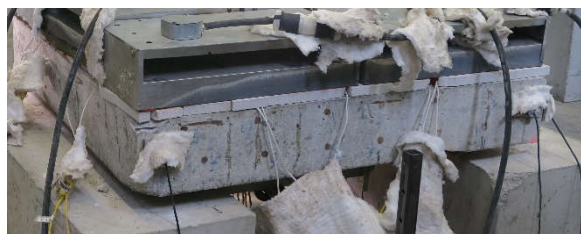
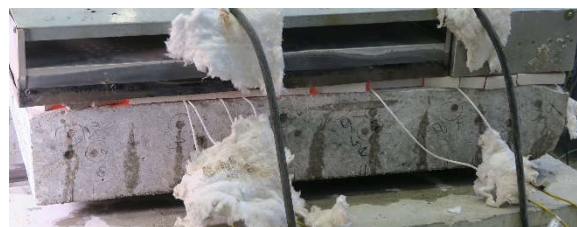
Figure 4-4. Observation of Moisture from D-40-1100 during Test

The first experiment involved heating the deck specimen on one side for 40 minutes. The heaters were placed on the exposed surface of the deck specimen. During the experiment, moisture was observed at 16 minutes, when the surface temperature was around 600°F (316°C) and kept coming out till the end of the test. Figure 4-4 shows the observation of moisture from deck specimen during test. The locations with moisture were also observed to have cracks after the heating test.

At 16 Minutes– Surface Temperature: 600°F

At 36 Minutes – Surface Temperature: 1014 °F

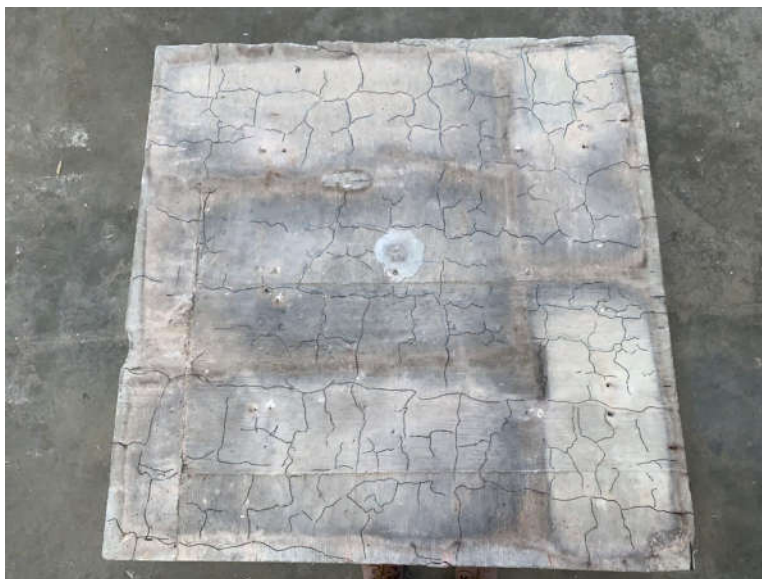
Figure 4-5. Map of Cracks for D-40-1100

After the test was finished, cracks on the exposed surface were observed and marked. It can be observed that cracks developed due to thermal expansion. As shown in Figure 4-5, thin cracks (< 0.005 in.) were observed. Most cracks were found along the locations of reinforcement bars, and some cracks extended into side face of the specimen. No spalling was found at the surface of concrete. Concrete color at some areas at exposed surface changed to darker grey after the heating test.

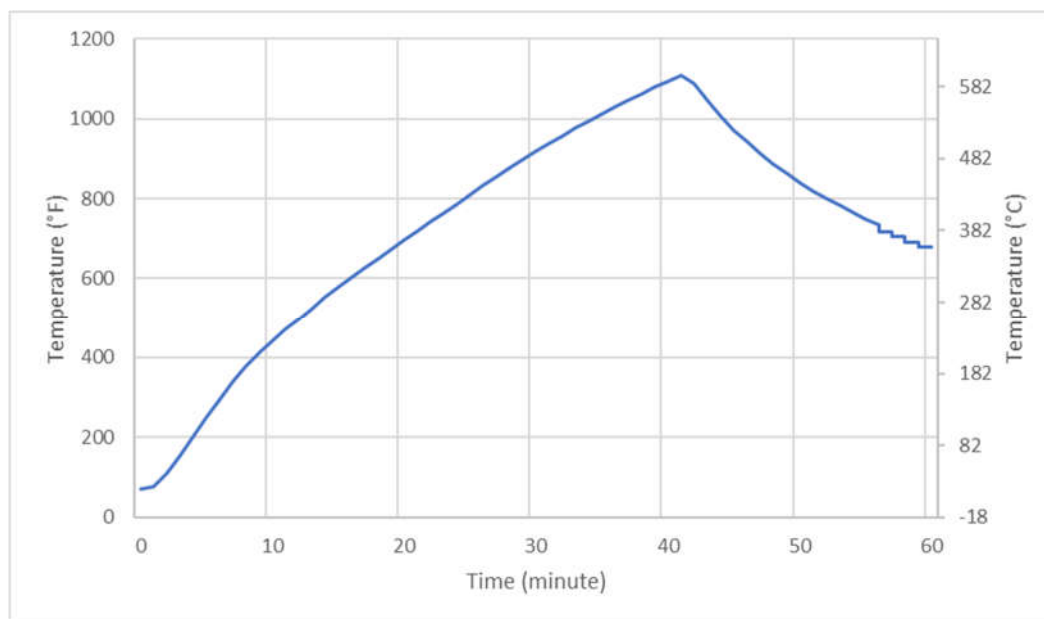
Figure 4-6. Surface Temperature Results of D-40-1100

The test ended at 40 minutes. After 40 minutes of heating, the maximum surface temperature of concrete reached to 1108°F (598°C), as shown in Figure 4-6.

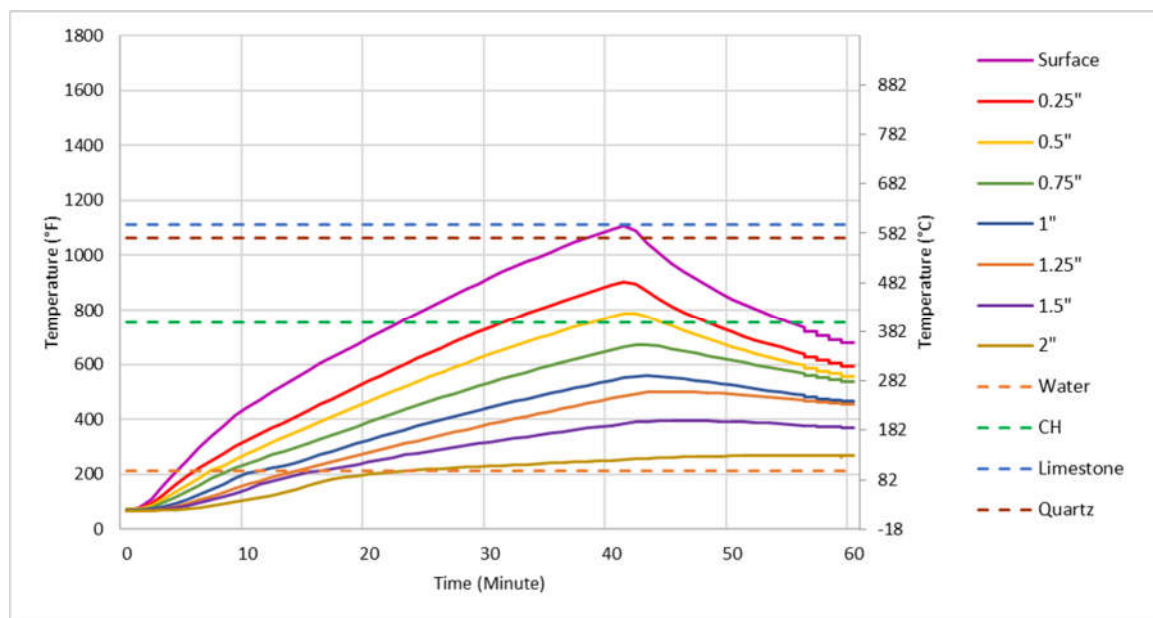
Figure 4-7. Through-Depth Temperature Results of D-40-1100

At 40 minutes, maximum temperatures at 0.25 in., 0.5 in., 0.75 in., 1 in., 1.25 in., 1.5 in., and 2 in. are 903 °F, 786 °F, 673 °F, 557 °F, 493 °F, 395 °F, and 258 °F (484 °C, 419 °C, 356 °C, 292 °C, 256 °C, 202 °C, and 126 °C), respectively. As shown in Figure 4-7, none of the temperature results is great enough for limestone to decompose and quartz to change phase from α to β , which agrees with the observation on surface of specimen D-40-1100 that only thin cracks were found. Also, temperature results for up to 0.25 in. depth from exposed surface is greater than the temperature to decompose calcium hydroxide (CH), for which the loss of CH can cause debonding cracks and increase in porosity in the microstructure of concrete and reduction in strength.

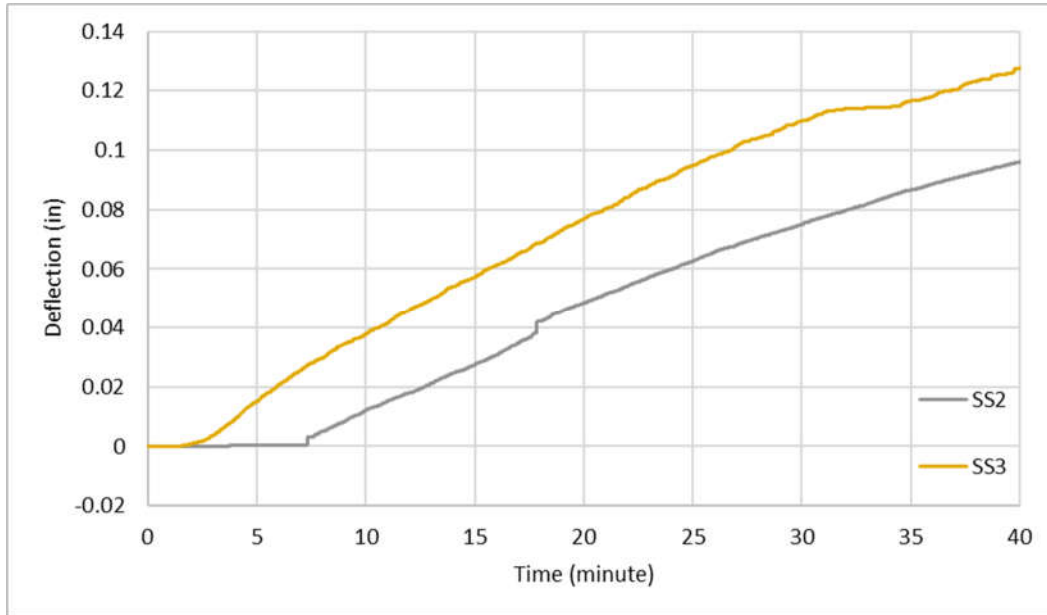
Figure 4-8. Results of Vertical Deflections of D-40-1100

Vertical deflection results at center and quarter spans are shown in Figure 4-8. The location of each displacement transducer is shown in Figure 3-16. Deflection at the center (SS3) and quarter span (SS2) of D-40-1100 are 0.13 in. and 0.1 in respectively.

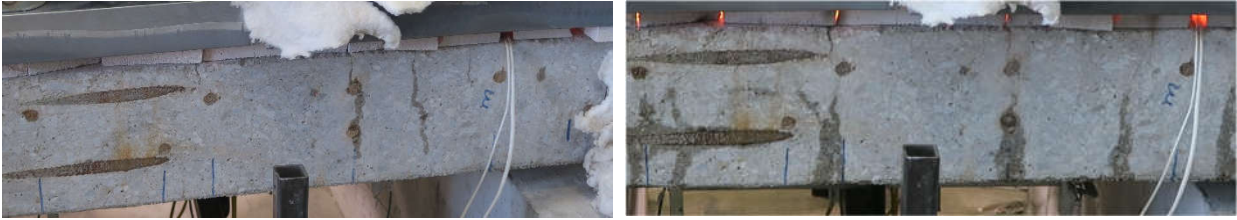
Figure 4-9. Observation of Moisture from D-80-1600 during Test

The third experiment involved heating the deck specimen on one-side for 80 minutes. During the experiment, moisture was observed at 15 minutes, when the surface temperature was around 600°F (316°C) and kept coming out till the end of the test. Figure 4-9 shows the observation of moisture from deck specimen during test. The locations with moisture were also observed to have cracks after the heating test.

At 15 Minutes– Surface Temperature: 626°F At 76 Minutes – Surface Temperature: 1418°F

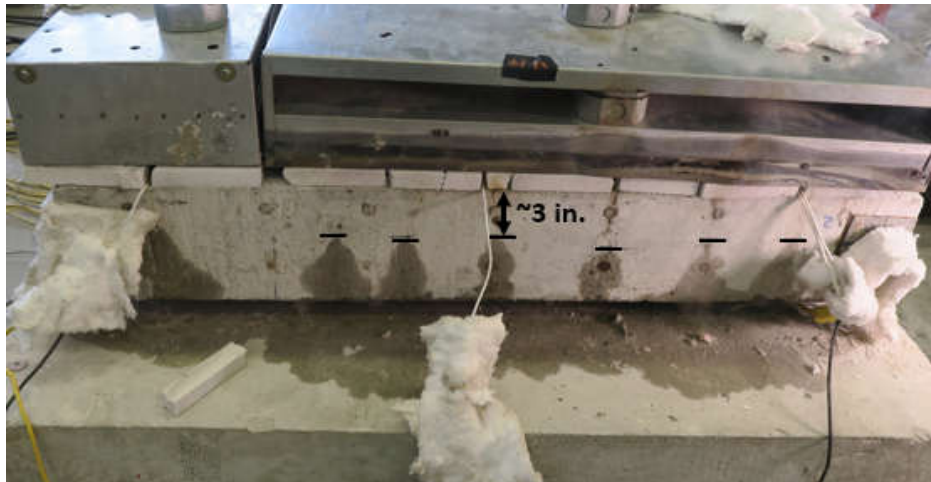
Figure 4-10. Locations of Sweeping Moisture at One Side of D-80-1600

The locations of seeping moisture moved downward during heating. At the end of test, the average distance from the top of seeping points to the exposed surface was about 3 in, as shown in Figure 4-10.

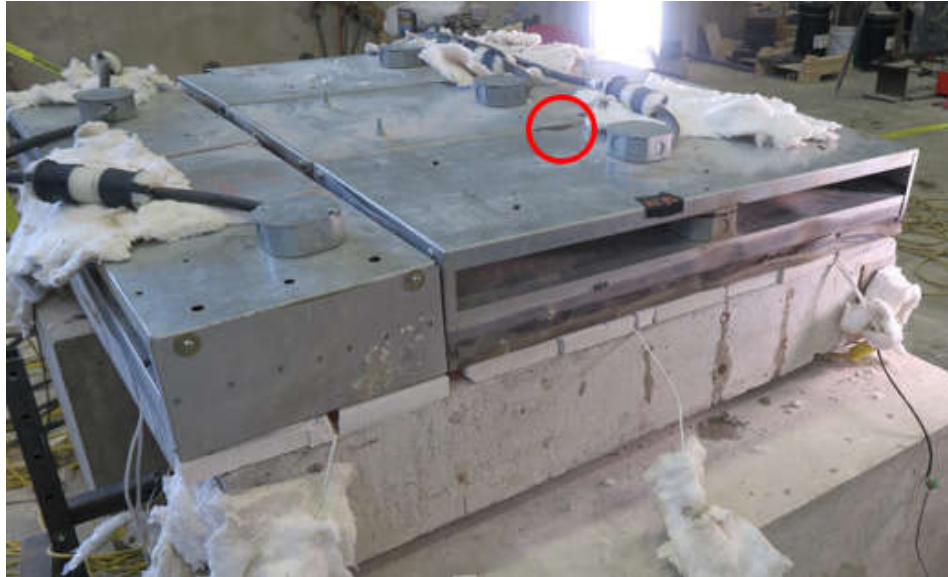
Figure 4-11. Location of Fire during Test of D-80-1600

At 69 minutes, duct tape on one of the heaters caught fire due to extreme high temperature at the gap between heaters, as shown in Figure 4-11. All heaters were shut down for safety check and turned back on. The whole process lasted for one minute. This caused the decrease in temperature measurement, which can be also observed in Figure 4-13 and Figure 4-14.

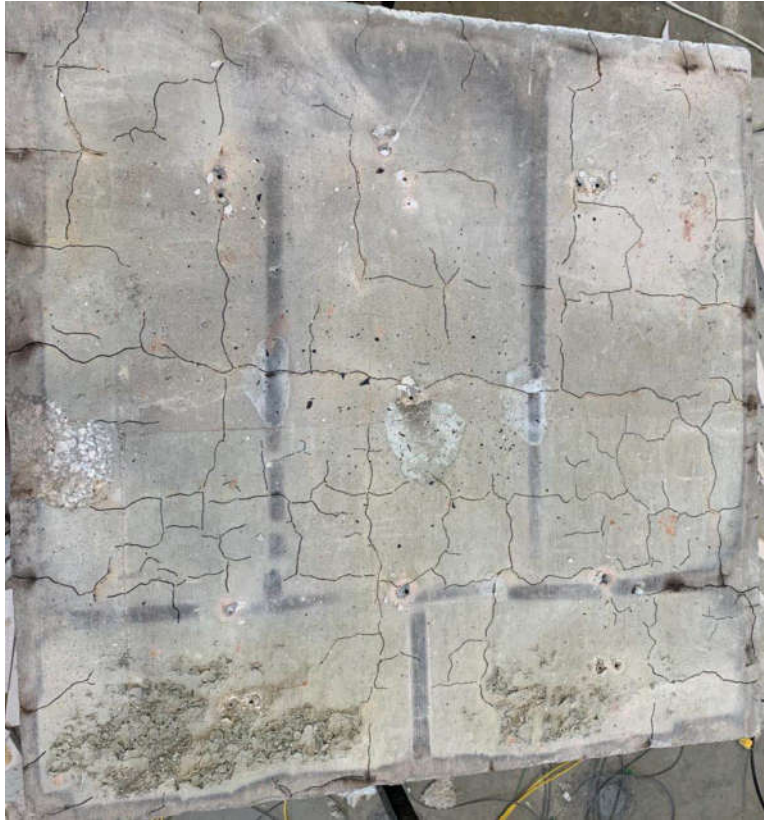
Figure 4-12. Map of Cracks for D-80-1600

After the test was finished, cracks on the exposed surface was recorded. As shown in Figure 4-12, wide cracks (about 0.005 in.) were observed. Most cracks were found along the locations of reinforcement bars, and some cracks extended into side face of the specimen. Spalling was easily found at the exposed surface. After the spalling part was cleaned, more aggregates were exposed. Concrete color at some areas at exposed surface changed to yellowish grey color after the heating test.
