POST-FIRE ASSESSMENT OF CONCRETE IN BRIDGE DECKS

A Thesis

Master of Science in Civil Engineering

August 2019

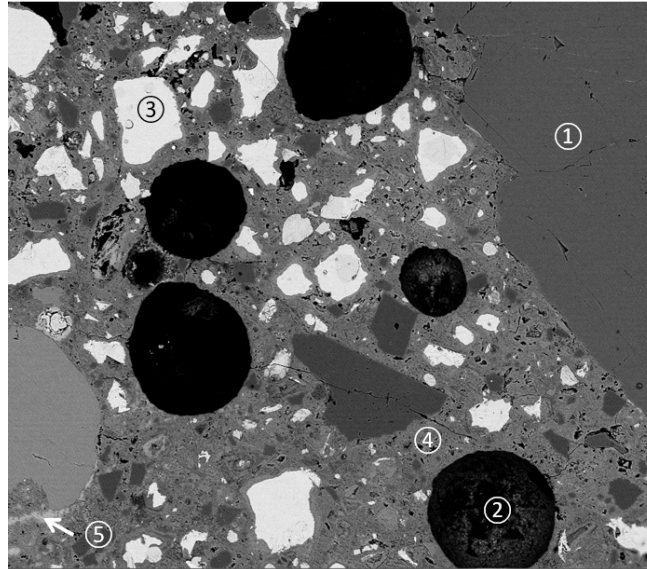
Figure 4-21 shows an example of SEM observation figures and explains the features of microstructure of concrete.

①: Aggregate ②: Pore ③: Unhydrated Cement ④: Paste Matrix ⑤: CH at Interfacial Transition Zone

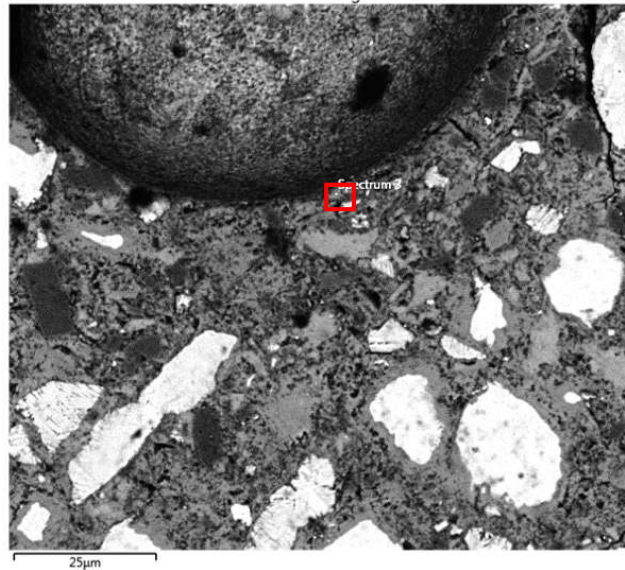
Figure 4-30. EDS Identification of CH of Unheated Sample at Exposed Surface

Figure 4-30 shows the EDS identification of CH at exposed surface in Unheated sample. CH is carbonated and can only be found around pores. CH at exposed surface of Unheated sample is very limited. No sign of CH can be observed at exposed surface of Heated – 40 or Heated – 80 samples due to exposure to heat for long time duration.

Figure 4-30 to Figure 4-36 show the EDS identification of calcium hydroxide (CH) in the microstructure of Unheated, Heated – 40, and Heated – 80 at various depths. Normally, CH exists in interfacial transition zones (ITZs) between the aggregates and the paste in the concrete, which is shown as bright greyish color in the EDS figures. The presence of thin film of CH provides bonds between the aggregates and the pastes so that concrete can remain its strength. With temperature rising and moisture evaporating, CH loses water and disappears, which is also an indicator of temperature at certain depth of concrete. CH will be hard to find if temperature reaches to 752°F to 932°F (400°C to 500°C) and lasts for more than 20 minutes.

As one can tell from Figure 4-30 to Figure 4-36, the presence of CH is much easier to observe in unheated sample than in heated samples. It is also easier to find CH at deeper location through the depth of concrete than at shallower location. At exposed surface, even for Unheated sample, CH is hard to observe and mainly carbonated due to long time exposure to weather during the service life of the bridge deck.
