**DEFORMATION MECHANISMS IN UNIRRADIATED & IRRADIATED  
IRON CHROMIUM ALUMINUM IDENTIFIED BY TEM IN SITU  
TENSILE TESTING**

**A Thesis**

**Master of Science in Materials Engineering**

School of Materials Engineering  
West Lafayette, Indiana  
August 2021

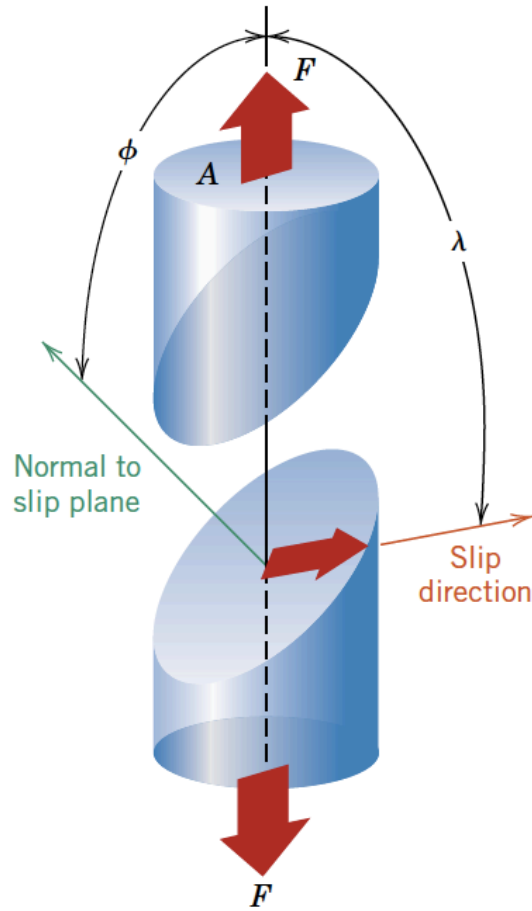
Figure 1 CRSS is defined as the stress acting on the plane and in the direction that slip occurs. Slip will occur in the plane and direction with the least resistance to dislocation motion [16].

A diagram is shown below in Figure 1 displaying the CRSS. From Equation 1, if both the angle between the slip plane and the applied stress and the angle between slip direction and the applied stress are both 45 degrees, the shear stress on the slip plane will be maximized. Furthermore, if either of these angles is 90 degrees to the applied stress, the shear stress on the slip plane will be nonexistent.

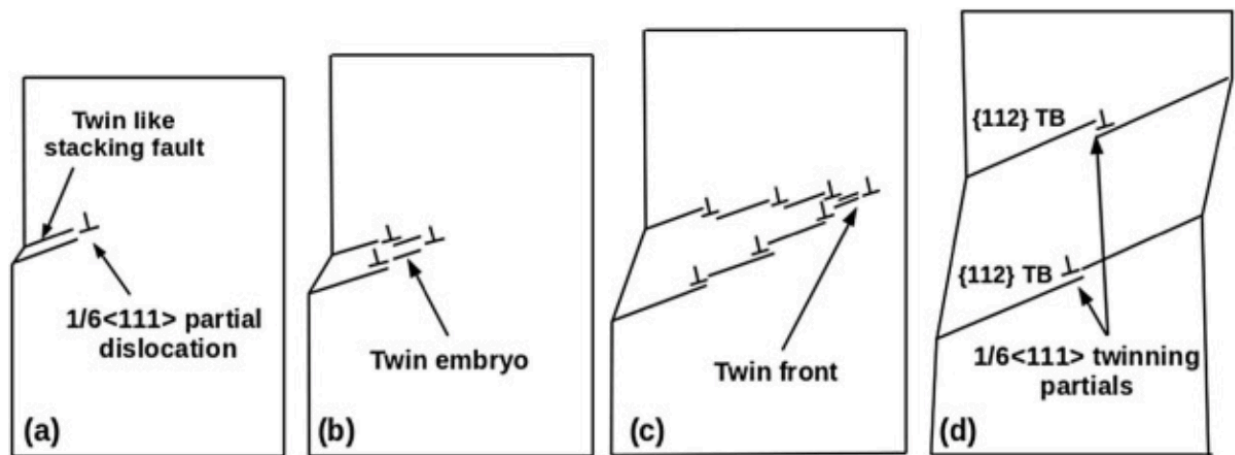
Figure 2 Stacking faults, produced by partial dislocations with  $1/6\langle 111 \rangle$  character gliding in parallel planes, build upon one another. If an energy barrier is passed, a stable twin is formed and can grow [17].

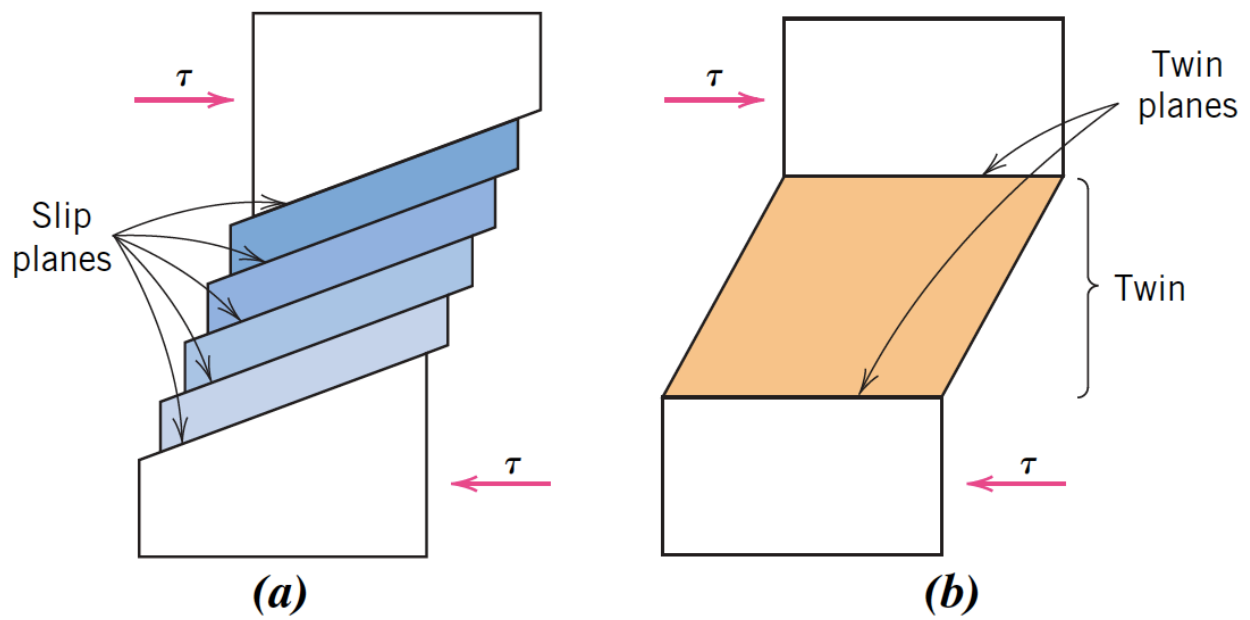
Figure 3 As a crystal slips, the orientation remains constant through the slipped planes (a). When twinning occurs, the crystal orientation above and below the twinning plane is changed (b) [16].

The reoriented grain, or twinned grain, tends to be preceded by microcracking and also potentially provides new slip systems that are favorable for slip to occur [16,18,22–24]. Figure 3 shows a comparison between deformation slip and deformation twinning. Highlighted are the unchanged crystal orientation in deformation slip (blue region in (a)) and the reoriented crystal in deformation twinning (yellow region in (b)).

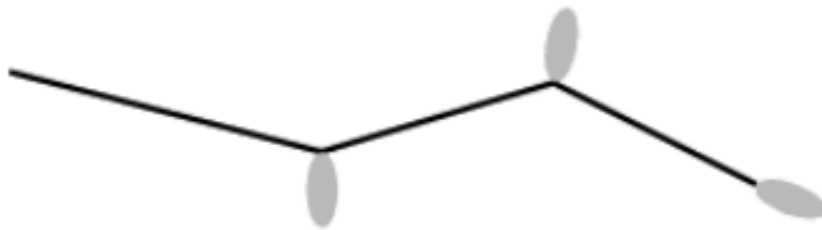
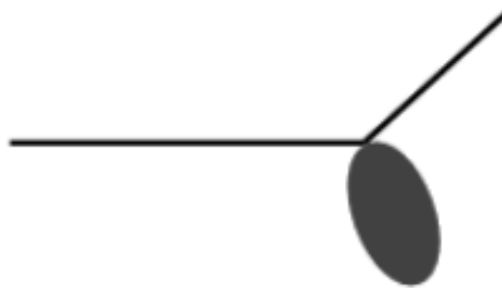
1 MeV electrons  
 $\bar{T} = 60 \text{ eV}$   
 $\varepsilon = 50\text{--}100\%$

1 MeV protons  
 $\bar{T} = 200 \text{ eV}$   
 $\varepsilon = 25\%$

1 MeV heavy ions  
 $\bar{T} = 5 \text{ keV}$   
 $\varepsilon = 4\%$

1 MeV neutrons  
 $\bar{T} = 35 \text{ keV}$   
 $\varepsilon = 2\%$

Figure 4 The damage profile produced by different irradiating particles. The damage profile depends on parameters such as the irradiating particle energy, size and charge [25].

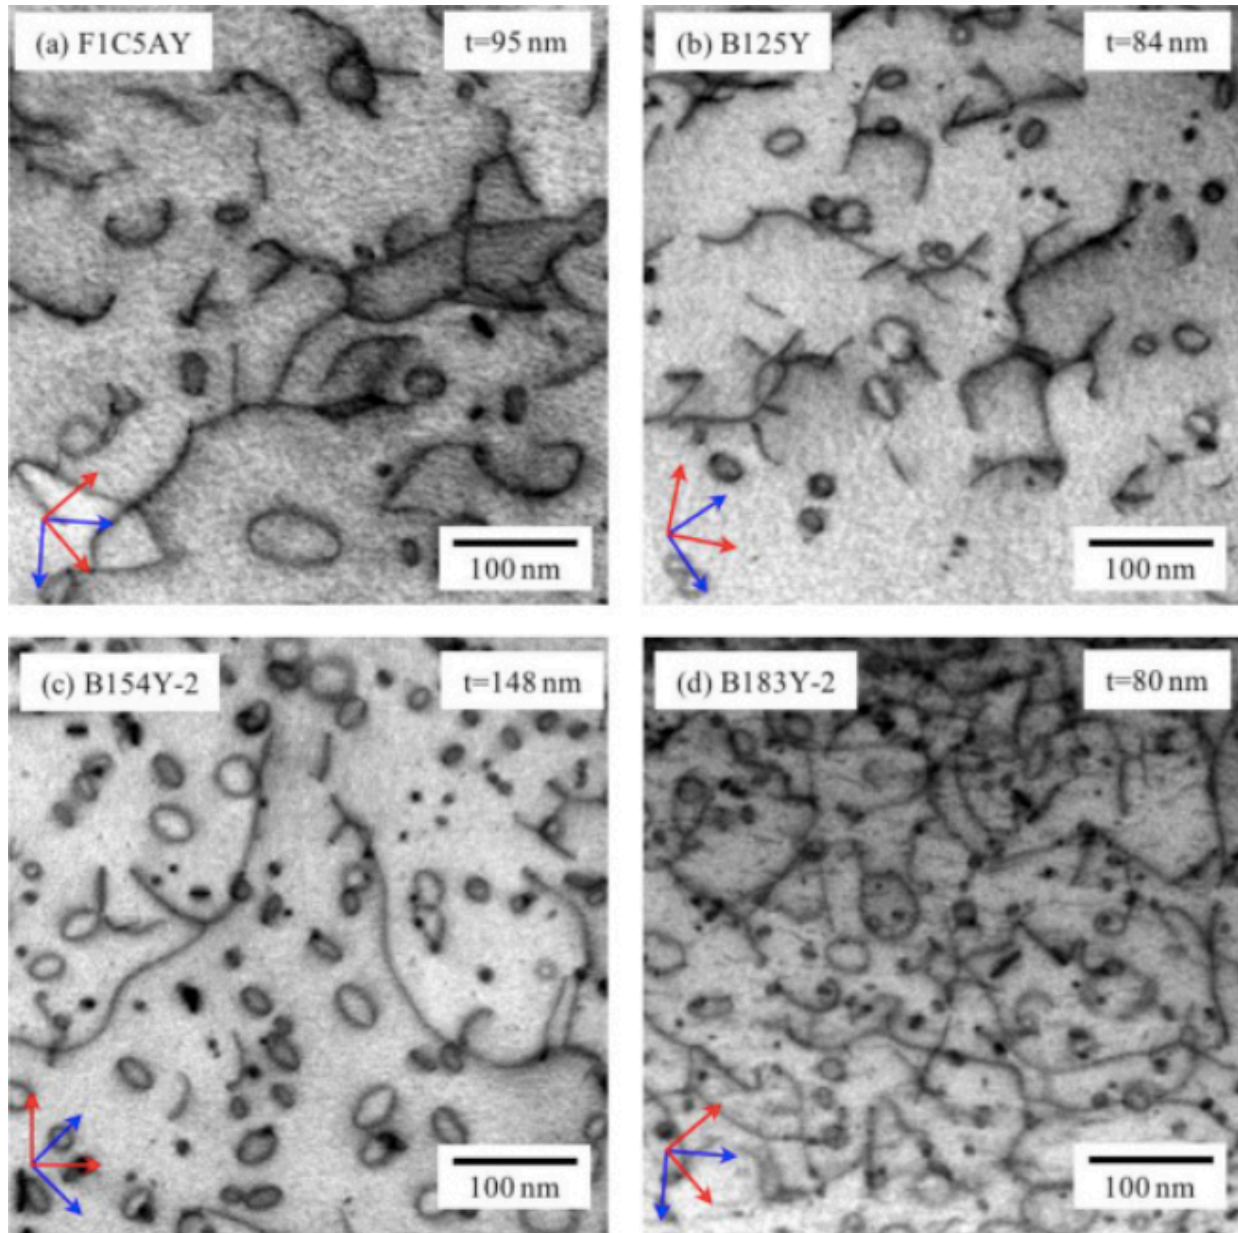
Figure 5 Four FeCrAl alloys irradiated with neutrons to between 0.3 – 0.8 DPA at temperatures between 335C° - 355C°. Dislocation loops with  $a/2\langle 111 \rangle$  and  $a\langle 100 \rangle$  character along with dislocation line networks are present [29].

FeCrAl has been shown to develop microstructural features such as dislocation networks, dislocation loops, black dots, and solute clustering as a result of irradiation. Bright field scanning TEM (BFSTEM) images of these defects are shown below in Figure 5 and Figure 6. These microstructures are important as they relate directly to the mechanical behavior [9,10,29–31]. When stress is applied to the material, these defects can act as barriers to dislocation motion. This blocking of dislocation motion can manifest itself as hardening or softening of the material. The localization of high and low density areas of defects can also occur and this can lead to large variations of mechanical behavior in small scale mechanical tests. In small scale tests this may happen because of the small volume of material being tested and the chance of defects either existing or not existing within that volume. In addition to blocking dislocations, these defects can

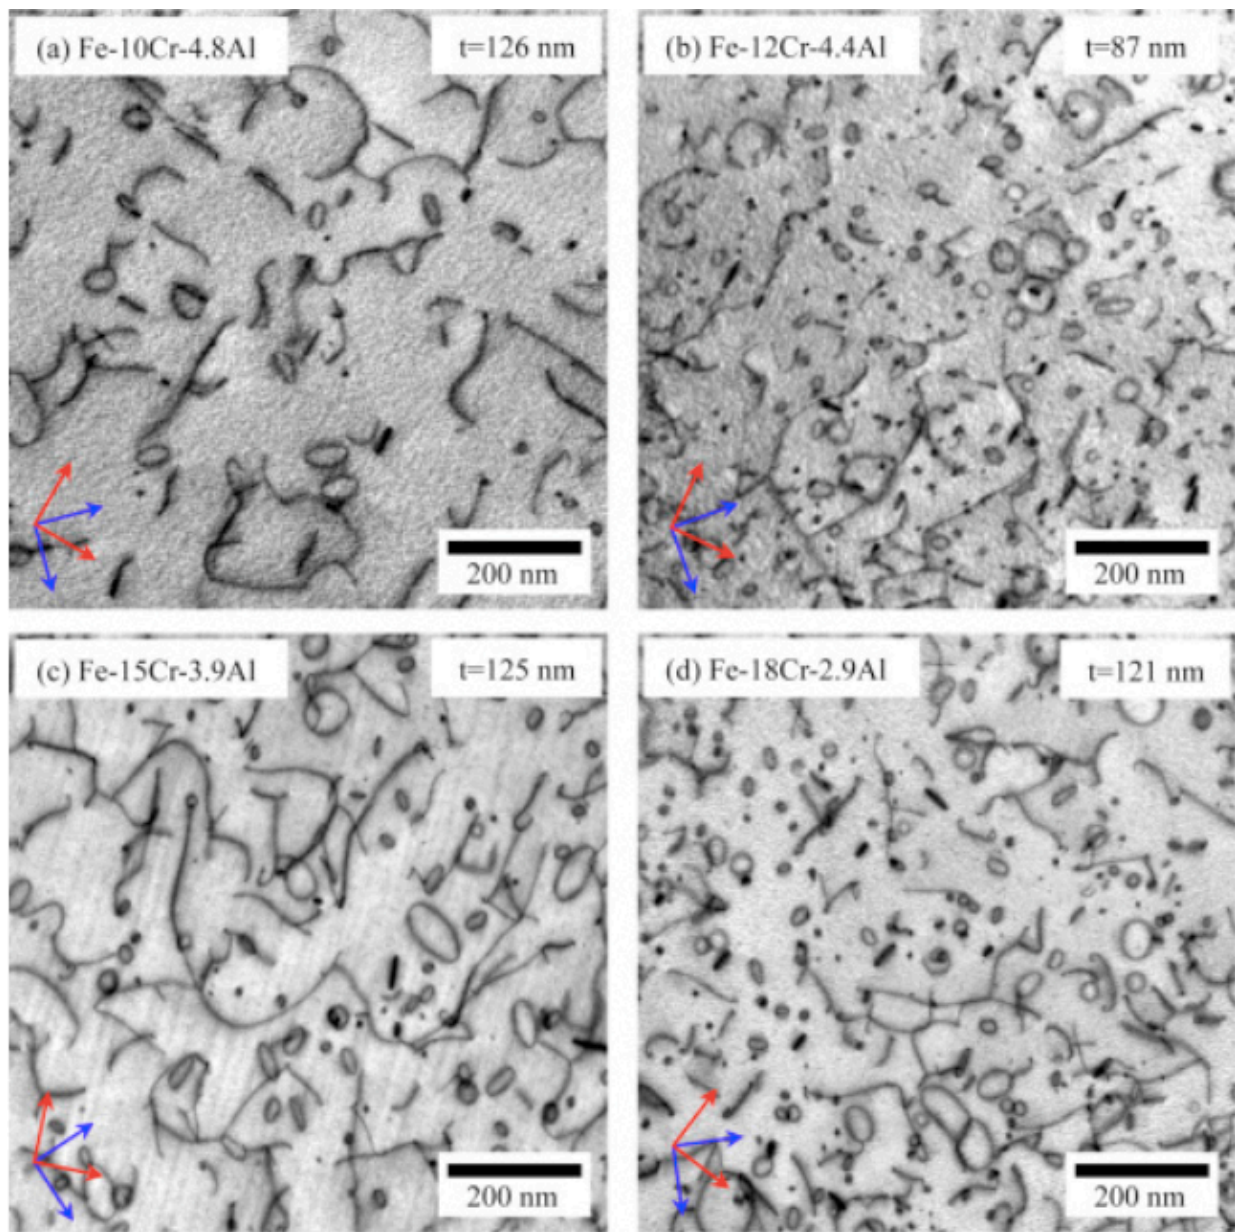
Figure 6 Four FeCrAl alloys with 10 – 18 wt% Cr and 2.9 – 4.9 wt% Al neutron irradiated to 1.8 DPA at 382°C for the purpose of studying microstructure and mechanical properties as a function of alloy composition [10].

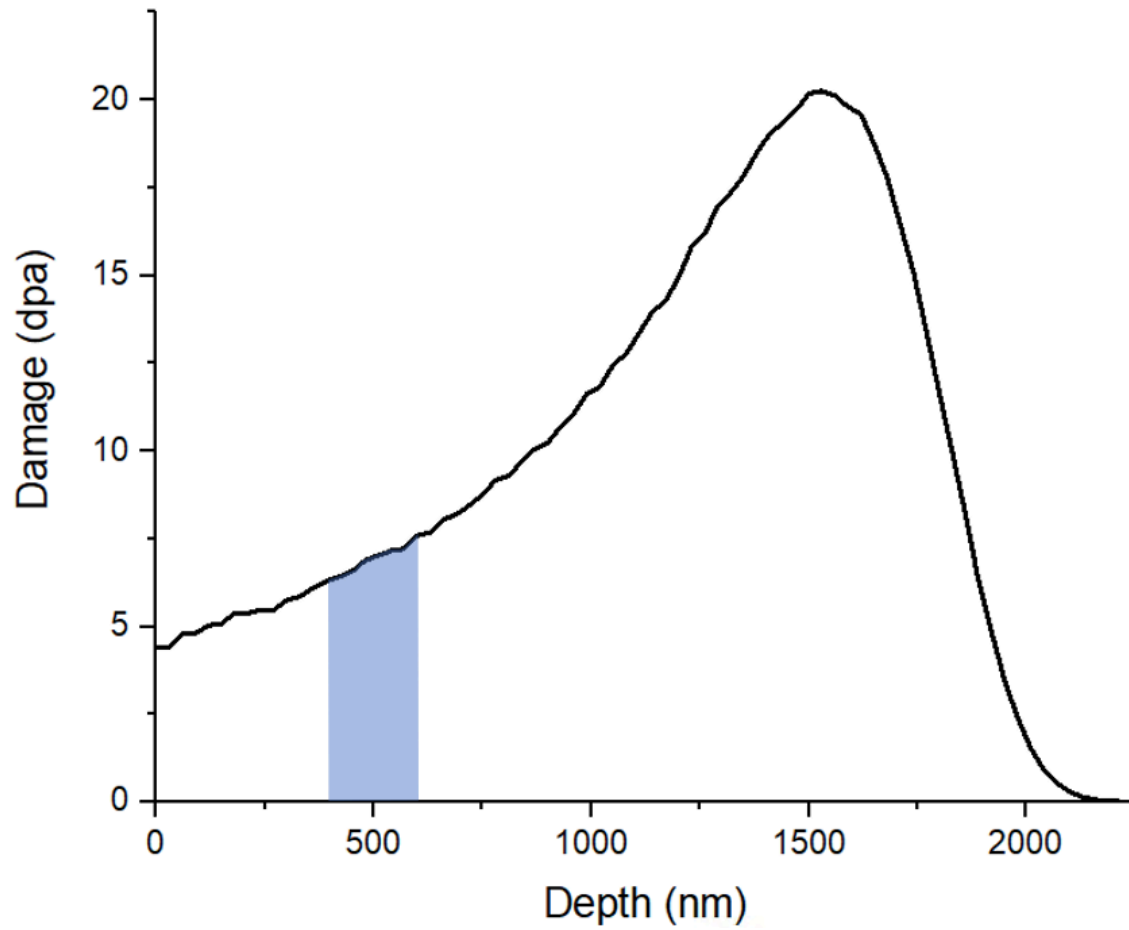
Figure 7 Ion irradiation damage profile with respect to depth as calculated from SRIM simulation. A depth of 400nm – 600nm was targeted for mechanical properties in this study (highlighted in blue).

The targeted damage for this study was 7 DPA at a depth of 400 – 600 nm. The maximum damage achieved was about 20 DPA at just over 1.5um depth. The calculated damage depends on the current of the ion beam which is calculated using the total charge that is applied to the specimen. The simulation software then provides  $10^6$  counts/coulomb to each microcoulomb arbitrarily and, using Equation 2, the damage is calculated.

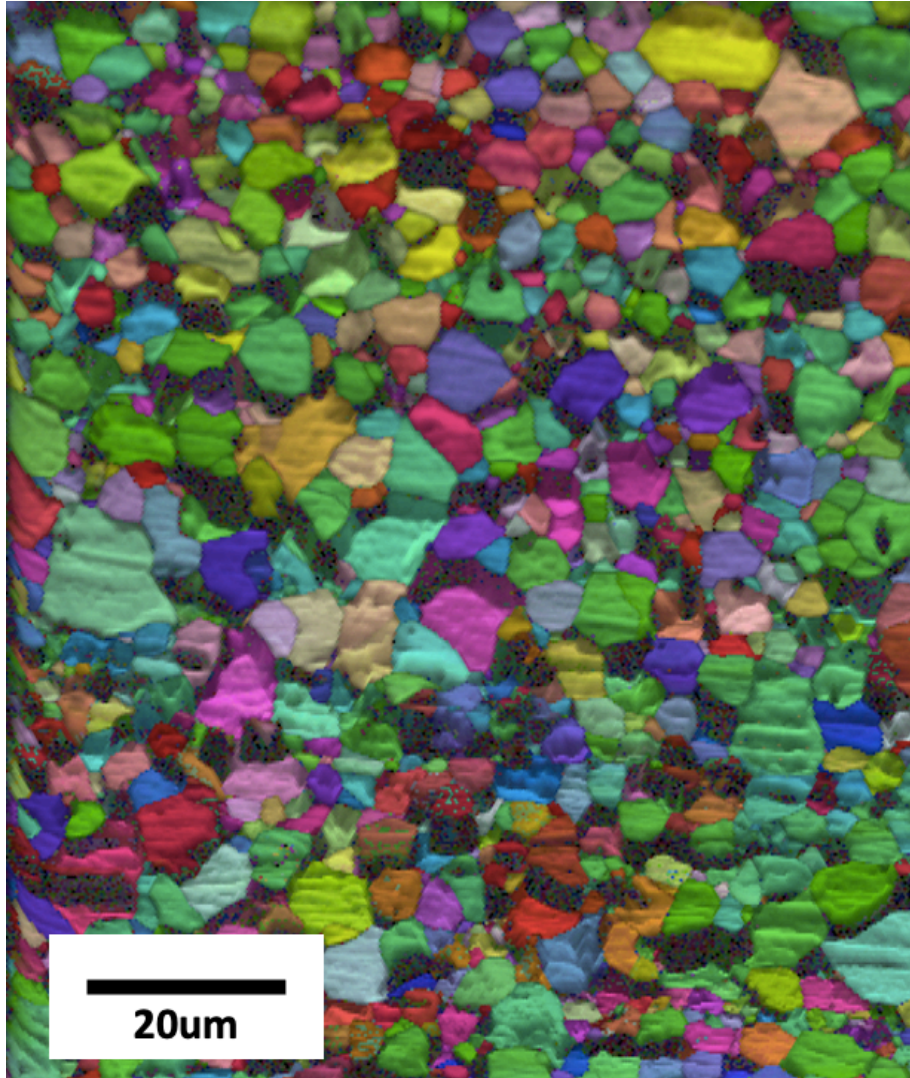
Figure 9 EBSD image displaying the grain structure and size of FeCrAl.

The size of the grains ranged from a few hundred nm to tens of  $\mu\text{m}$ . The average grain size, as measured by the mean lineal intercept method, was  $4.4\mu\text{m}$ . Although there was strong texturing in different regions of the bulk material which favored a variety of different grain orientations, shown below in Figure 9 is an EBSD image displaying the grains in a region where no specific texturing was evident. Dislocation lines were quantified in the unirradiated material, and it was found that there was an areal number density of  $4.14\text{E-}5\text{m}^{-2}$ . Dislocation loops were quantified in the irradiated material, and it was found that there was a number density of  $1.12\text{E}22\text{m}^{-3}$  at a depth of 600nm into the irradiated surface with an average diameter of 12.46nm. Figure 10 & 11 shows representative TEM lamella for both conditions. The average distance between defects in the unirradiated and irradiated conditions were 41nm and 2.9nm, respectively. These data are superimposed in figure 12. The graph in figure 12 shows the likelihood that meaningful mechanical data is experimentally obtained based on defect distance vs the limiting dimension of the sample being tested.

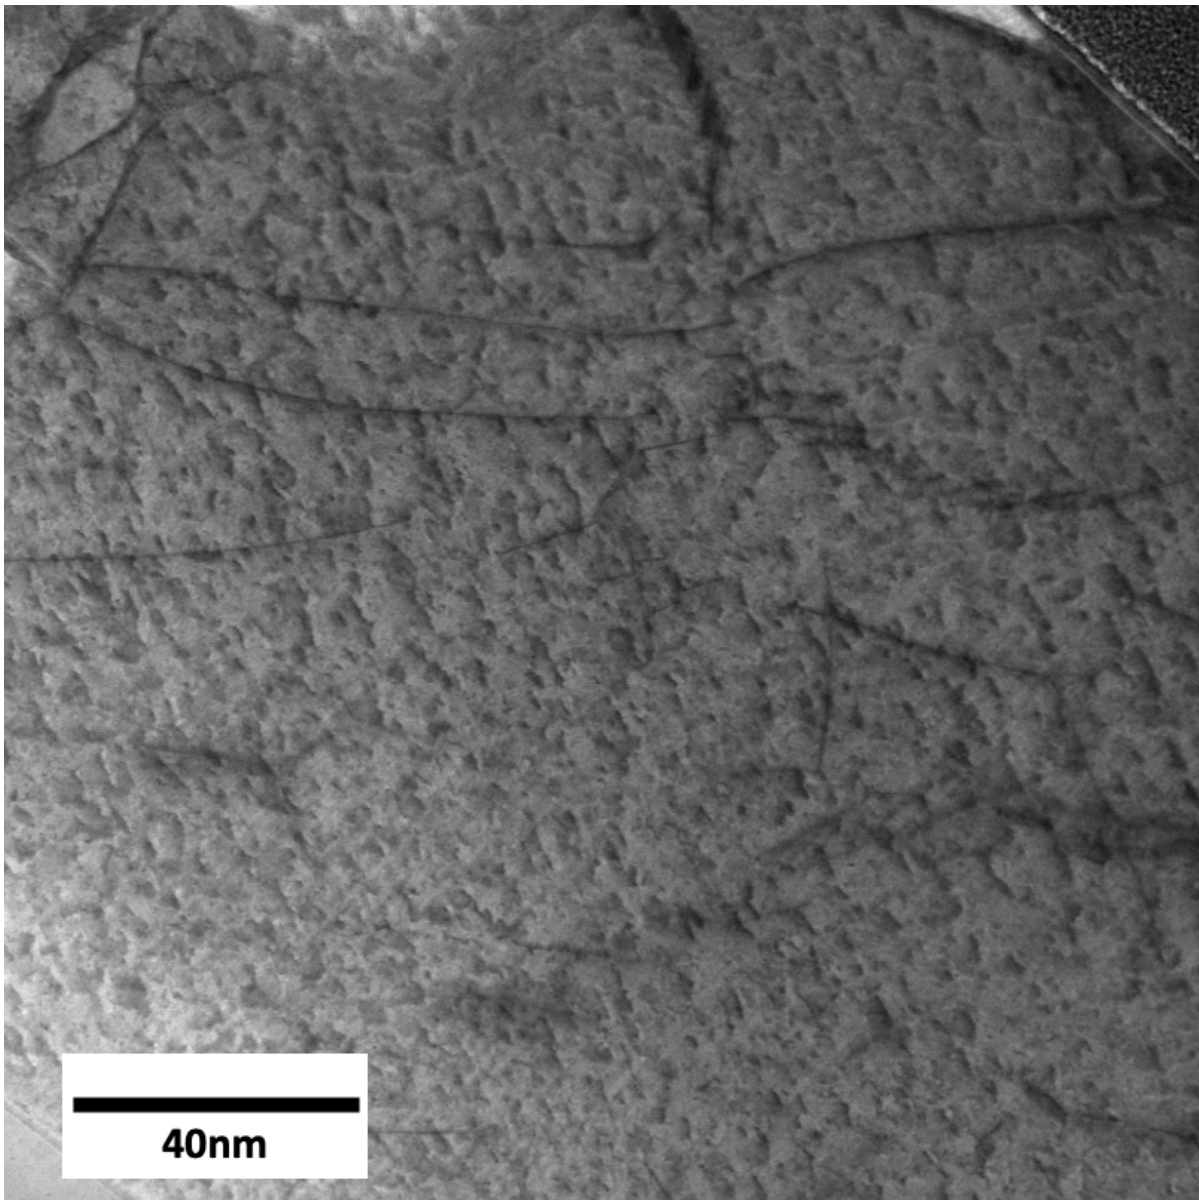
Figure 10 TEM lamella imaged using BFSTEM down the 011 zone axis. It was decided that the distributed spots were caused by FIB milling.

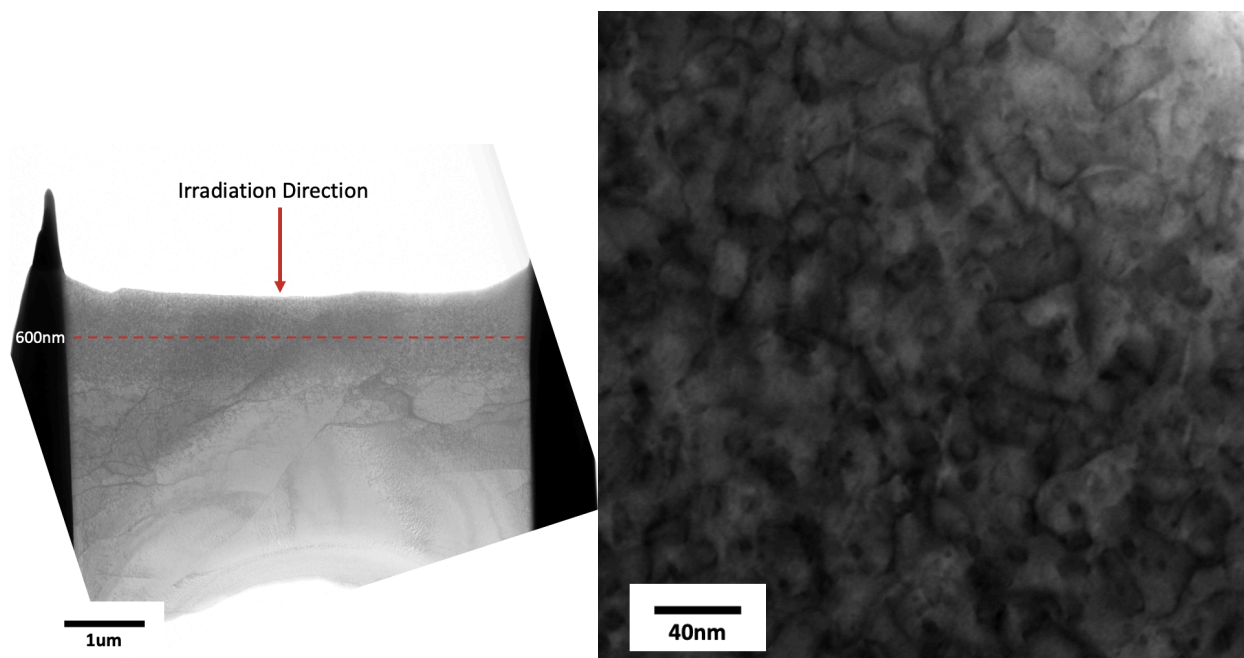
Figure 11 (left) TEM lamella imaged using BFSTEM down the 011 zone axis and (right) dislocation loops imaged 600nm into the irradiated surface.

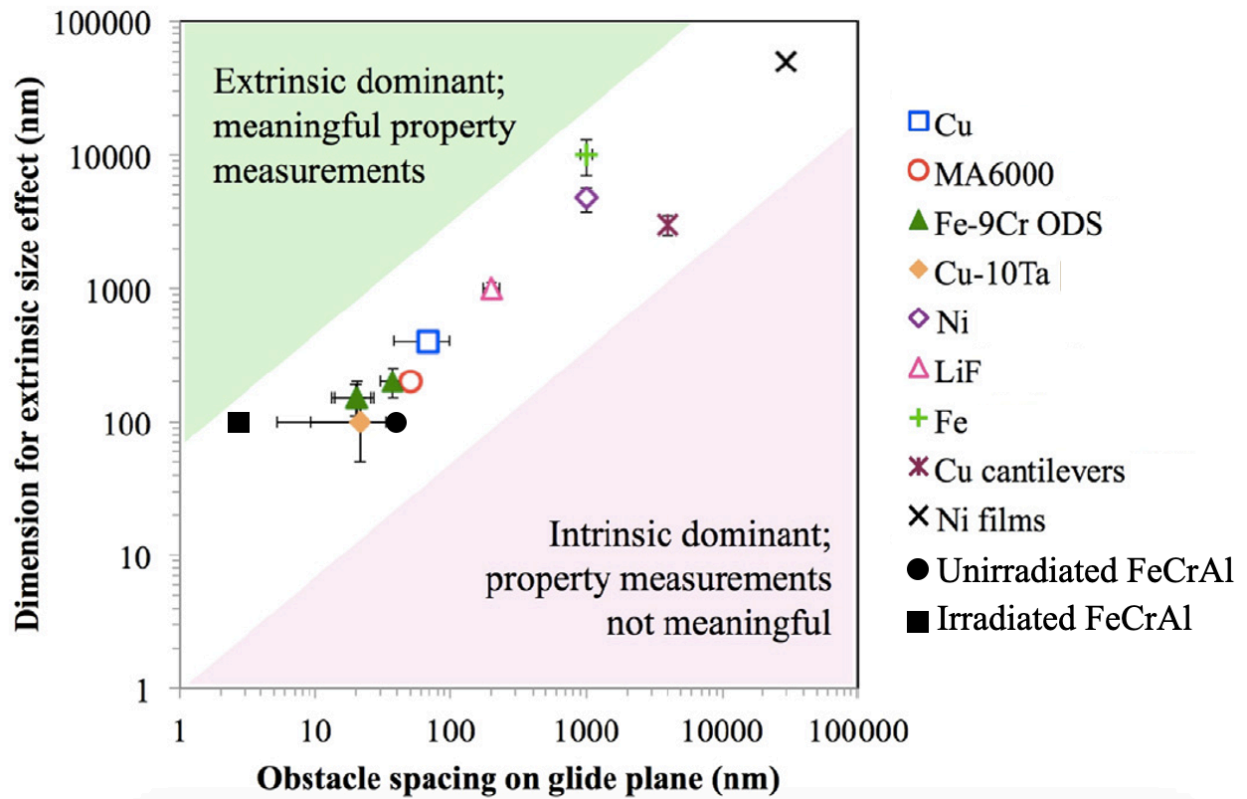
Figure 12 Unirradiated & irradiated FeCrAl microstructural data superimposed on graph displaying the relationship between extrinsic and intrinsic size effect from [43].

The hardening was quantified by finding the difference in hardness between the unirradiated and irradiated material at a common depth. It was decided that the depth at which the difference in hardness would be measured would be 250nm due to [34] logic. The rapid decrease in hardness of the irradiated material on the hardness vs depth curve signifies the point at which the strained volume has reached / exceeded the irradiation damage peak. This depth marks the transition between the irradiated and nonirradiated hardness zones [34]. This transition occurred at 300nm which was consistent with measurements from the Yabuuchi et al paper done on BCC iron with similar irradiation conditions. The difference in hardness at 250nm was measured to be 1.13GPa for both alloys. This can be seen graphically below in Figure 12.

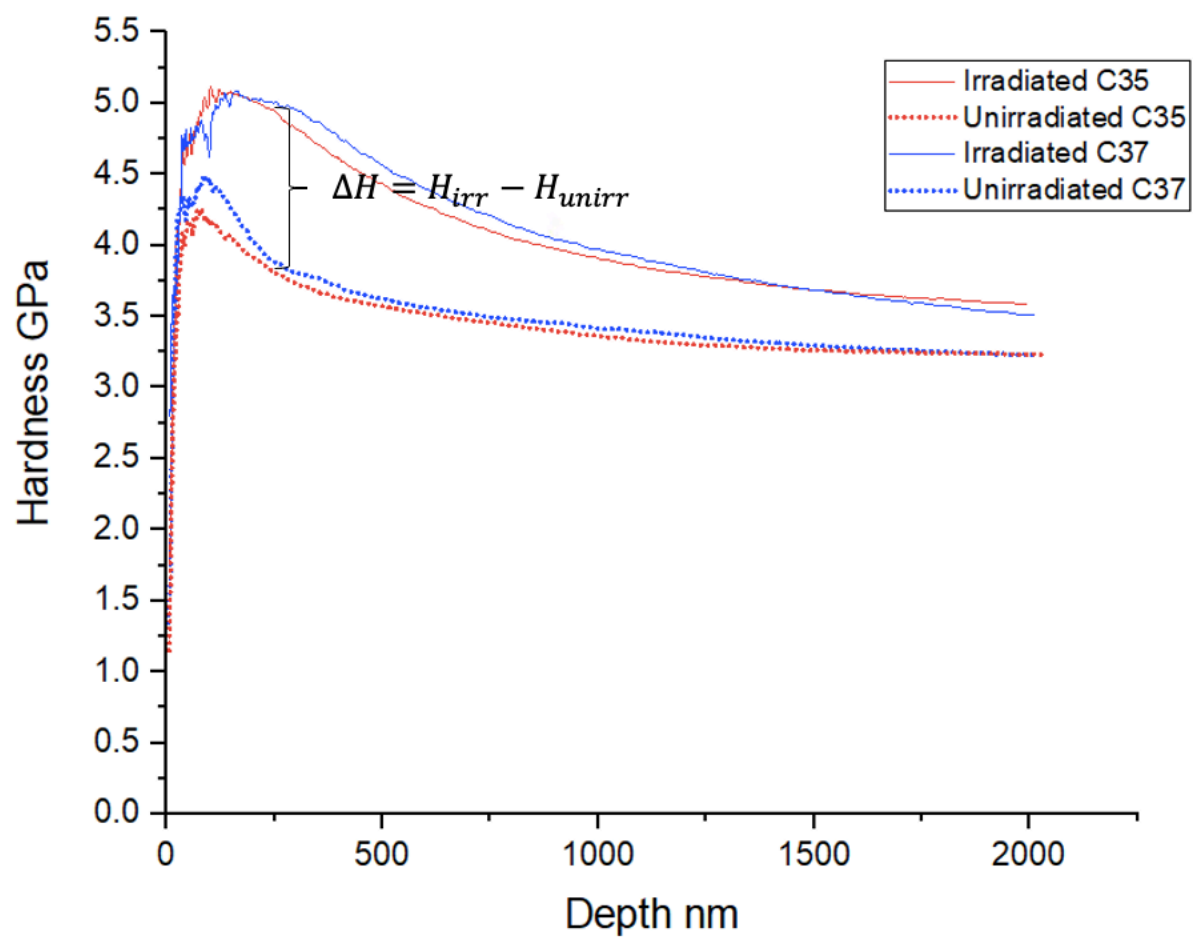
Figure 13 Nanohardness tests done on two FeCrAl alloys with 5wt% Al (red) and 7wt% Al (blue) displaying the irradiation induced hardening.

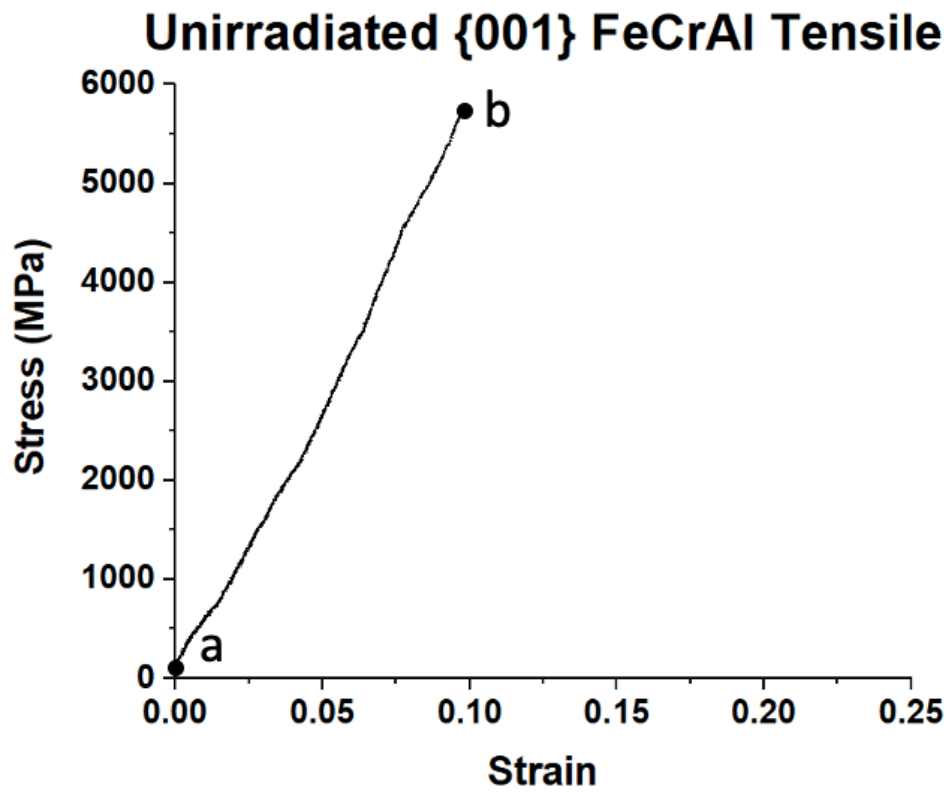
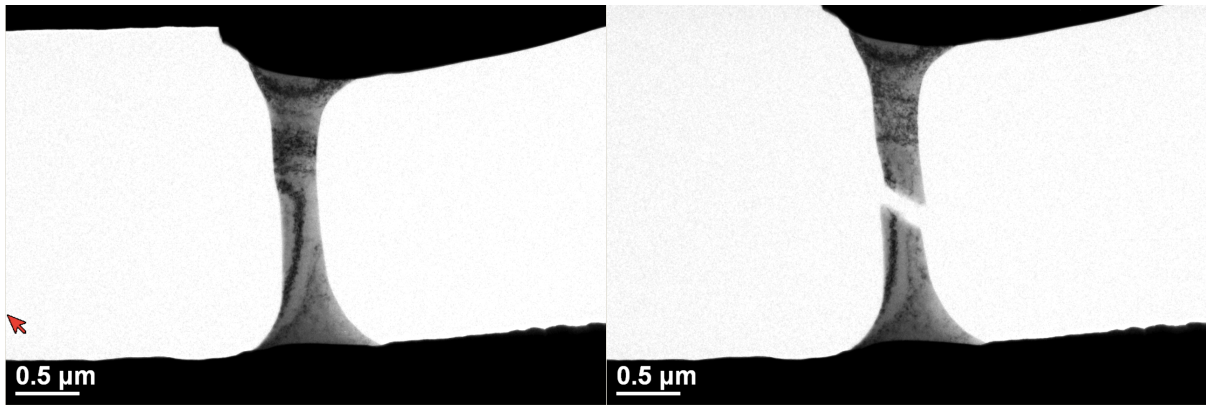
Figure 14 (above) Tensile test for unirradiated 001 grain orientation exhibiting failure after linearly deforming. (below) Still images from BFTEM video at the beginning of test and after failure.

Three unirradiated 001 grains were tested, two of which deformed linearly until fracturing in a brittle manner without yielding and one that yielded, and strain hardened before fracturing. The two samples that deformed linearly without yielding had different elastic moduli, with one being 58.5GPa and the other being 20GPa and their fracture stresses were 5.7GPa and 4GPa, respectively. The stiffer of these two samples did not show any sign of where the fracture would occur prior to it happening. The width of this beam was uniform throughout the entire gauged region and the elongation was uniform throughout the tensile test. Ultimately the fracture occurred near the center of the beam at an angle of 27 degrees and the total elongation was 9.7%. The gauged region on the lesser stiff beam was less wide near one end which is where the fracture took place. During the tensile test, the fracture location became less damaged and when fracture occurred it happened at an angle of 20 degrees and the total elongation was just over 20%. The sample that exhibited a clear yield point and a high degree of strain hardening appeared to be made up of two grains, with the grain boundary extending along the length of the gauged region. The modulus and yield stress for this sample were 39GPa and 470MPa, respectively, and it fractured at 1.4GPa. The fracture surface of this beam wasn't angled, but instead it was jagged and uneven until the fracture reached the second grain, where the fracture was completely horizontal. This sample had a total elongation of 7%.

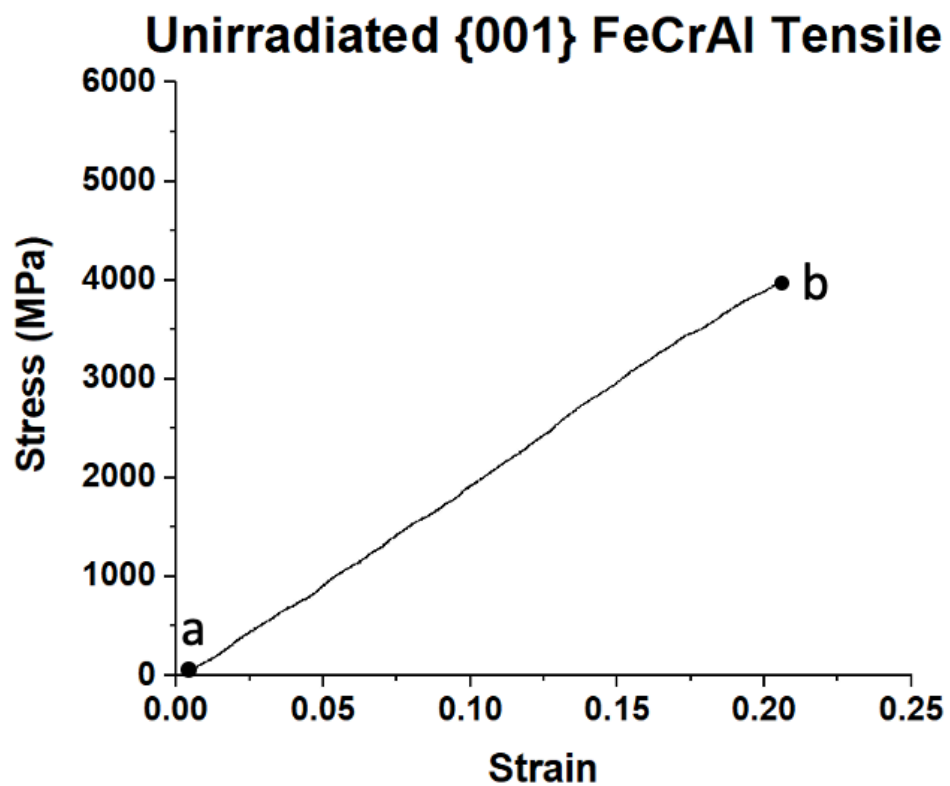
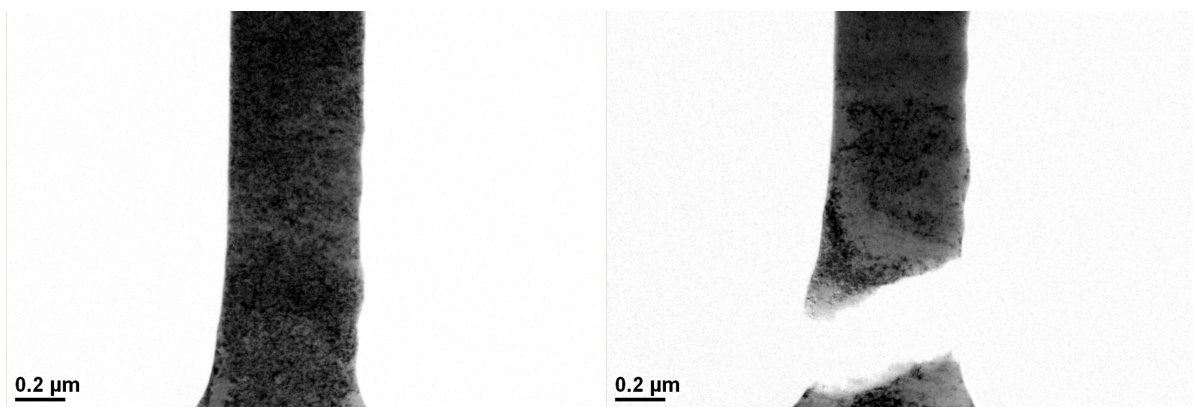
Figure 15 (above) Tensile test for unirradiated 001 grain orientation exhibiting failure after linearly deforming. (below) Still images from BFTEM video at the beginning of test and after failure.

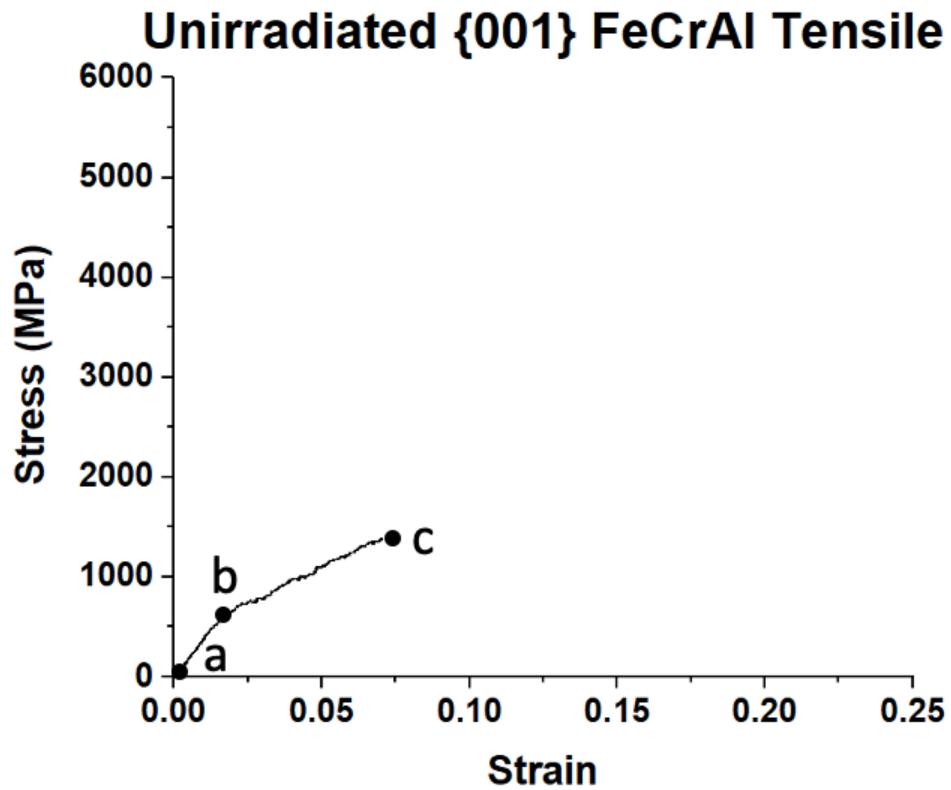
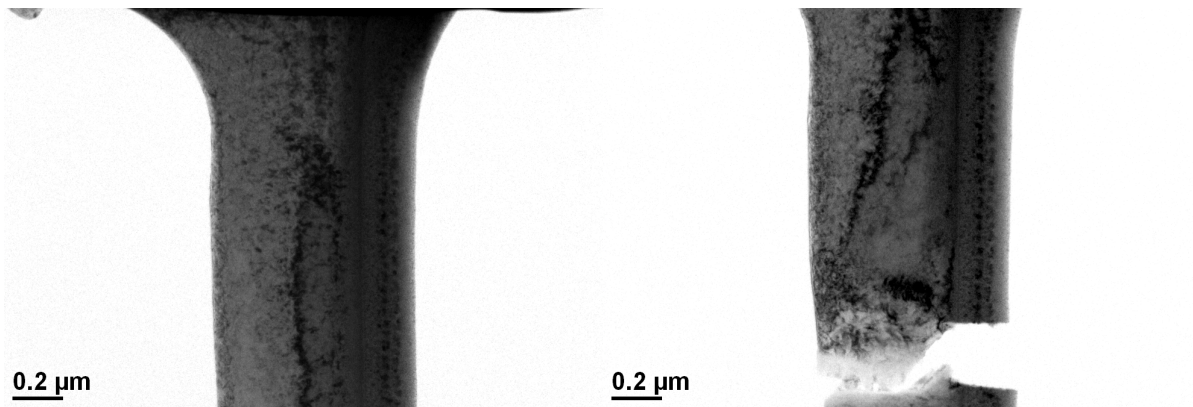
Figure 16 (above) Tensile test for unirradiated 001 grain orientation exhibiting failure after yielding.  
(below) Still images from BFTEM video at the beginning of test and after failure.

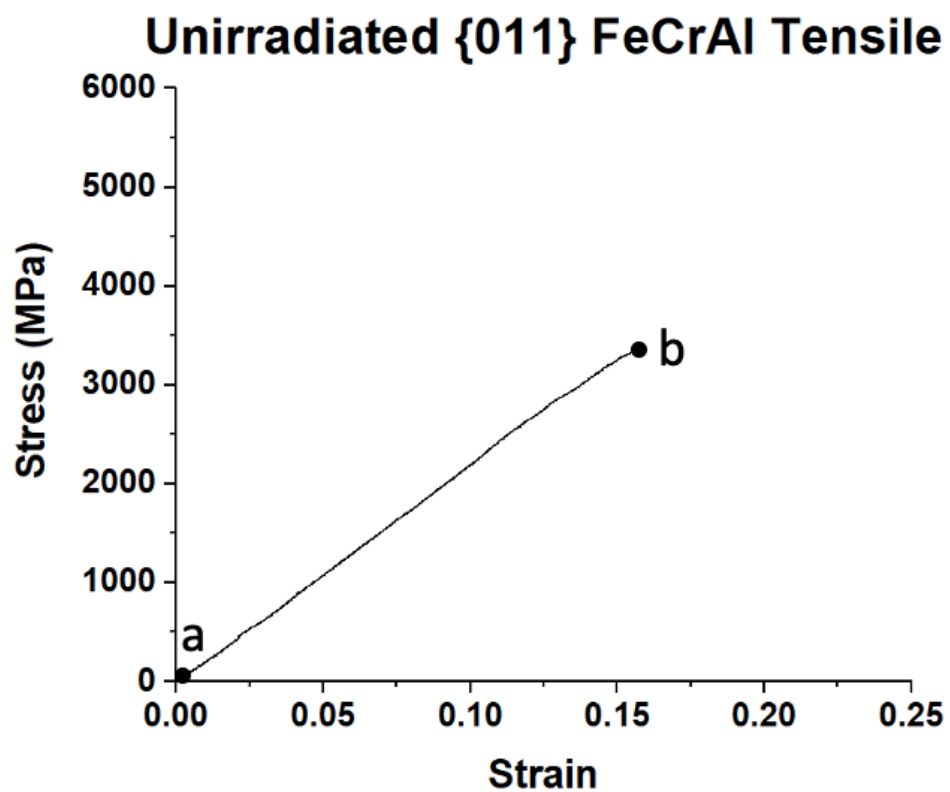
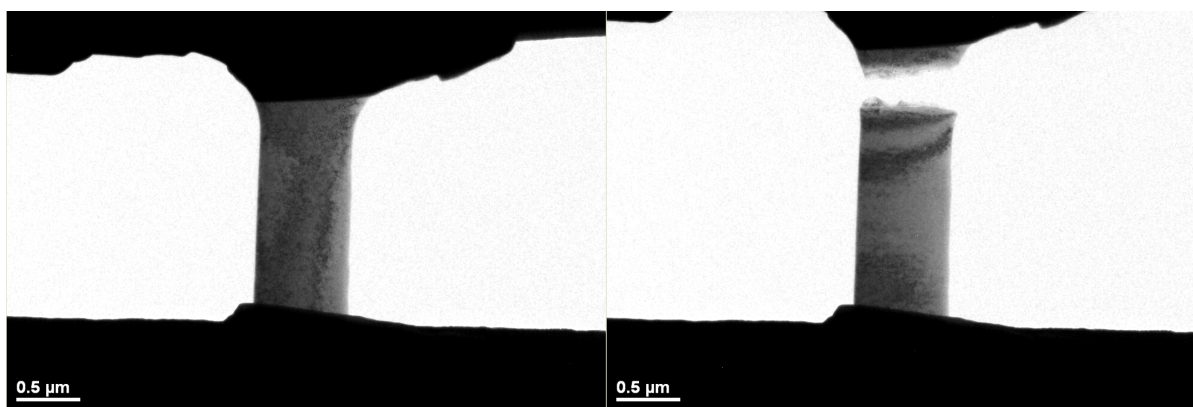
Figure 17 (above) Tensile test for unirradiated 011 grain orientation exhibiting failure after linearly deforming. (below) Still images from BFTEM video at the beginning of test and after failure.

The two unirradiated 011 grains that were tested behaved very differently. The first sample deformed uniformly along its gauged region until fracture. The fracture occurred in a brittle manner at the end of the gauged region at a stress of 3.3GPa. The stress vs strain curve was linear until fracture with a modulus of 22GPa. During the tensile test, similar to the unirradiated 001 grain, the region where fracture occurred becomes less damaged prior to fracture. The total elongation of this sample was 15.4%. The second sample tested exhibited deformation slip at an angle of 45 degrees. The stress vs strain curve shows yielding at 2GPa followed closely by a small strain burst and then a large increase in strain which corresponds with the slipping of the beam. The large strain burst is followed by many smaller strain bursts corresponding to more slippage at higher and higher stresses. The total elongation of this sample was about 17%.

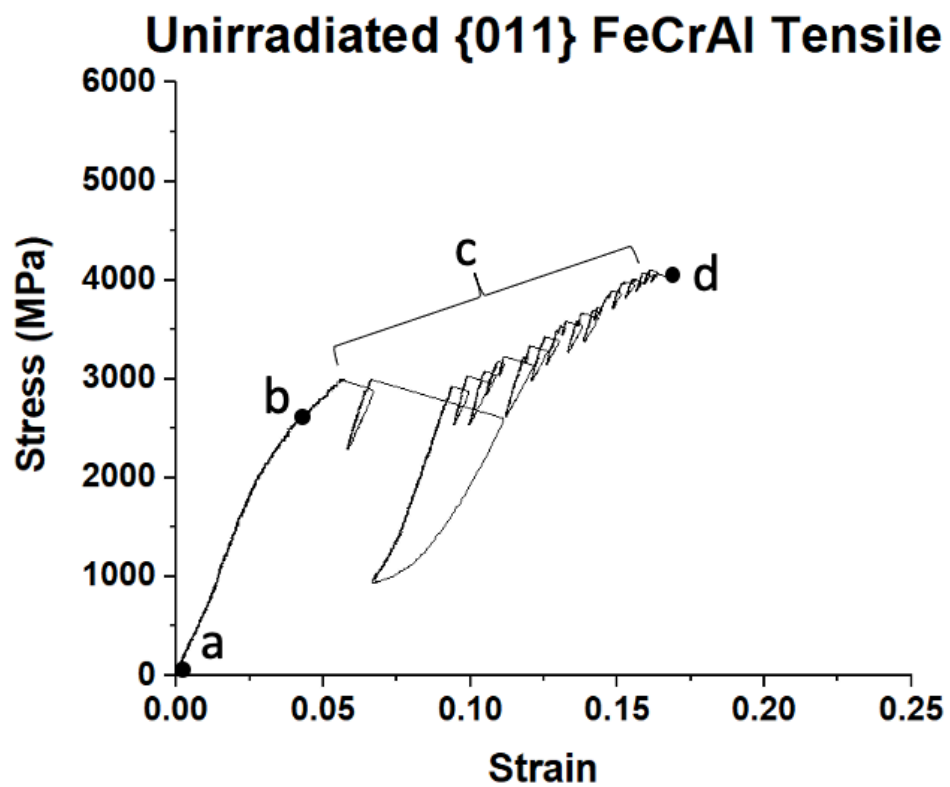
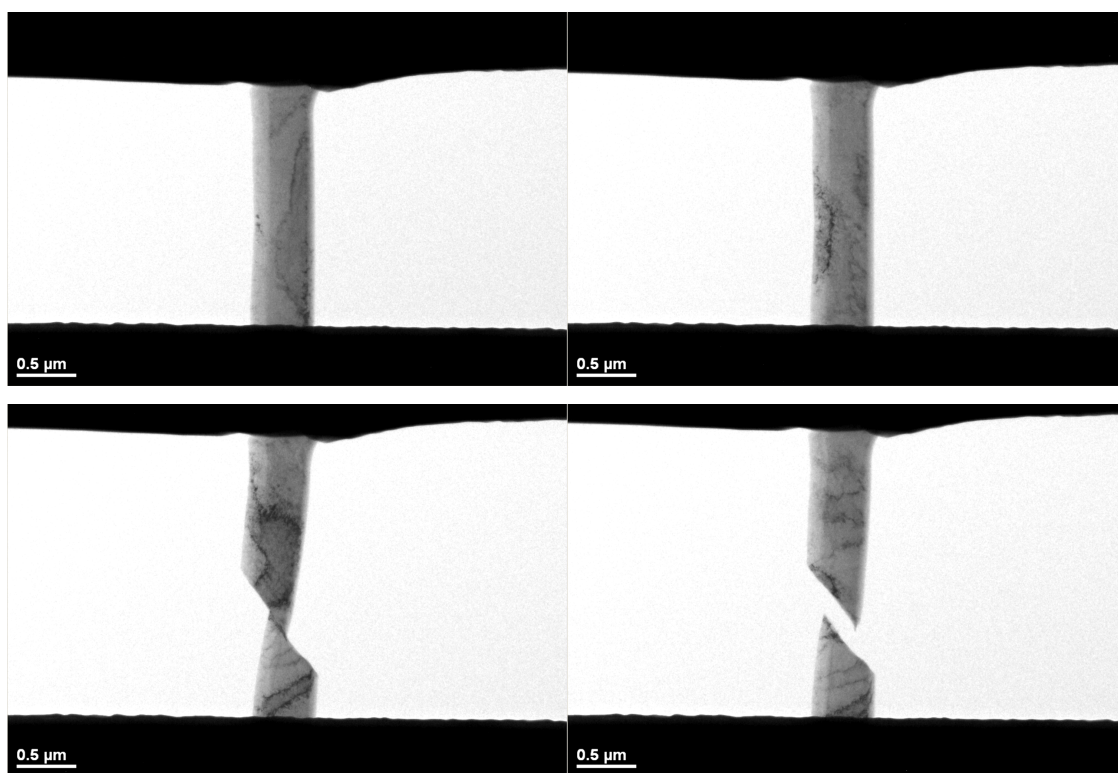
Figure 18 (above) Tensile test for unirradiated 011 grain orientation exhibiting many slip events during plastic deformation. (below) Still images from BFTEM video corresponding to beginning, yield, slip, and failure.

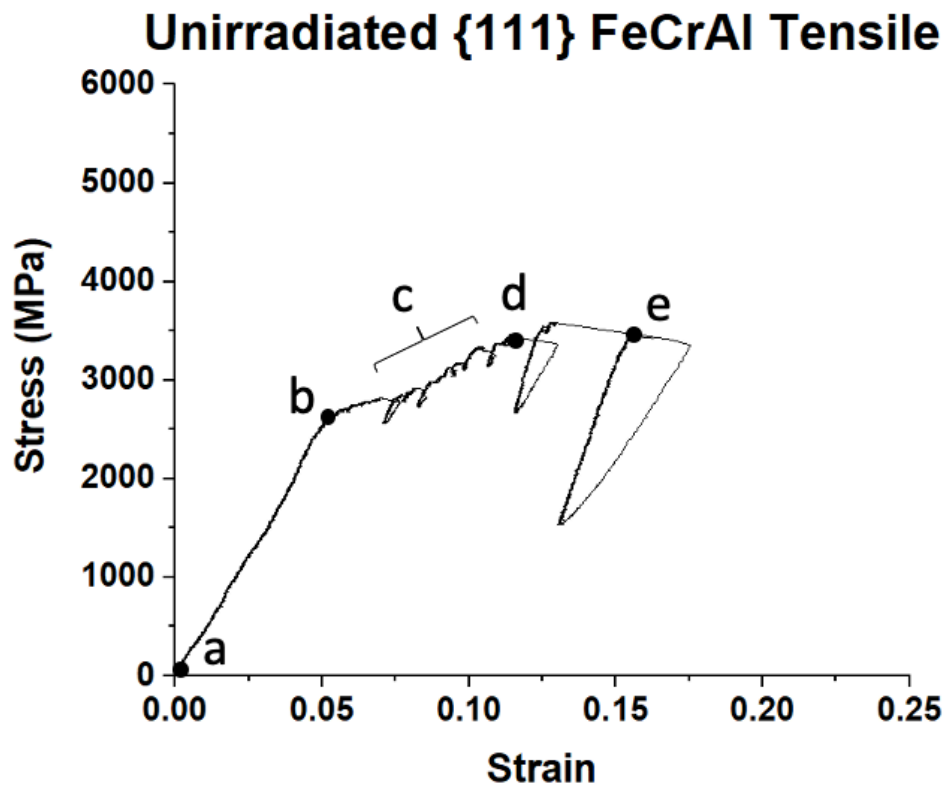
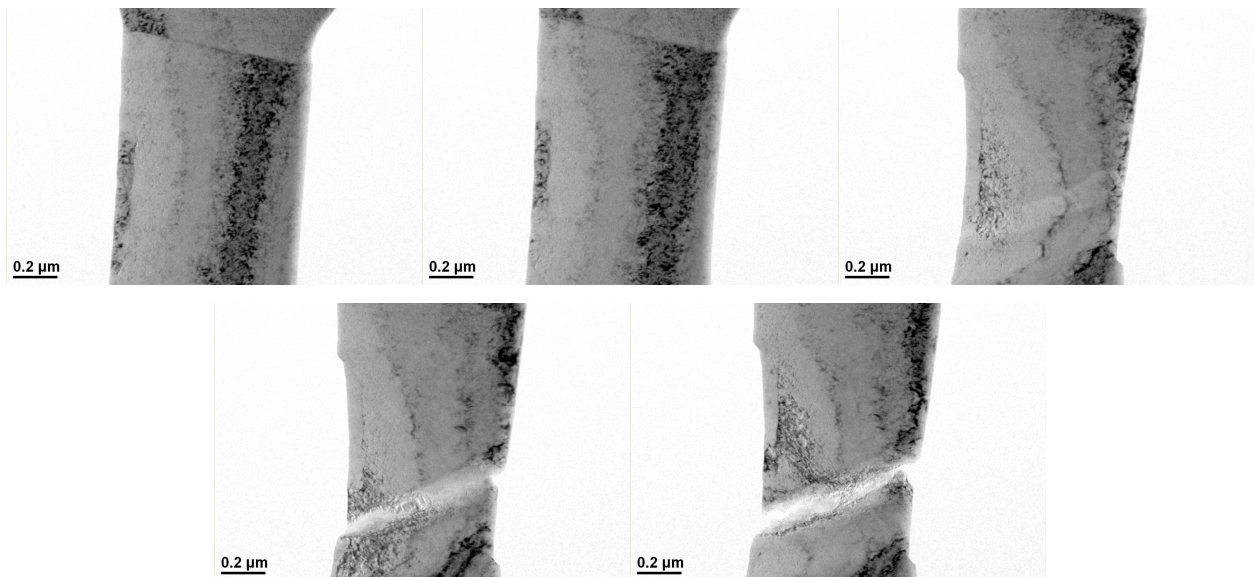
Figure 19 (above) Tensile test for unirradiated 111 grain orientation exhibiting twinning and slip. (below) Still images from BFTEM video corresponding to beginning, yield, twin formation, slip, and failure.

During this test yielding occurred at 2.7GPa, a slip step formed at a stress of 2.7GPa and then at a stress of 3.4GPa and strain of 12% a band with width of 97nm appears along the length of the beam at an angle of 156 degrees. This band is believed to be a twin. At one side of the twin are microcracks that form during the stress test. Fracture occurs along the line of the twin at a strain of 15% and stress of 3.4GPa. Prior to fracture, strain hardening occurs. Load drops were observed corresponding with the slip and twin formation.
