**DEFORMATION MECHANISMS IN UNIRRADIATED & IRRADIATED  
IRON CHROMIUM ALUMINUM IDENTIFIED BY TEM IN SITU  
TENSILE TESTING**

**A Thesis**

**Master of Science in Materials Engineering**

School of Materials Engineering  
West Lafayette, Indiana  
August 2021

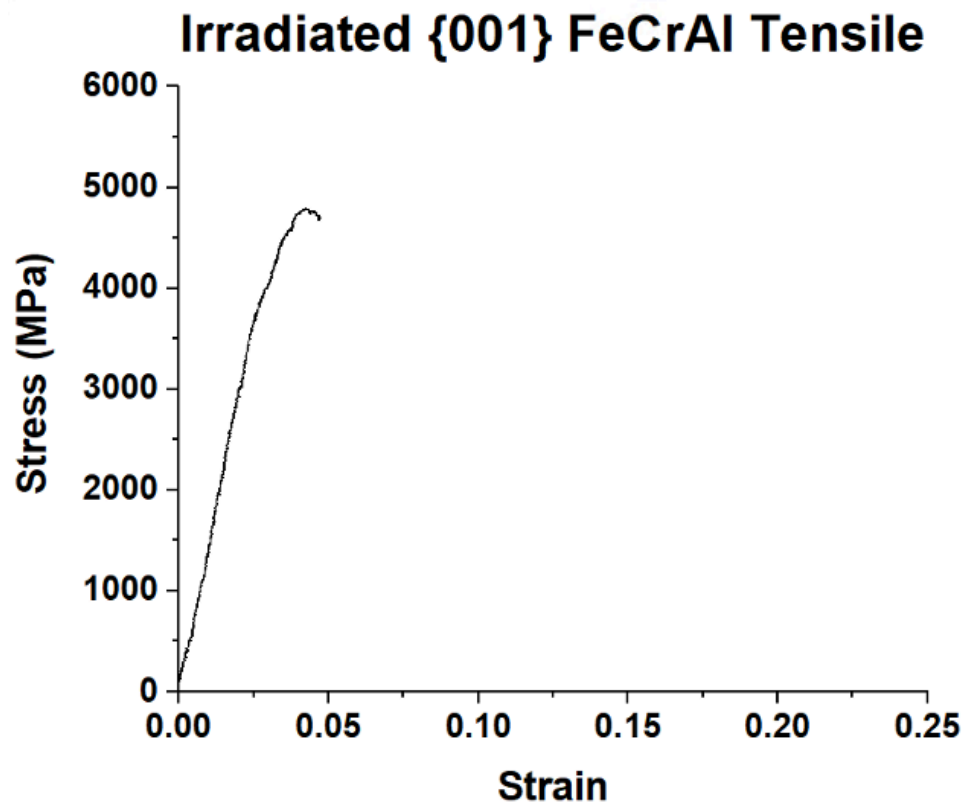
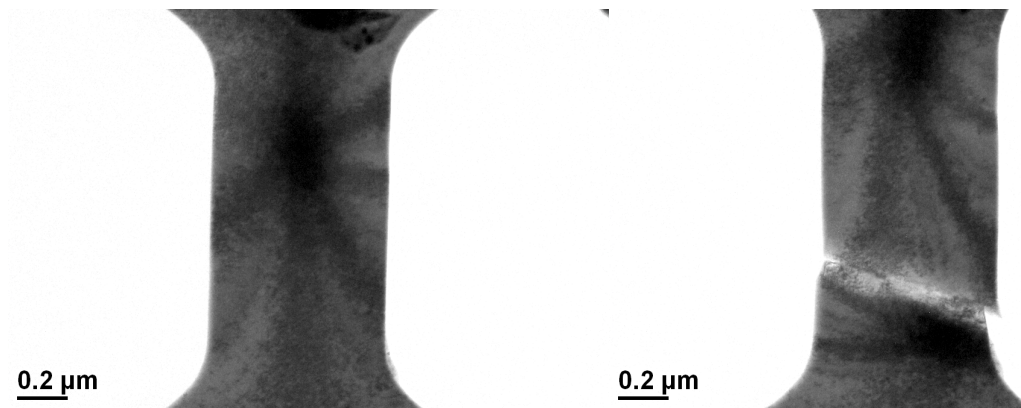
Figure 20 (above) Tensile test for irradiated 001 grain orientation exhibiting failure after yielding. (below) Still images from BFTEM video at the beginning of test and after failure.

One test was performed on the irradiated 001 condition. The sample yielded at about 4GPa and quickly fractured thereafter at 4.7GPa after reaching an ultimate tensile stress of 4.8GPa. The total elongation of the sample was 4.7% and the sample fractured at an angle of almost 18 degrees near the lower half of the sample.

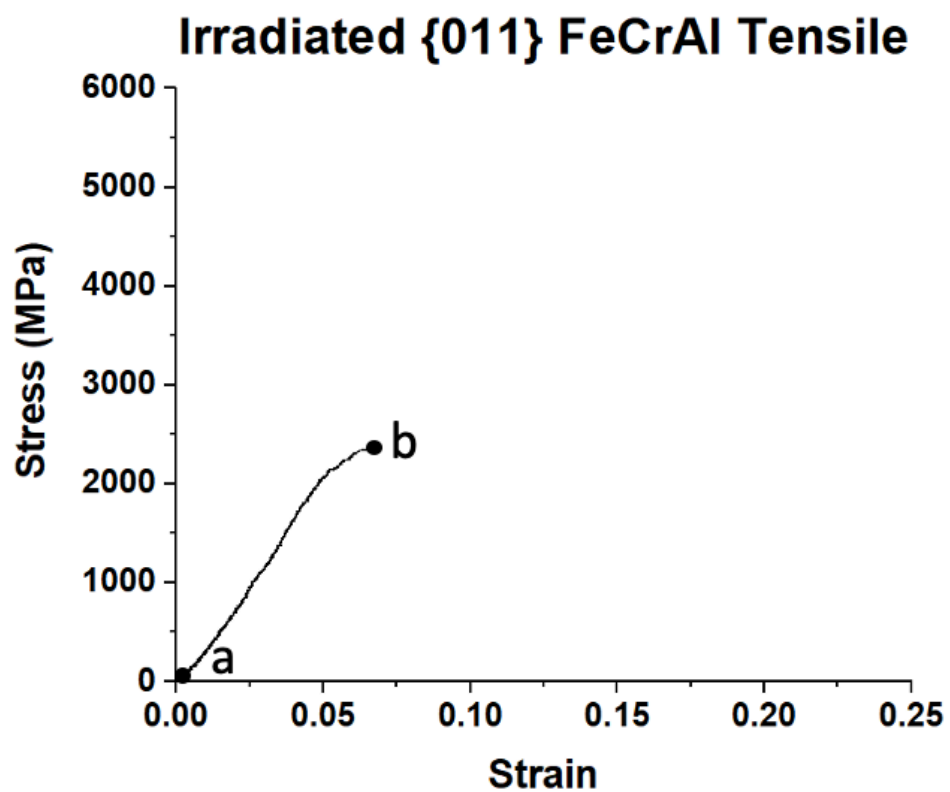
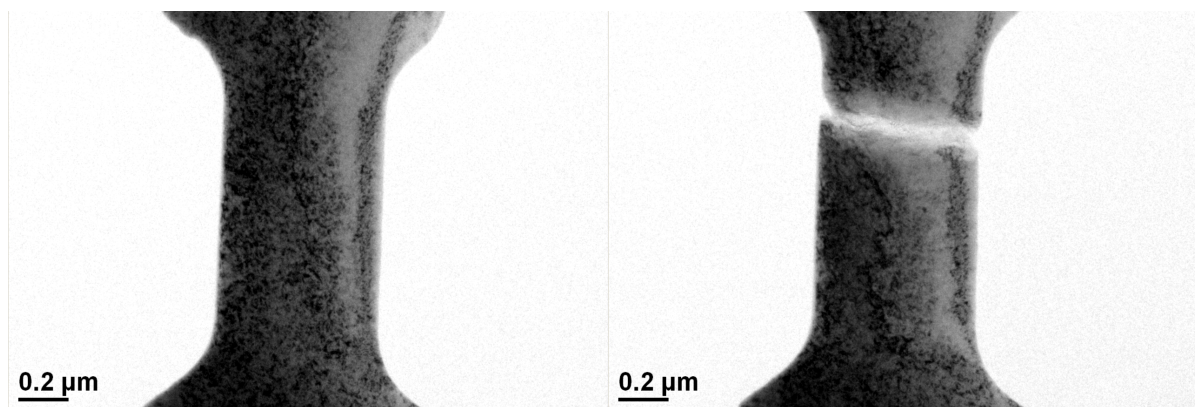
Figure 21 (above) Tensile test for irradiated 011 grain orientation exhibiting failure after yielding. (below) Still images from BFTEM video at the beginning of test and after failure.

One test was performed for the irradiated 011 grain orientation. The test yielded a uniform elongation throughout the specimens gauged region, a smooth transition from the linear elastic regime to plastic deformation, slight strain hardening, followed by fracture. The fracture occurred at a slight angle of 13 degrees. The elastic modulus for this sample was 43.5GPa and the yield stress was 2.1GPa. The sample ultimately fractured at a stress of 2.4GPa with a total elongation of 6.7%. There was little evidence in the stress vs strain curves of strain bursts or stress drops.

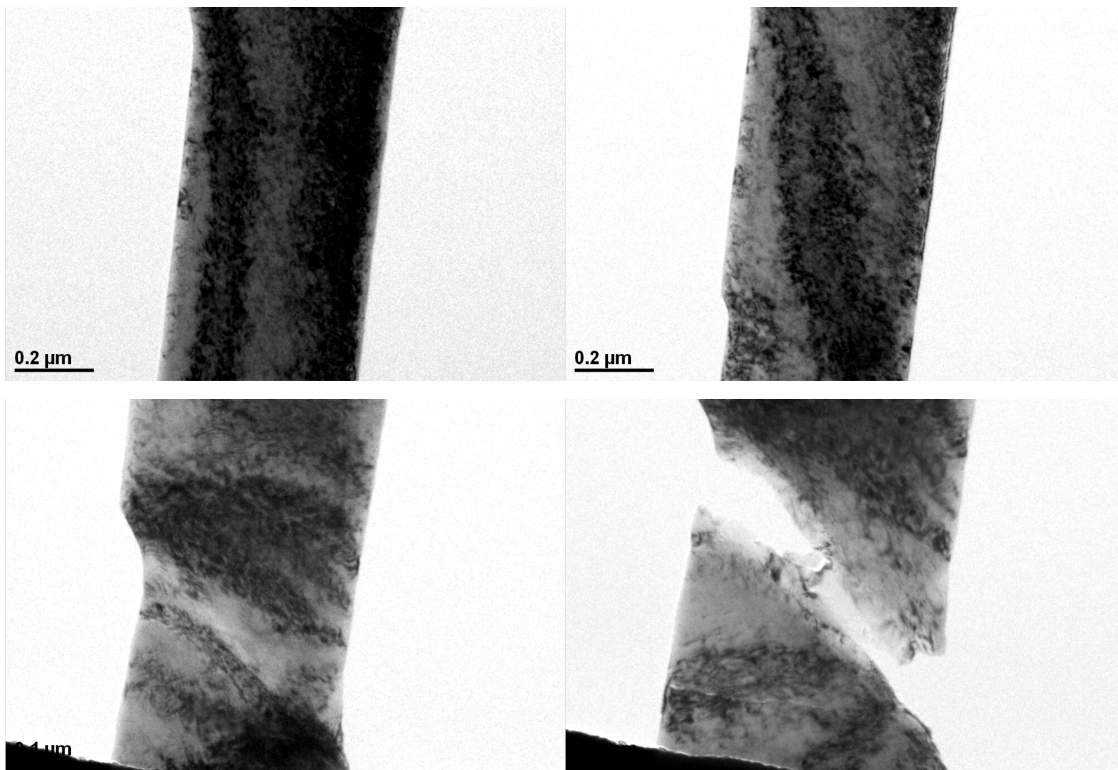
Figure 22 (above) Tensile test for irradiated 111 grain orientation exhibiting slip and softening. (below) Still images from BFTEM video corresponding to beginning, yielding, slip and failure.

Two tests were performed for the irradiated 111 grain orientation. Both tests resulted in many visible and measurable slip events. One of the samples was much stiffer than the other and they had elastic moduli of 103.4GPa and 64.7GPa. The stiffer sample resulted in a slight strain softening of the material after yielding at 2.3GPa whereas the less stiff sample resulted in a slight strain hardening after yielding at 2GPa. During the test on the stiffer sample, slip began below where the imaging was taking place and so the image was repositioned to where the slip was happening. The sample fractured at the angle in which it was slipping which was 44 degrees. This sample produced four major events as shown in the stress vs strain curve, with the smallest being a drop in stress of 500MPa and the largest being a drop in stress of 1.7GPa. After the fourth slip event the sample failed at a stress of 1.9GPa and at a total elongation of 12%. The less stiff sample exhibited an initial stress drop of 500MPa, followed by a series of relatively small stress drops, which ranged from tens to hundreds of MPa, and finally a series of larger stress drops comparable to the initial drop when the sample finally fractured at a stress of 2.5GPa. A large slip step is formed during the test and fracture occurs along the slip step at an angle of 50 degrees after an elongation of 20.5%.

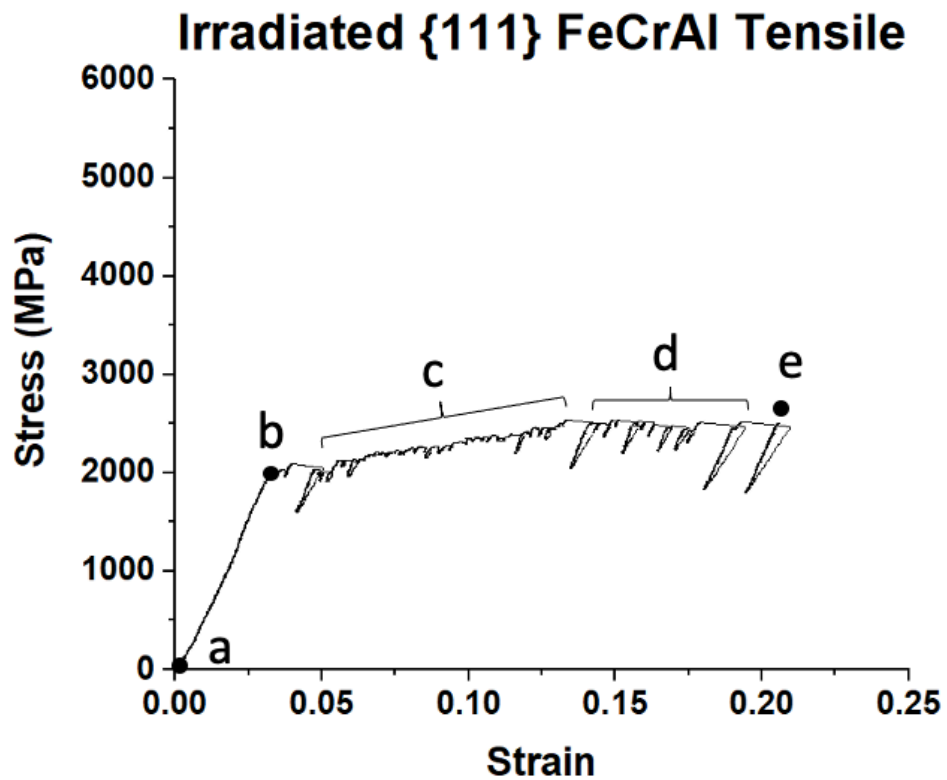
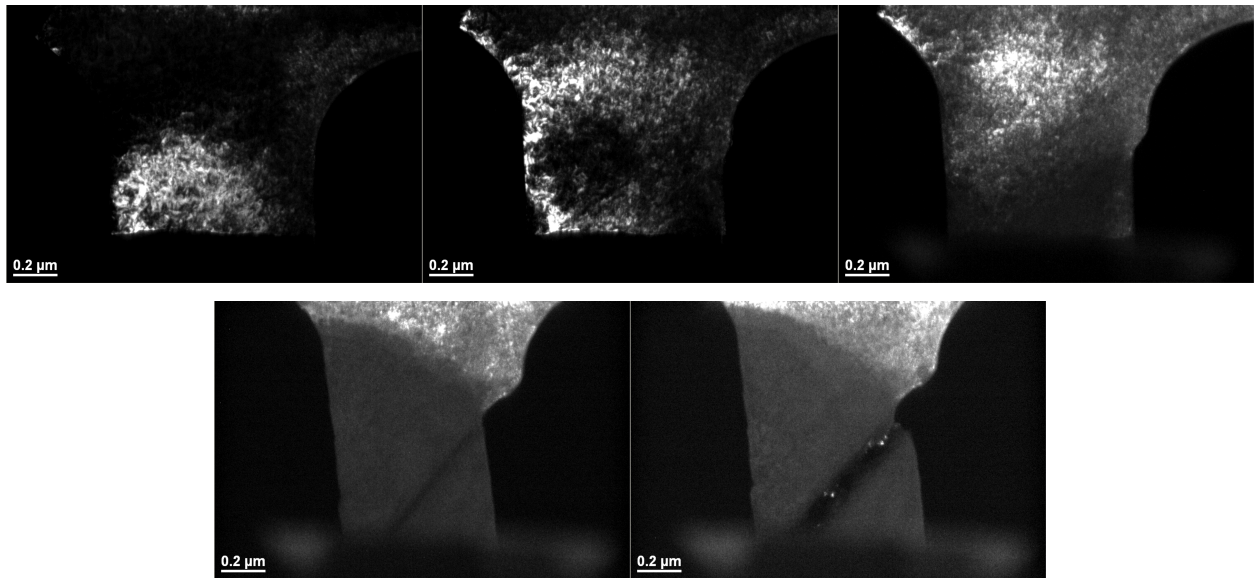
Figure 23 (above) Tensile test for irradiated 111 grain orientation exhibiting slip and slight hardening. (below) Still images from dark field TEM (DFTEM) video corresponding to beginning yield, slip and failure.
