ASSESSMENT OF TI-6AL-4V LASER CLAD REPAIR

A Thesis

Master of Science in Aeronautics and Astronautics

May 2022

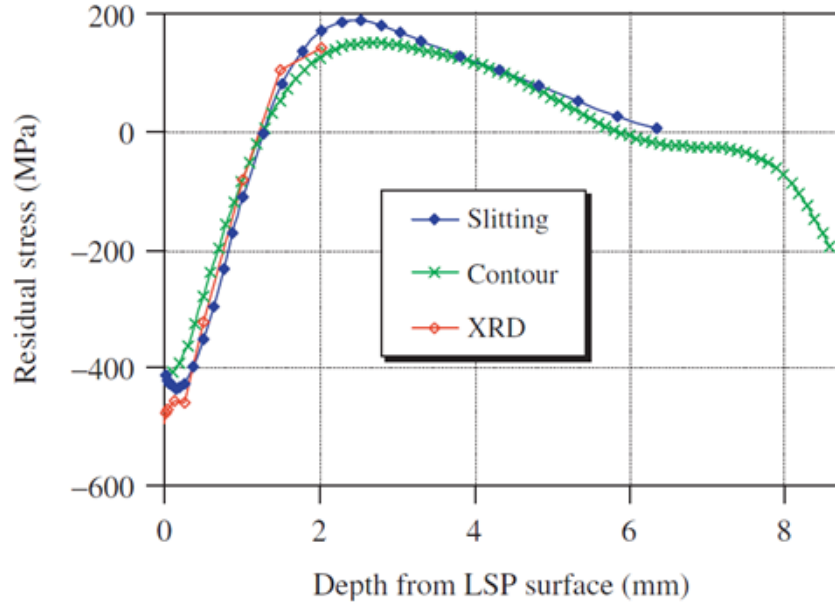
Figure 2.4. Comparison of residual stress results within specimen depth [29]

Previous research compared residual stress within Ti-6Al-4V using the slitting, contour and X-ray diffraction through layer removal methods [29]. Methods correlated fairly well, as detailed in figure 2.4, showing a similar stress distribution throughout the depth of the specimen from the free surface. Notably, there are deviations that are less than 100 MPa between HXRD and the destructive methods at the surface. A contributing factor leading to these deviations is higher uncertainties experienced by the destructive methods at the surface of the material.

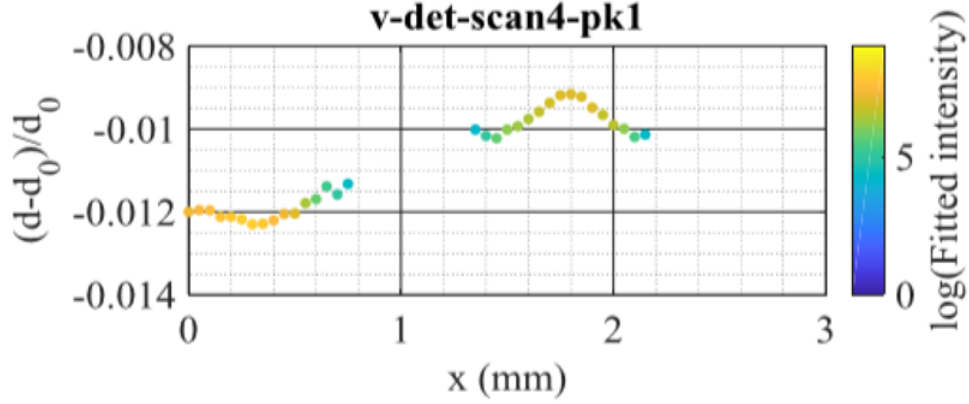
Figure 2.7. Inconsistent lattice strains for EDD application [40]

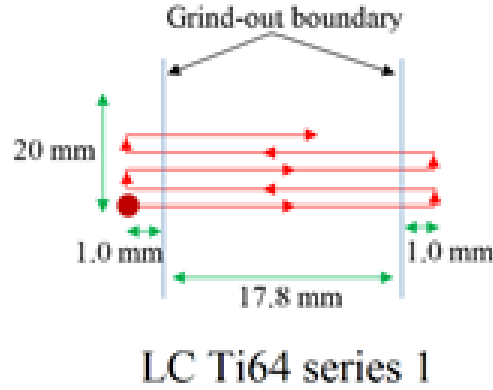
Figure 3.5. Deposition pattern [40]

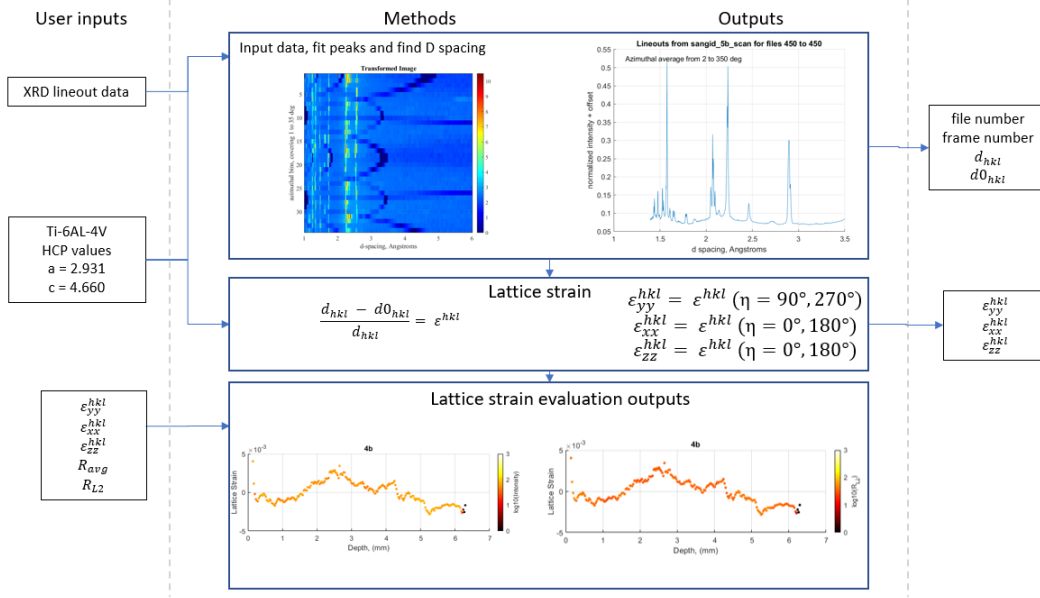
Figure 4.1. XRD method

clad repair. As stated in the literature review, Bragg's law can be utilized to evaluate the distance between crystal lattices, d_{hkl} , with identification of diffraction peaks leading to an understanding of the lattice crystal structure.

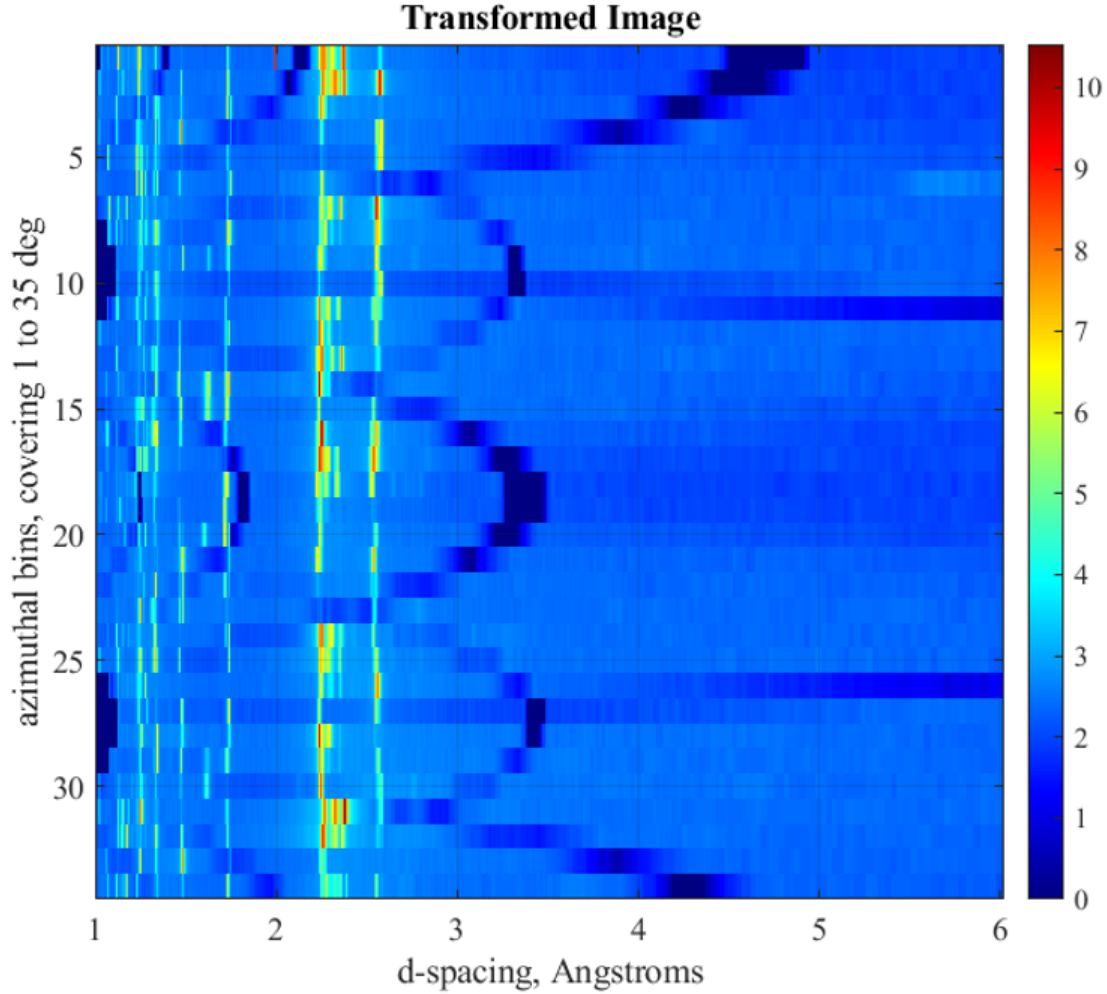
Figure 4.3. Intensity from As-clad specimen

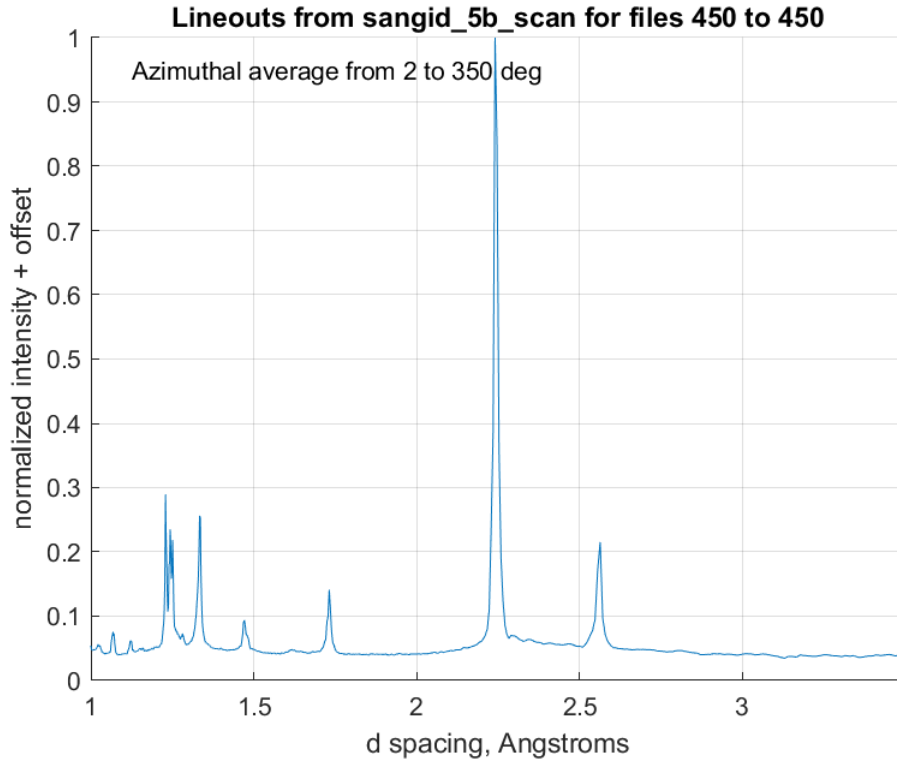
Figure 4.4. Sample Ti-6AL-4V lineout

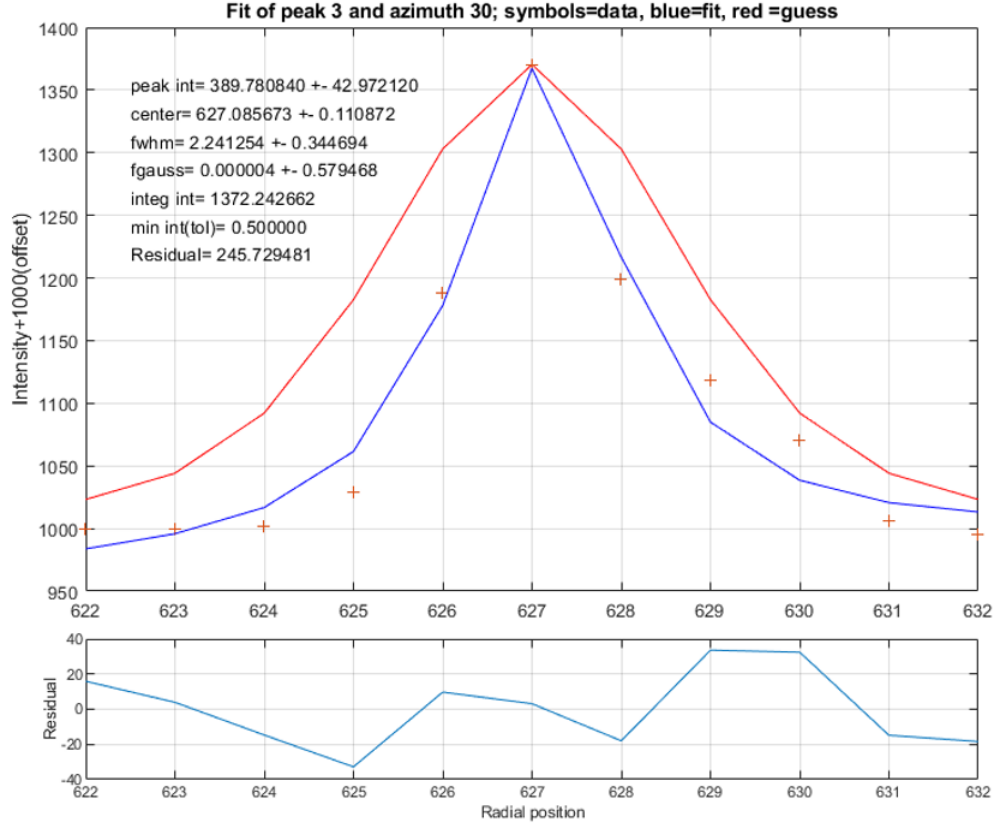
Figure 4.6. Residual example from As-clad specimen

The residual is utilized as a measure of how the experimental data compares to the review of intensity conducted at each peak to make sure it fits the residual value, R, with good matches following from low R values. A high R value reveals the experimental data points that are being interpreted may not be a good match to the expected calculated data.

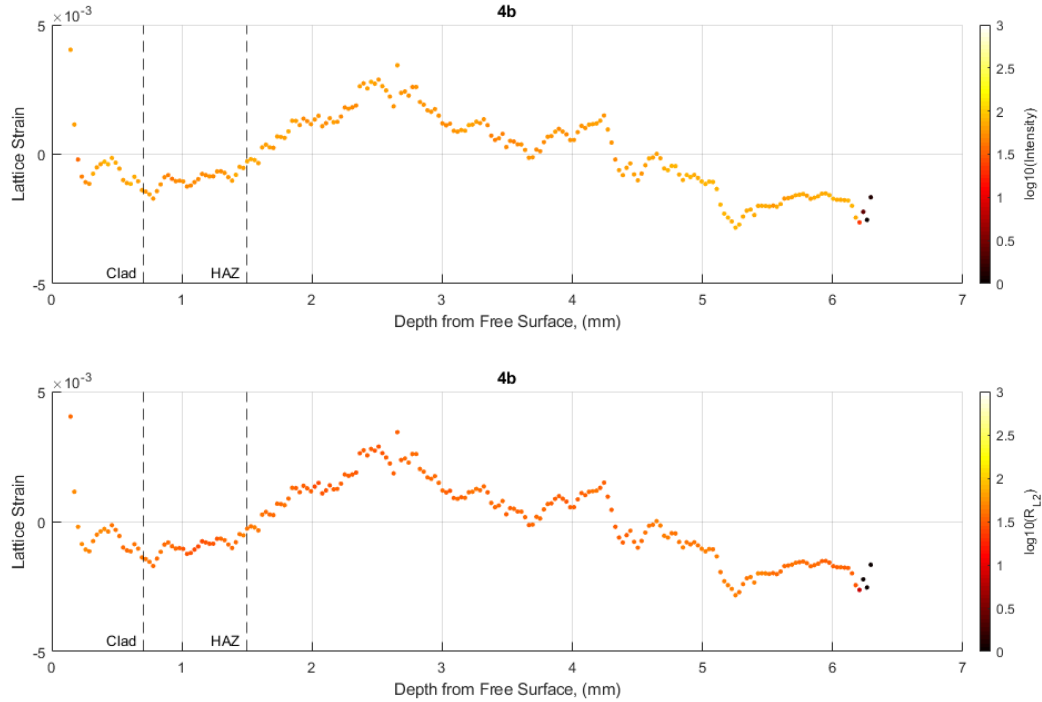
Figure 4.8. Lattice strain for PHT specimen

The lattice strain was computed for each file, or each scan at a particular y position utilizing the axis from figure 4.2. To aid in interpretation of the lattice strain figures the peak intensity and norm residual, denoted as R_{L2} , corresponding to each data point were added as color bars to the lattice strain plots. However, when plotting the results of a scan at a single y position throughout the depth of the specimen, a significant amount of scatter was observed with no distinguishing pattern between the data points. To establish a more consistent lattice strain pattern that we would expect from the material, a sum of every lattice strain value at each depth position was taken. As observed in figures 4.7 and 4.8, this method significantly reduced the scatter of a single y position, with a smoother behavior observed in the lattice strain throughout the depth of the specimen.

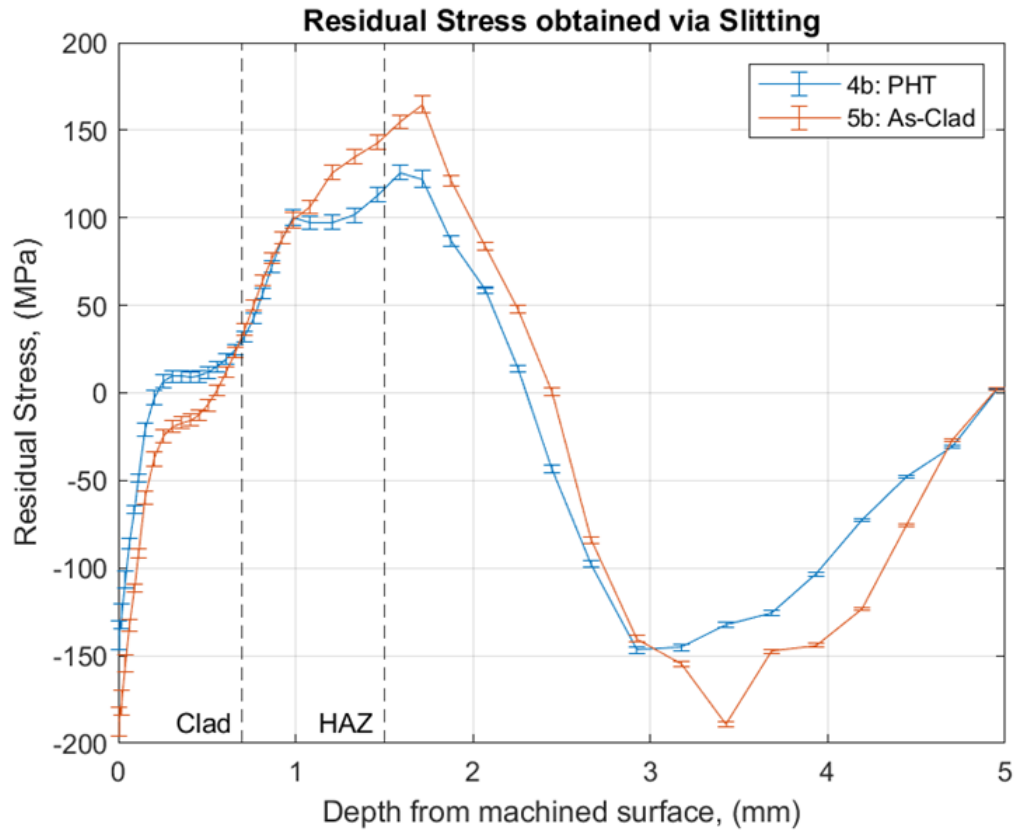
Figure 4.10. Slitting results

The slitting results highlighted differing magnitudes of residual stress between the As-clad and PHT specimens. This outcome is expected, with the application of heat treatment

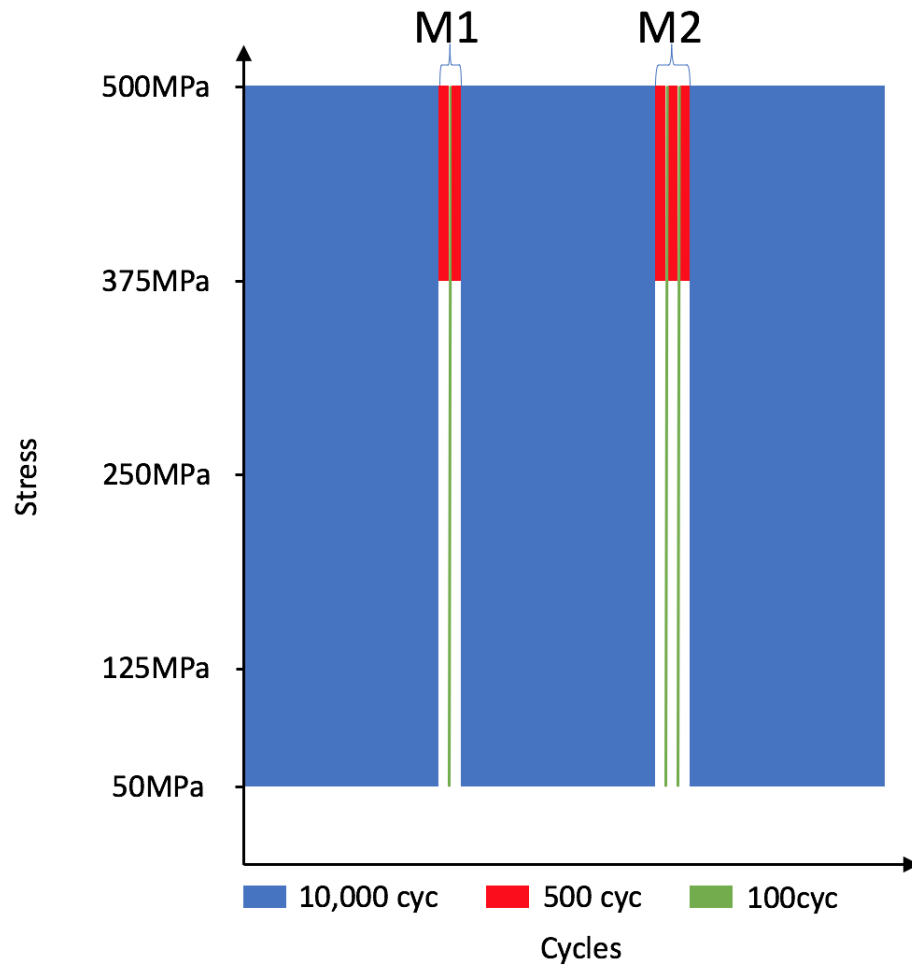
Figure 5.1. Example marker band loading sequence [40]

and repeating groups of cycles with a higher minimum applied stress to the tensile fatigue loading.

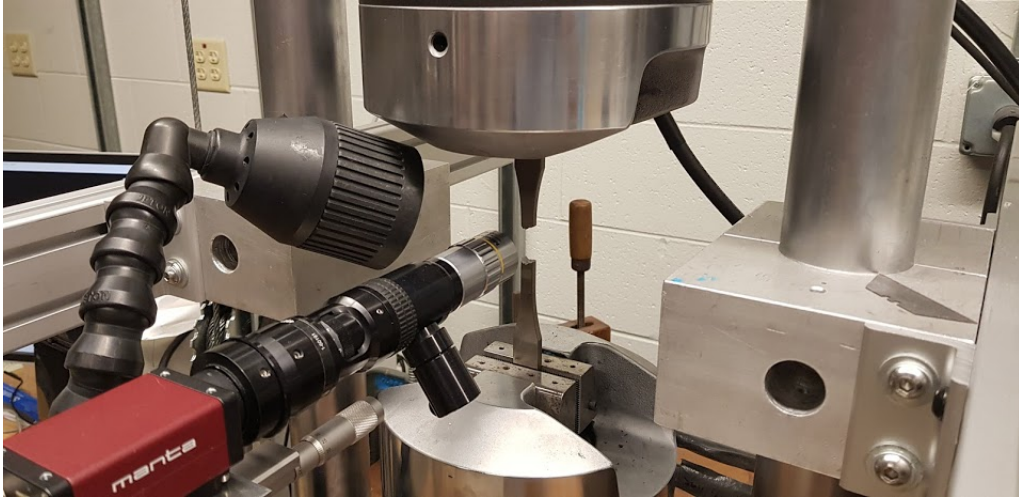
Figure 5.3. Camera configuration with 10x optical lens

Previous research had encountered problems in initiating cracks in the notch region, which allows for tracking of the crack growth within the specimen during the fatigue test [40]. Of six specimens tested, only one failed within the notch region, with four of the six failing within the gauge region which was exposed to the laser clad repair. The other two specimens failed at the transition between the gauge region and the neck of the specimen leading to the grip area. Whilst previous research was able to detect and characterize marker bands in a sample that had not failed at the notch [40], this progression did not occur in the clad region. Due to the thin thickness of the laser clad deposition, selected to model

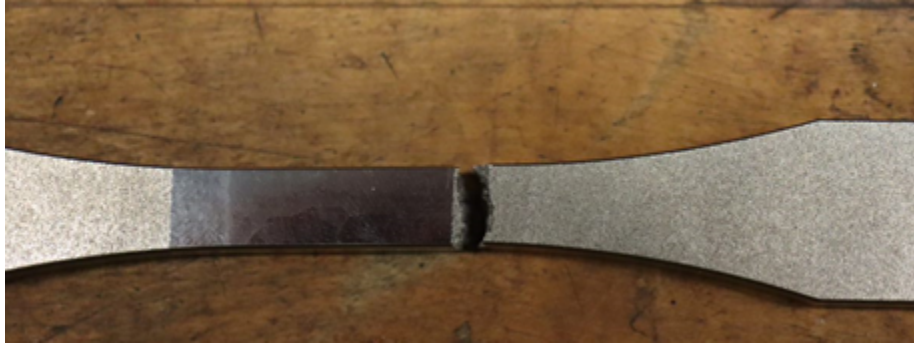
Figure 5.4. Failure of design 3.1

From a visual review of the specimen, crack initiation occurred at the transition between the clad region and the remainder of the specimen which had been exposed to the shot-peen application. As this is a laser clad sample, the interactions between the residual stresses from machining the surface of the specimens post-repair and at the surface of the shot-peen surface can act as a stress concentration and source of crack initiation. As this occurred

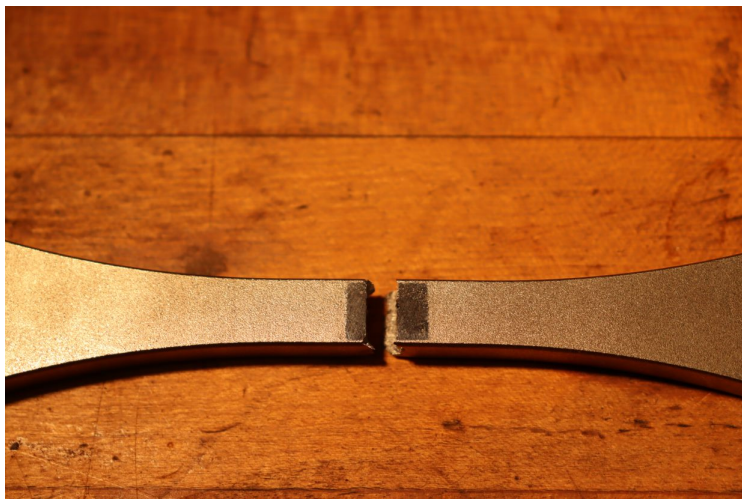
Figure 5.5. Failure of design 3.2

Once design 3.2 was implemented across the remaining specimens fatigue testing was completed on each specimen until failure. The same load sequence was retained as in previous tests, as the dimensions are the same as previous designs, therefore the same stress was applied to the specimen gauge. In a similar manner to the previous specimen design iterations, images were taken of the notches when appropriate to determine any crack initiation until specimen failure.
