**STAGNATION IMPACTS ON BUILDING DRINKING WATER SAFETY:  
THE PANDEMIC AND MICROPLASTICS**

**A Dissertation**

Lyles School of Civil Engineering

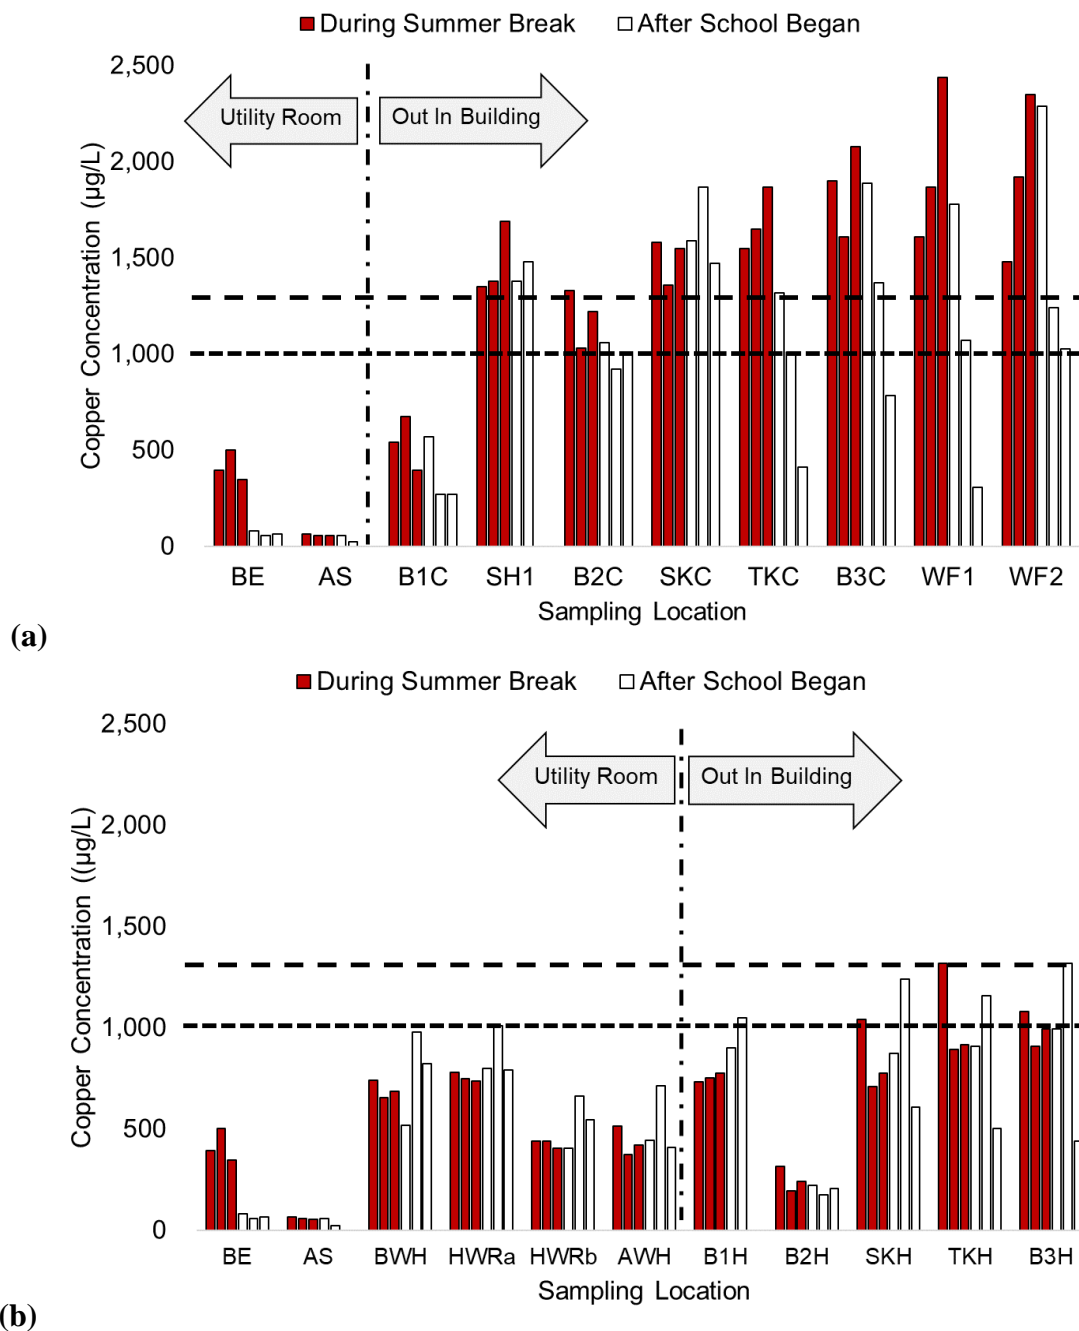
Figure 1-2. From June to October, 2018 total copper concentration was monitored at the building entry point (BE), water exiting the softener (AS), and (a) 8 cold water locations in the building, and (b) 4 hot water locations in the utility room and 5 hot water locations in the building. Each bar represents one sampling event and the results represent first draw samples only. Sampling location (left to right) corresponds to distance from the water meter. The dashed horizontal lines indicate the health based AL of 1,300 µg/L, and aesthetic based secondary MCL of 1,000 µg/L. Trip and field blanks were free of contamination. BE = Entering building, AS = After softener, BWH = Before water heater, HWR = Hot water return, AWH = After water heater, B = Bathroom, C = Cold water, H = Hot water, SK = Student's classroom kitchen sink, TK = Teacher's lounge kitchen sink, WF = water fountain.

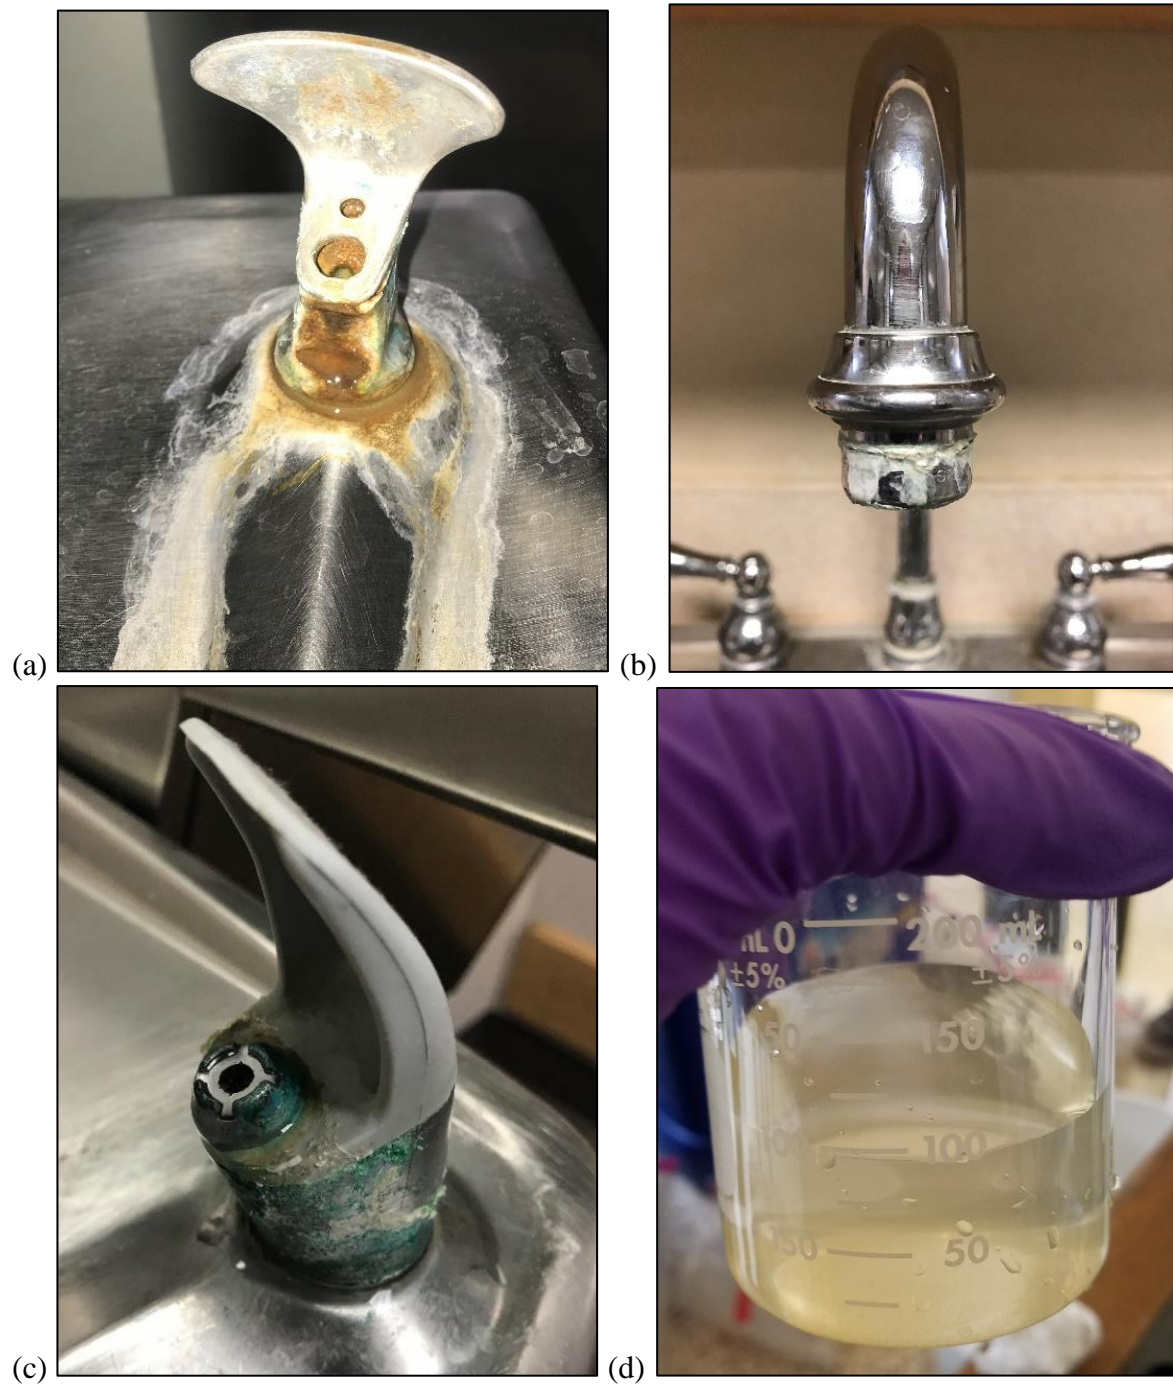
Figure 2-3. Fixture conditions at (a) Building A, (b) Building C, (c) Building D, and colored water from (d) Building D in March 2020. A drinking water fountain from building A has been changed with new drinking water fountain with filters after buildings re-opened.

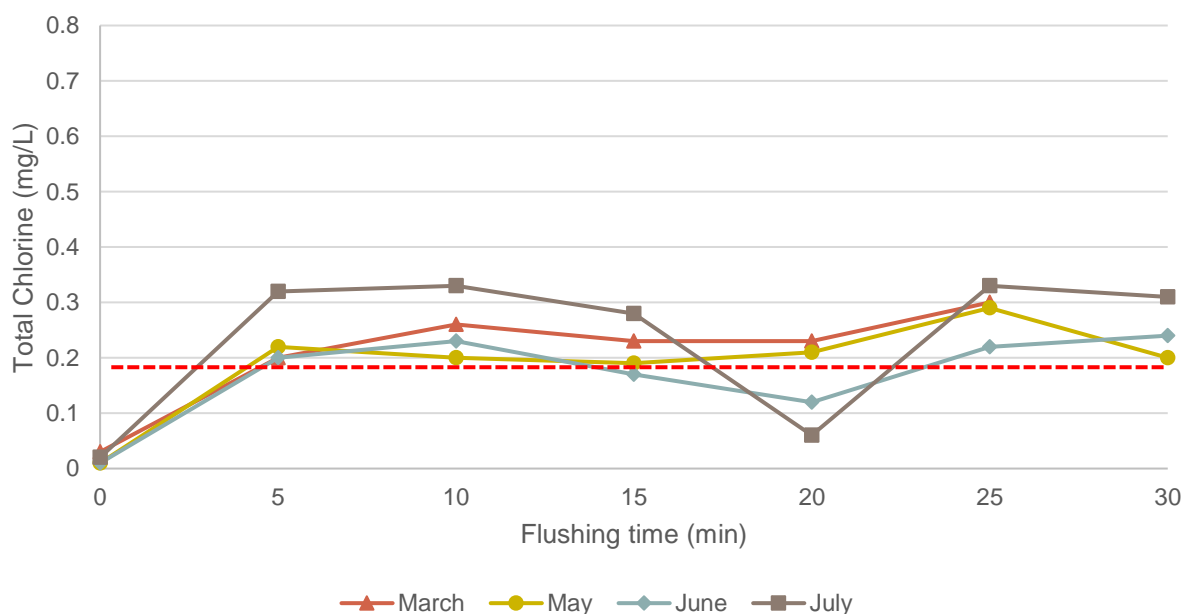
Figure 2-4. Total chlorine residual concentrations varied monitoring during continuous 30-minute flushing at building A. Red dotted line on 0.2 mg/L. See Figure SI-4 for other buildings.

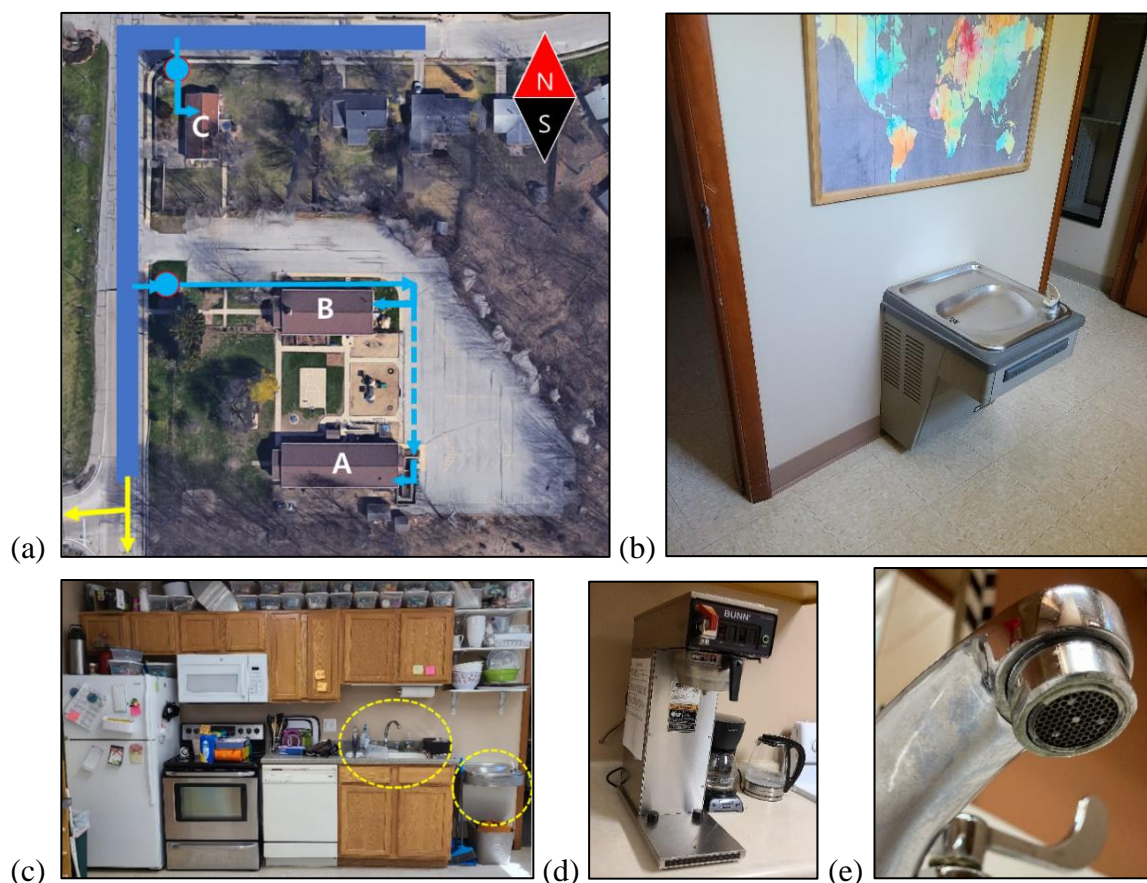
Figure 3-1. (a) Site property with building A, B and C with estimated location of public water supply pipe (blue), two water meters (sky blue circle) and service line to each building (sky blue) and where splits to deliver to building A (dotted sky blue), (b) Elkay drinking water fountains installed for kids' height, (c) All classrooms had their own sinks, drinking water fountain, and appliances, (d) Coffee maker connected to the plumbing in building A, and (e) Particulates on the aerator before removal.

None of the campus buildings were originally designed to be school buildings (**Figure 3-1**). Buildings A (2 floors, 2,423 m<sup>2</sup>) and B (1 floor, 1,024 m<sup>2</sup>) were constructed in 1966 as multi-purpose buildings on the property. In 2001, the property changed owners, buildings were renovated to be used as an elementary school, but the plumbing was not modified. In 2006, another building was constructed on the property (building C). Buildings A and B are served by a single service line entering the West side of the property while building C is served by a service line on the North side of the property. Another water meter was located underground near the building C (114 m<sup>2</sup>). The estimated distance from the water meter to the building B was about 78 meters, and to building C was 8 meters.

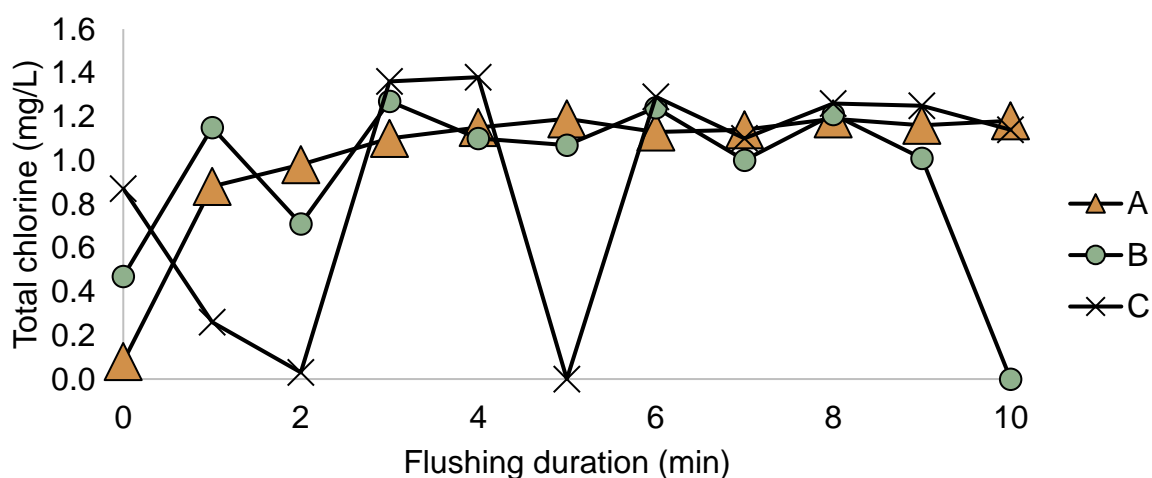
Figure 3-3. Chlorine residual fluctuated during the 10-minute cold water at the kitchen sink (building A) and the janitor sinks (building B and C).

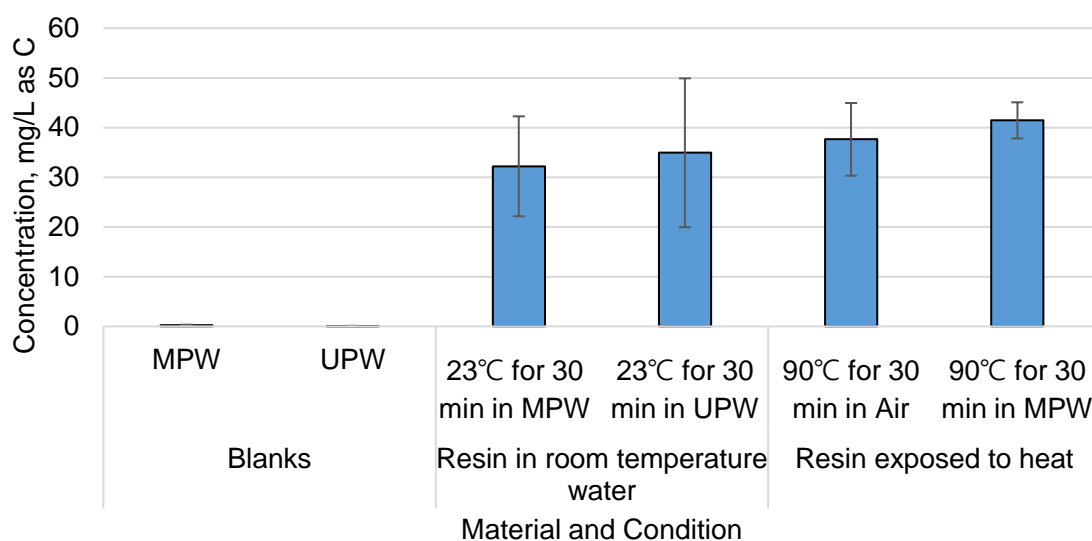
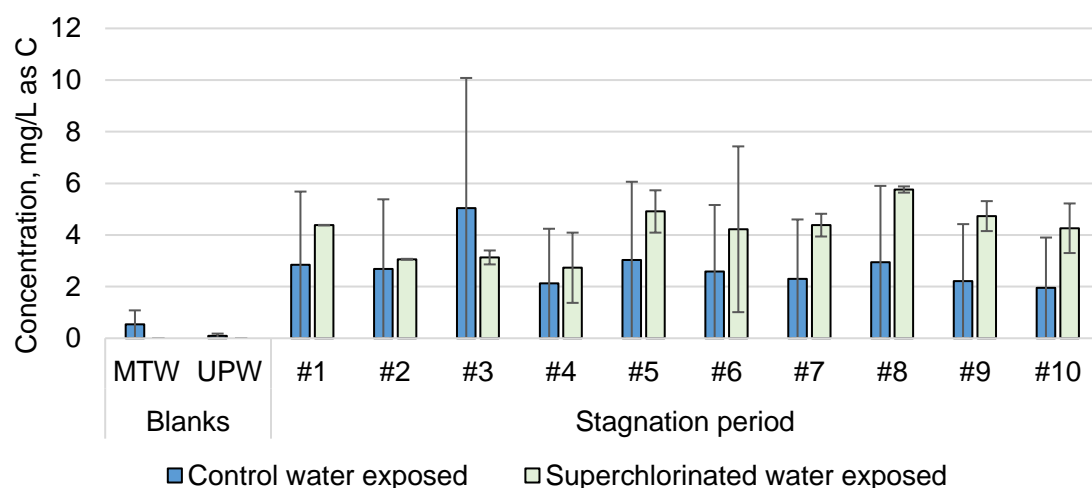
Figure 4-5. PSDVB water softener resins leached notable amounts of organic carbon into drinking water, but leaching was not affected by (a) Thermally treating the resin or (b) Exposing it 10 times to 300 mg/L as  $\text{Cl}_2$  super chlorinated drinking water. Mean and standard deviation values shown for three replicates. The basis of superchlorinated water was UPW. MPW was used for both control water and superchlorinated water during stagnation period.

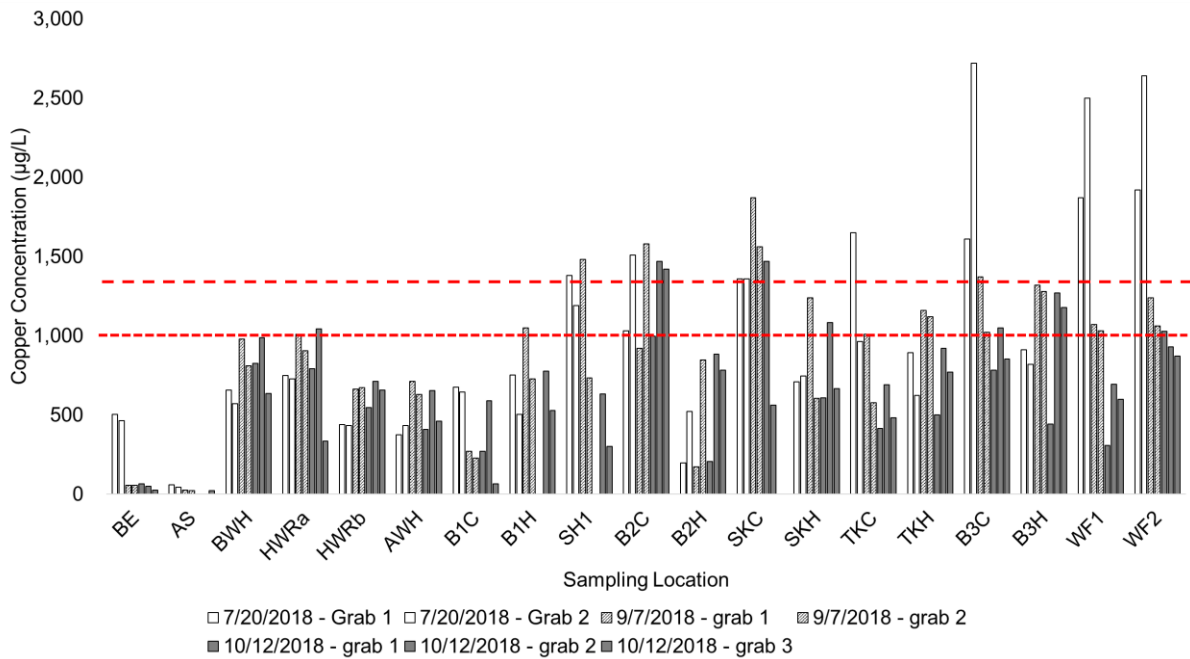
**Figure SI.1-4. Copper concentration of multiple grabs from routine sampling locations.**  
The 1.0 mg/L SMCL and 1.3 mg/L MCL are shown.

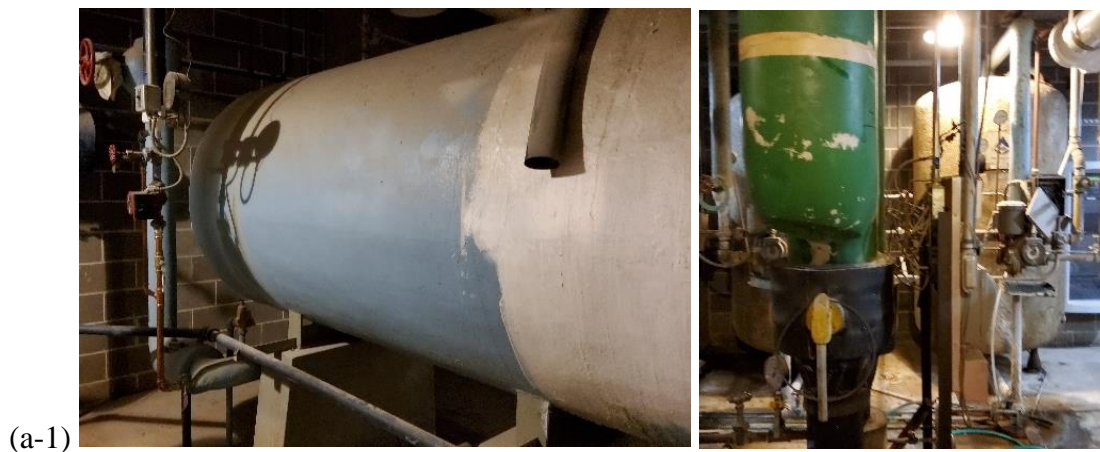
**Figure SI.2-2. Water devices in buildings (a) A, B, C, and D.** (a-1) water heater and two water softeners (not regenerated or water only goes through the softener but not being softened) in West side of building A, (a-2) water heater and water softeners in East side of building A; (b) water heater at building B; (c) a tankless steam heated system at building C; (d) two water heaters and water softeners at building D.
