PACK RUST IDENTIFICATION AND MITIGATION STRATEGIES FOR
STEEL BRIDGES

A Thesis

Purdue University

Patel, Chintan Hitesh M.S.C.E., Purdue University, December 2018. Pack Rust Identification and Mitigation Strategies for Steel Bridges. Major Professor: Mark D. Bowman.

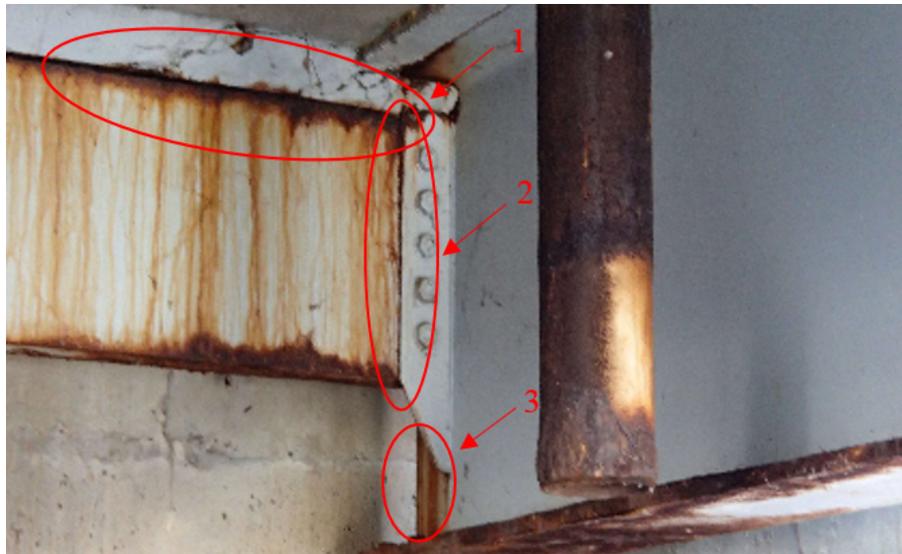
Fig. 4.1. Typical camera angle for photos of end diaphragms

The overall condition of the end diaphragms in steel bridges of Indiana does not look good. Many of the end diaphragms show surface rusting, and rusting of the top edge. The surface of diaphragms is generally covered by rust bleeding from the top edge, circled as 1 in Figure 4.1.

Figure 4.1 is the most common camera position from which the photos are taken. From this position, the crevice between the connections (location 2 in Figure 4.1) is not visible, and hence minor pack rust cannot be detected. There is a high possibility of pack rust in the crevice at the back of the diaphragms from the water and salt seeping down the deck joint but only rust bleeding can be seen, as shown in location 3 in Figure 4.1.

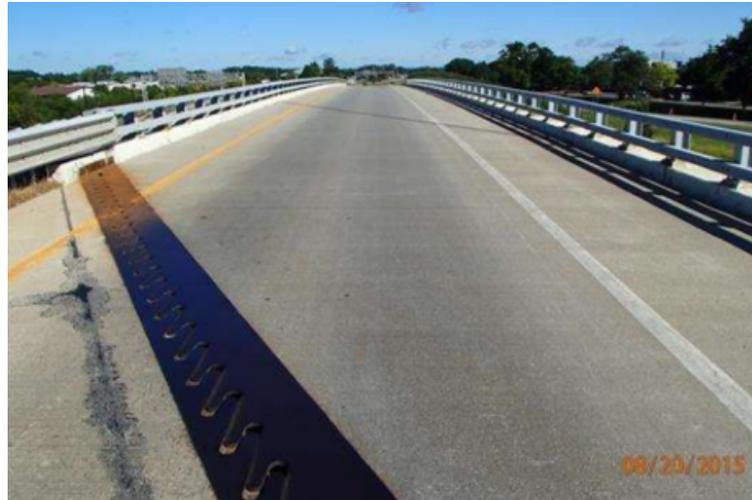
Fig. 4.12. Finger joint

Hinge-pin connections are the details were observed to be highly prone to pack rust. Hinge-pin connections are located below the deck expansion joints as seen in Figure 4.12 and Figure 4.13 on the left. The water and salt from the deck flows down into the crevice formed between the hinge plate and the web of the girder. The formation of pack rust prevents the free rotation at the connection. Visual inspection does not give a clear picture of the extent to which the pins have rusted. Ultrasonic tests are required to find the amount of section loss in pins. Depending on the severity of the section loss of the pin, a severe decrease in the shear capacity could occur. Pack rust between the hinge plates and the girder web causes an out of plane bending of the hinge plate, and it also displaces the hinge plates as seen on the right of Figure 4.13. The out of plane bending will introduce eccentric loading onto the pins for which they are not designed. It was suspected that this was the reason for the collapse of the Minus River Bridge.

Figure 4.12 shows a particular type of expansion joint called finger joint. This kind of joint allows all the material such as debris, water, and salt to pass through it. The seepage of water and salt from the deck to the beam or girder allows for an aggressive crevice corrosion. From Figure 4.13 on the left it can be observed that significant corrosion is occurring between the hinge plate and the web. Figure 4.13 on the right shows an example where the hinge plate has displaced due to pack rust. It is not clear as to the depth of the pack rust and the condition of the pins.

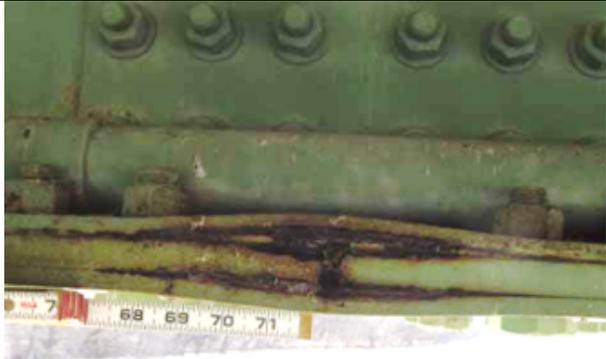
(c)
2	<p>Moderate to severe PR: 1/4 inch to 3/4 inch bowing of splice plates</p>

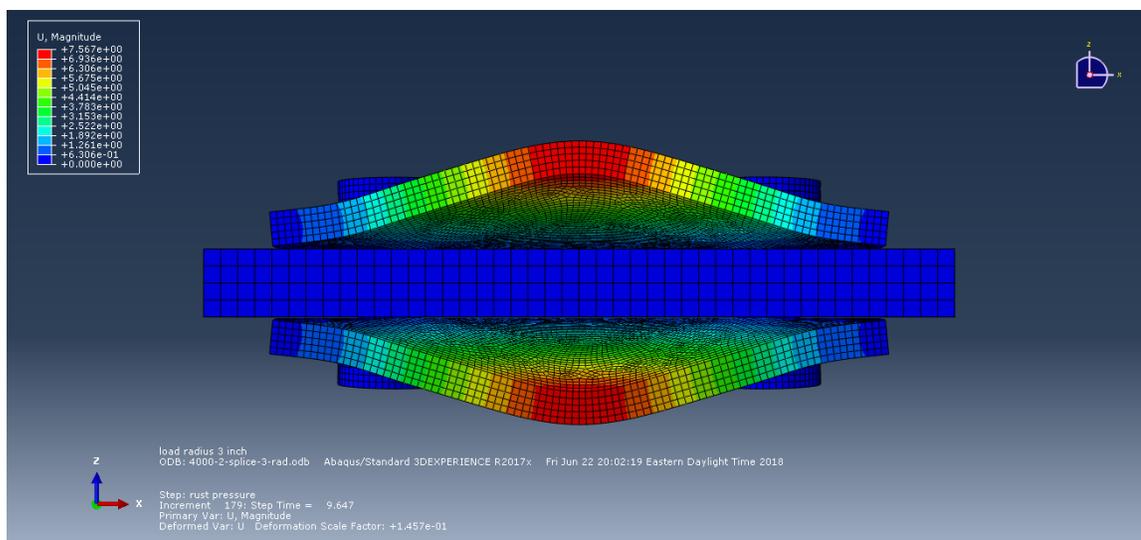
Fig. 5.10. Deformed shape of the splice connection

For the 1-in diameter bolts the analyses aborted at 3,850 psi pressure with the maximum deflection in the splice plate of 5.9 inch at the edge. The scaled deformed shape of the splice connection with 1-in diameter bolts is shown in the Figure 5.10.

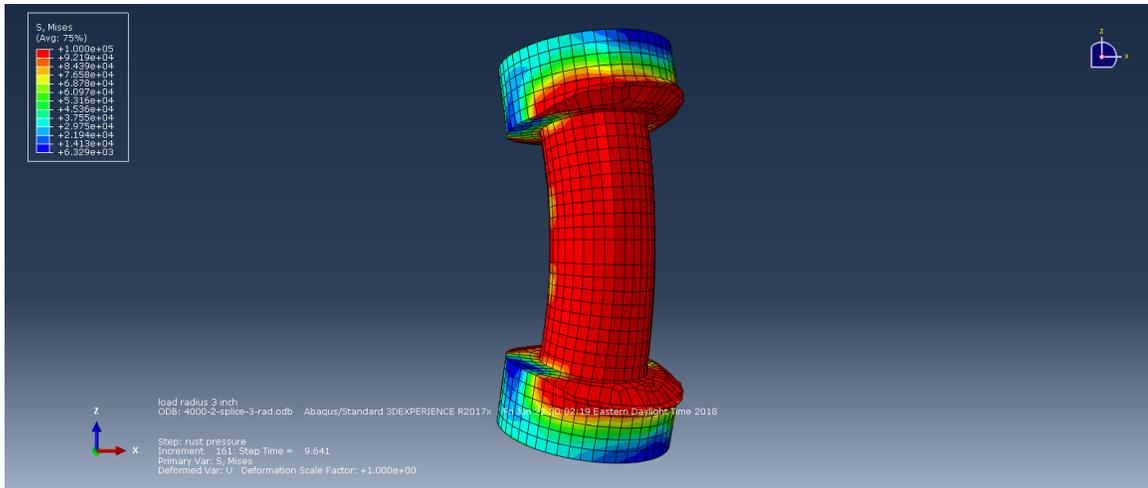
Fig. 5.11. Mises stress in bolt at 3,850 psi load, (5.9-in splice deformation)

At this load the bending of the splice plate leads to maximum principal strain of 0.17-in/in in the bolt shank thus reaching the strain at the point of failure. It is seen from Figure 5.11 that most of the bolt shank has yielded and the bottom of the bolt head has also yielded. It is also observed that the bolt not only experiences elongation but also bending which is expected due to the nature of loading. Figure 5.11 is plotted with a scaling factor of 1.

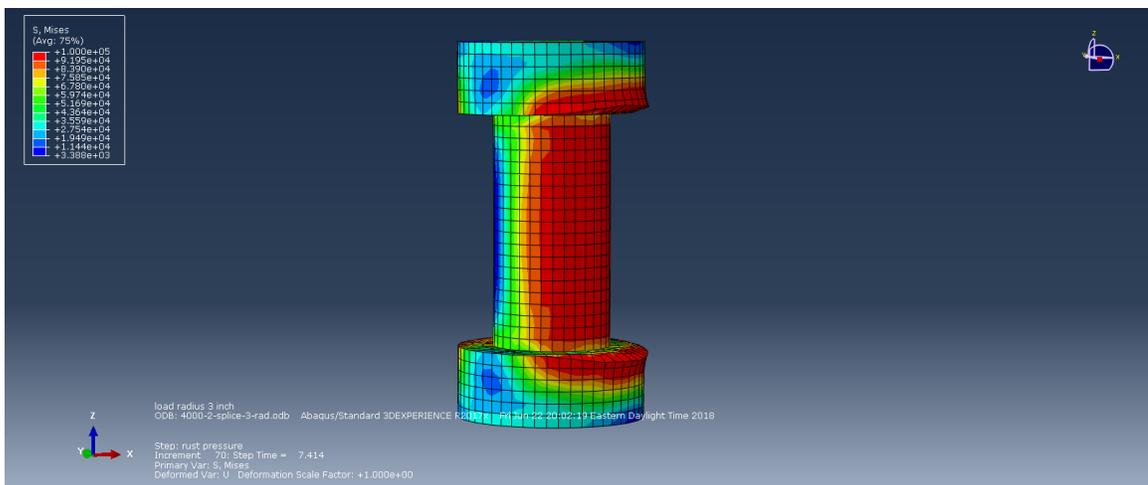
Fig. 5.12. Mises stress in bolt at 2,960 psi, (1-in. splice deformation)

The ABAQUS analyses shows that the maximum principal strain in the bolt shank at 1-in of splice plate deformation is 0.0075-in/in and part of the bolt shank has yielded as shown in the Figure 5.12. A uniform pressure of 2,960 psi over a semi-circular region of radius 3 inches causes 1-in of deformation in splice plate.

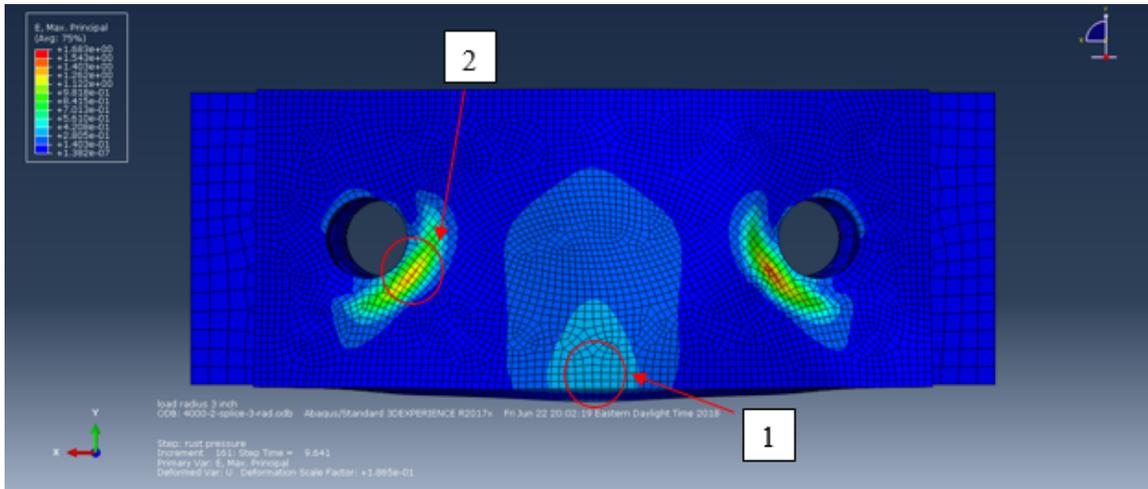
Fig. 5.13. Maximum principal strain in splice plate at failure of bolts

Figure 5.13 shows the maximum principal strain in the splice plate. It is observed that the strain at the edge of the contact between the bolt head and the splice plates marked as 2 in Figure 5.13 are large, and the maximum principal strain reached is 1.68 in splice plate. The value of strain at location 1 marked in Figure 5.13 is 0.38.

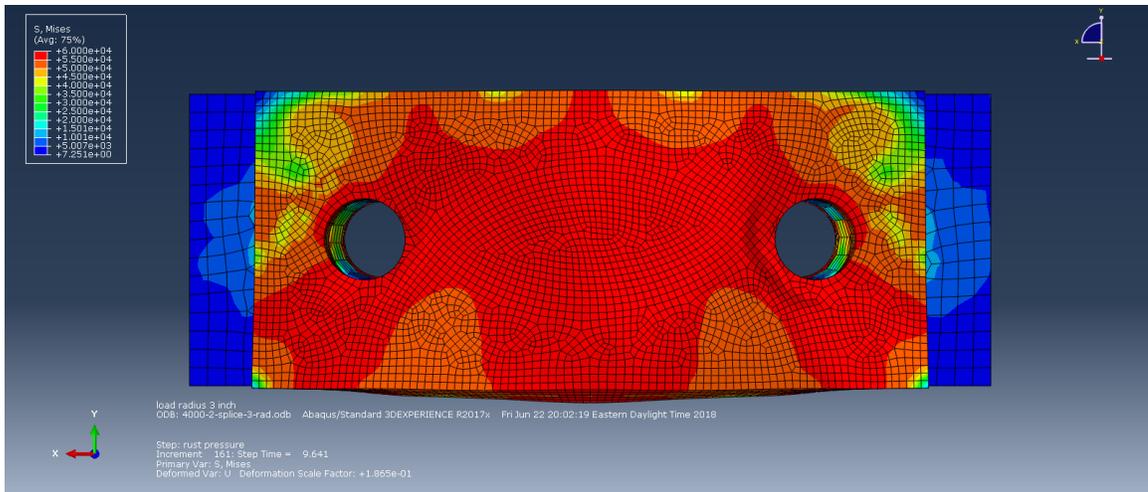
Fig. 5.14. Mises stress in the splice plate at failure of bolts

Figure 5.14 shows the Mises stress in the splice plate. It is seen that almost the entire plate has yielded. The splice plates in the current analyses did not fail.

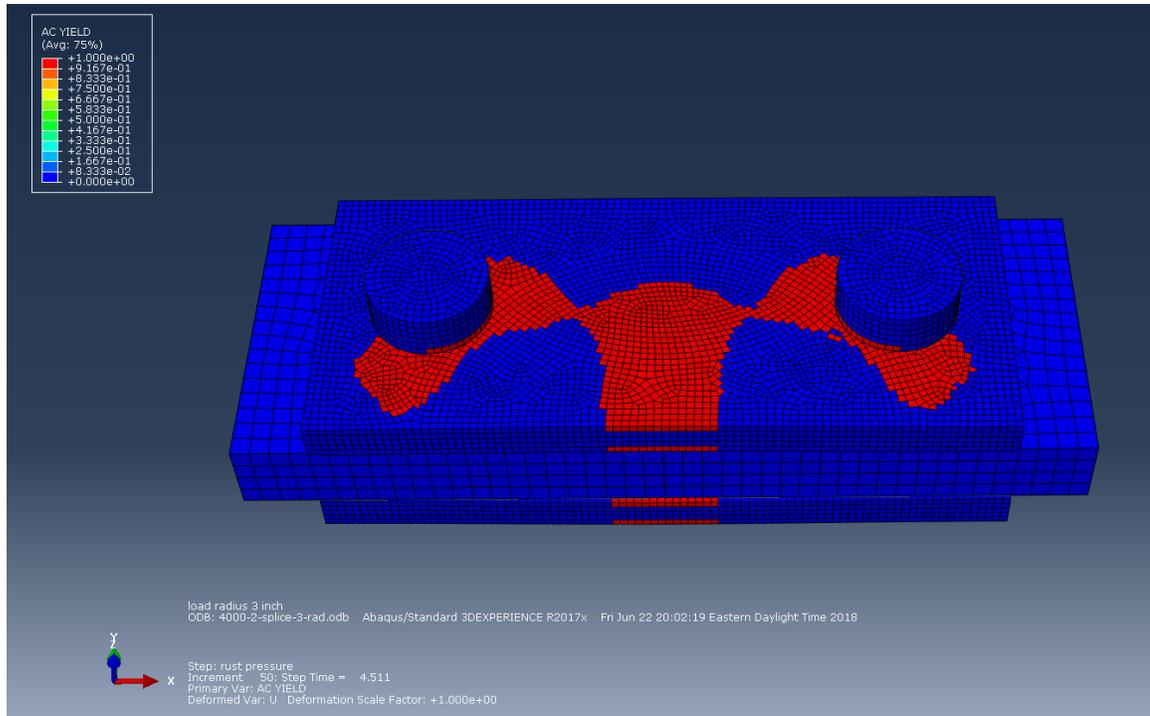
Fig. 5.16. Regions of the splice connection that has yielded at pressure of 1800 psi (elements in red color)

The ABAQUS model shows that the splice plates starts to yield near the bolt region and at the mid-length of the splices when the deflection at the edge is just 0.052-in. The pressure required to cause this deflection and yielding condition is 1800 psi. The red colored elements in the ABAQUS model shown in Figure 5.16 represents the region of the plate that has already yielded and blue colored elements have stresses that are below yield stress. The equivalent rectangular plate size of 6-in by 3-in and plate thickness of 0.5-in is used to calculate the elastic deflection using the equation by Timoshenko. In the assumed dimension of the rectangular plate, the length of the free edge is 6-in and width is 3-in. For this plate size the value of coefficient α is 0.0071. The calculated maximum deflection at the free edge using Equation 5.3 is 0.05-in. The difference in the deflection value can be explained by the regions of the splice plate undergoing plastic deformation leading to increased splice plate deformation.
