**EXPERIMENTAL INVESTIGATION OF REPAIR TECHNIQUES FOR
DETERIORATED END REGIONS OF PRESTRESSED CONCRETE
BRIDGE GIRDERS**

Master of Science in Civil Engineering

Lyles School of Civil Engineering
West Lafayette, Indiana
May 2021

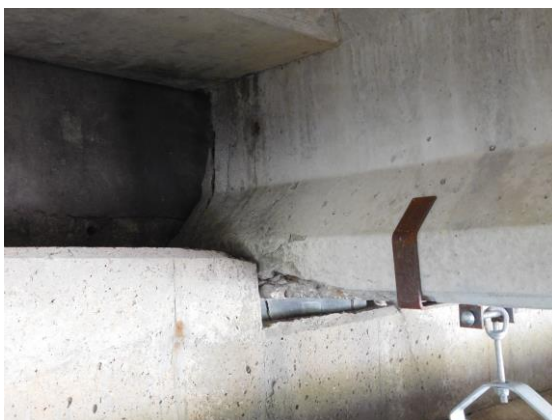
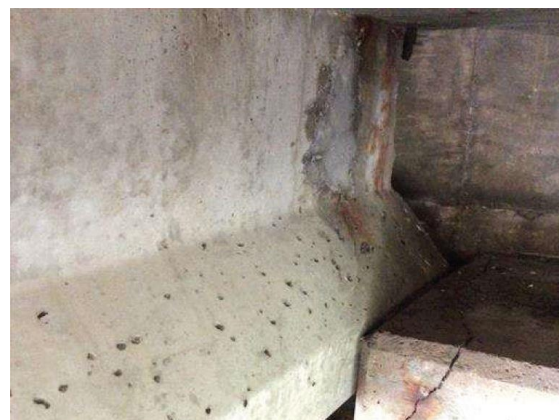
(a) Bottom Flange Deterioration

(b) Web Deterioration

Figure 1.2 Bridge Girders with End Region Deterioration (INDOT Asset Name I469-01-07020, near Fort Wayne, Indiana)

condition rating of six or less (condition ratings range from zero to nine, with a rating of nine indicating the element is in excellent condition). A condition rating of six indicates that the structural element is in satisfactory condition, but minor deterioration is present (Federal Highway Administration 1995). Of these 172 bridges, approximately 55% (96 bridges) either have or show signs of end region deterioration. Failed, leaking expansion joints in the deck or between the deck and approach slab expose girder end regions to the chloride-laden water, leading to a corrosive environment in which reinforcement section loss and concrete spalling can occur. This process is illustrated in Figure 1.1, and an example of a bridge girder with end region deterioration caused by this mechanism is shown in Figure 1.2.

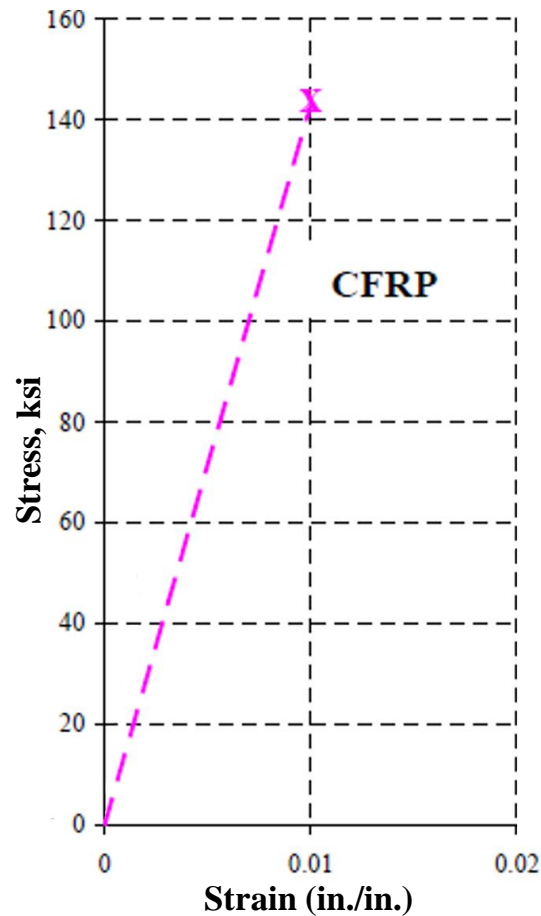
Figure 2.2 Example Stress-Strain Curve of CFRP Laminate (adapted from Kim 2008)

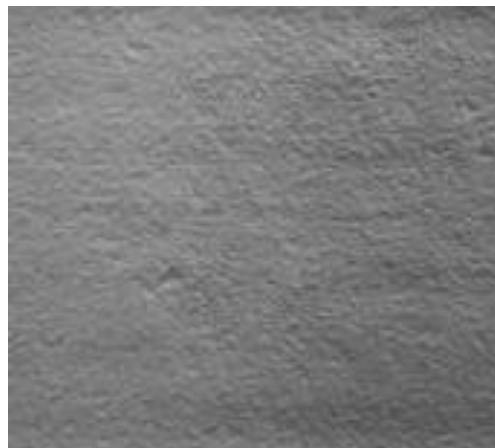
Figure 2.4 Example of CSP 3 (from ICRI 310.2R-2013)

(ICRI) and the American Concrete Institute (ACI) (ICRI 330.2-2016 and ACI 440.2R-17), the minimum acceptable concrete surface profile (CSP) for FRP applications is CSP 3. ICRI 310.2R-2013 correlates CSP 3 to a “light shotblast” and provides the example shown in Figure 2.4 as a reference profile. Molded replicas of CSPs 1-10 can be acquired through ICRI if further reference is needed to ensure that the proper surface preparation is achieved. Table 2.2 shows the surface preparation methods, and their CSP range, which ICRI suggests for obtaining a CSP of 3.

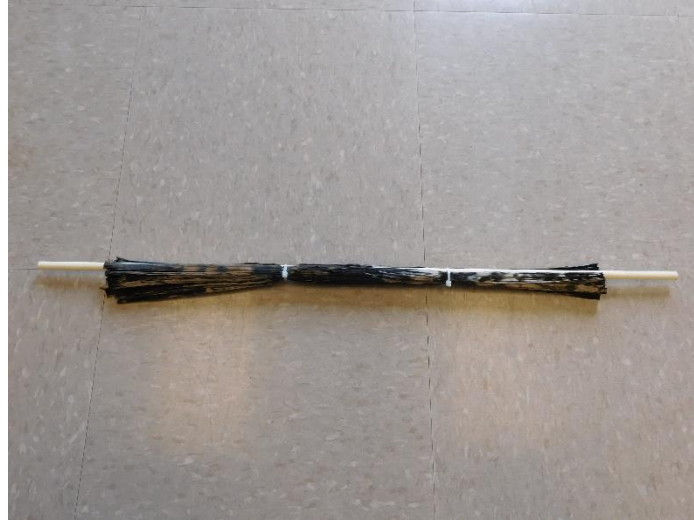
Figure 2.5 FRP Spike Anchor

FRP spike anchors, also known as FRP fan anchors or simply FRP anchors, are one anchorage system which has been developed to prevent debonding. As shown in Figure 2.5, spike anchors consist of individual FRP fibers that have been bound together. Spike anchors can either be manufactured and pre-assembled or field-assembled by separating individual fibers from an FRP sheet. The anchor is then saturated with resin and inserted through the externally bonded FRP sheet into a pre-drilled hole in the concrete substrate. As suggested in ICRI 310.2R-2013, the edges of the pre-drilled anchor holes should be rounded to a 0.50-in. radius. The individual fibers are then splayed out in an arch shape on the externally bonded sheet. The splayed portion of the anchor is then saturated. Two FRP patch sheets are then placed over the splayed anchors. The fibers of the first patch sheet should be orientated perpendicular to the fibers of the externally bonded sheet, while the fibers of the second patch sheet should be orientated parallel with the fibers of the externally bonded sheet (Orton 2007, Quinn 2009, Kim et al. 2012, Pudleiner 2016, Shekarchi et al. 2020). Figure 2.6 provides an example of this installation procedure.

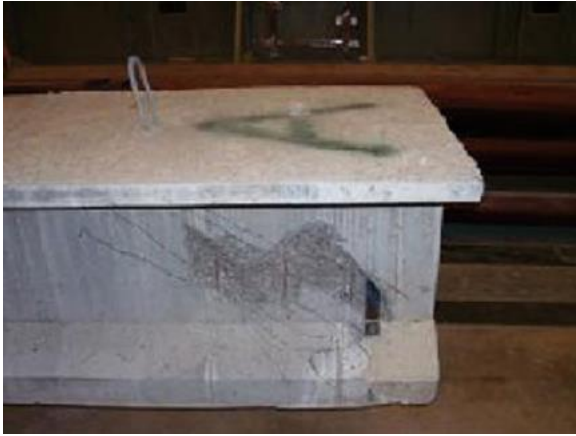
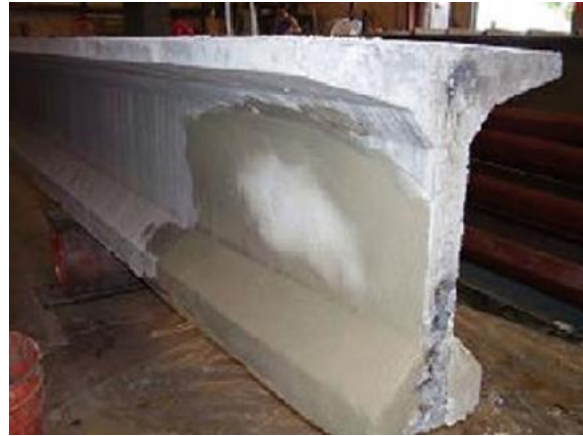
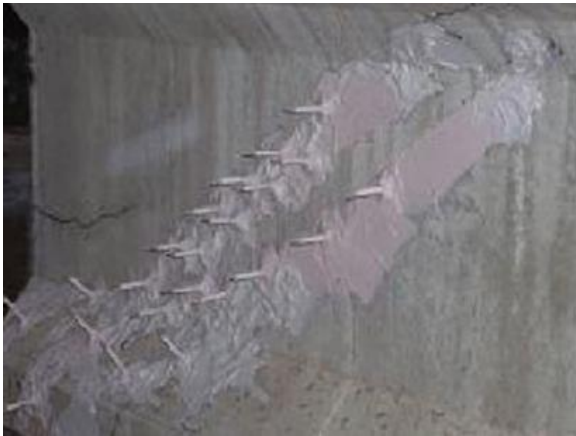
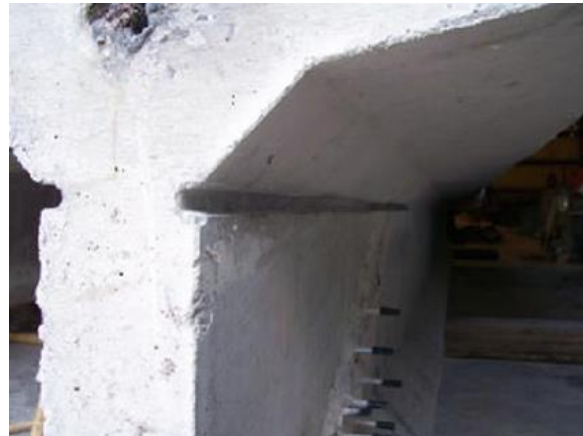
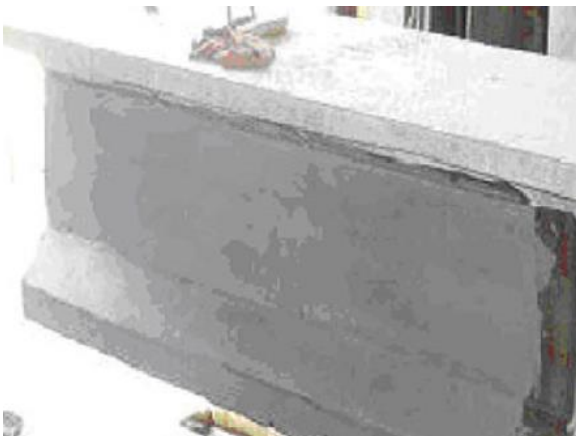
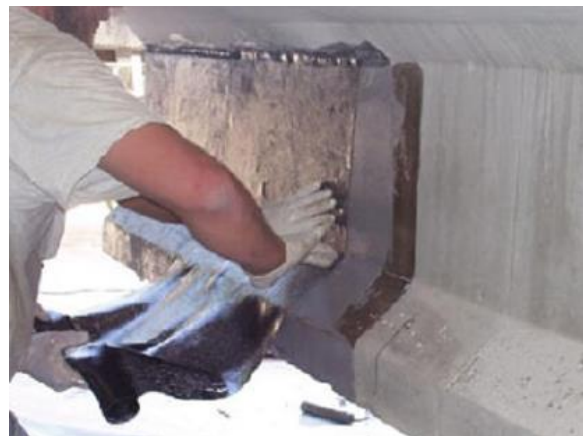
(a) Delaminated Concrete Removed

(b) Cross Section Restored

(c) Epoxy-Injected Cracks

(d) Groove Cut

(e) Primed Concrete

(f) FRP Repair

Figure 2.10 Repair Procedure for Damaged End Regions (from Ramseyer and Kang 2012)

Ramseyer and Kang (2012) examined the effectiveness of glass and carbon FRP repair systems for prestressed concrete bridge girders with deteriorated end sections. Type II AASHTO bridge girders were artificially damaged by failing the girder ends in shear. This damage was meant to simulate in-field corrosion. The end regions were then repaired by (1) removing delaminated concrete, (2) restoring the section using rapid set mortar, (3) epoxy-injecting cracks (only on select specimens), (4) cutting anchorage grooves at the top of the web, (5) applying externally bonded FRP U-wraps onto the repair section, and (6) inserting a metal rod into the groove to anchor the U-wrap. Figure 2.10 illustrates the repair process. As Table 2.3 shows, the only repair system to regain the shear strength of the undamaged end region was the system with glass FRP U-wraps and epoxy-injected cracks. However, the authors concluded that the carbon FRP systems recovered more stiffness than the glass FRP systems (Ramseyer and Kang 2012).

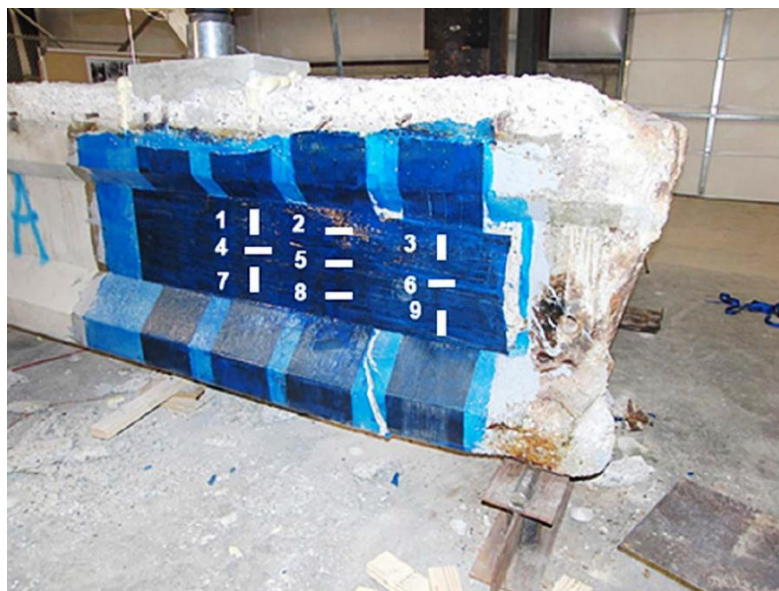
Figure 2.14 CFRP Repair System with Vertical U-Wrap and Longitudinal Strip Anchorage (from Petty et. al 2011)

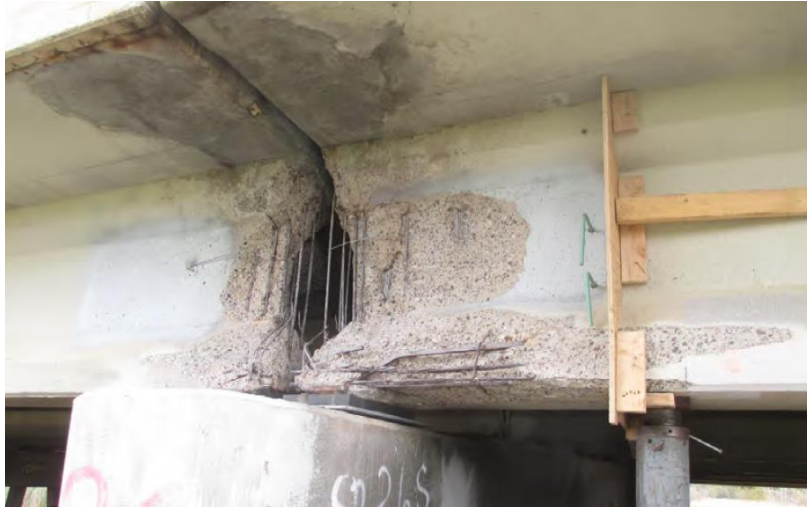
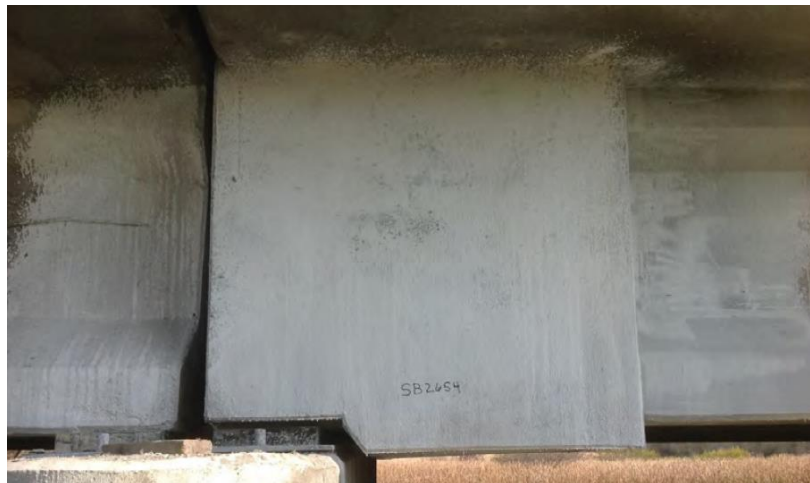
(a) Condition of the Girder Following Removal of Delaminated Concrete

(b) Complete Shotcrete Repair

Figure 2.16 Girder Condition Prior to and Following Shotcrete Repair (from Shield and Bergson 2018)

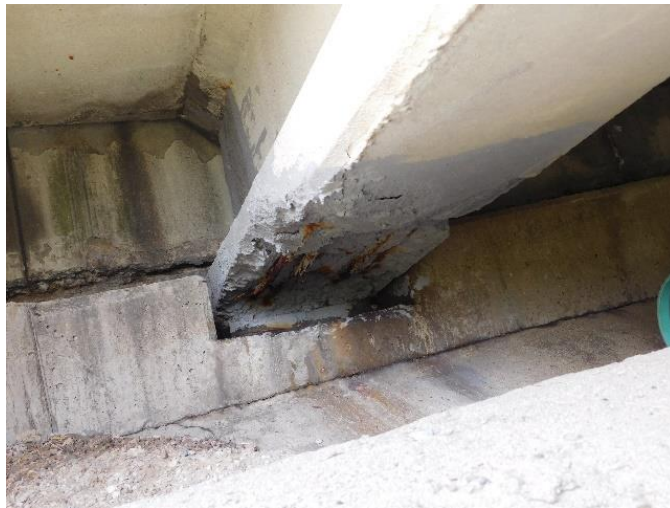
Figure 3.1 Typical In-Service Condition of Girder End Regions Prior to Removal

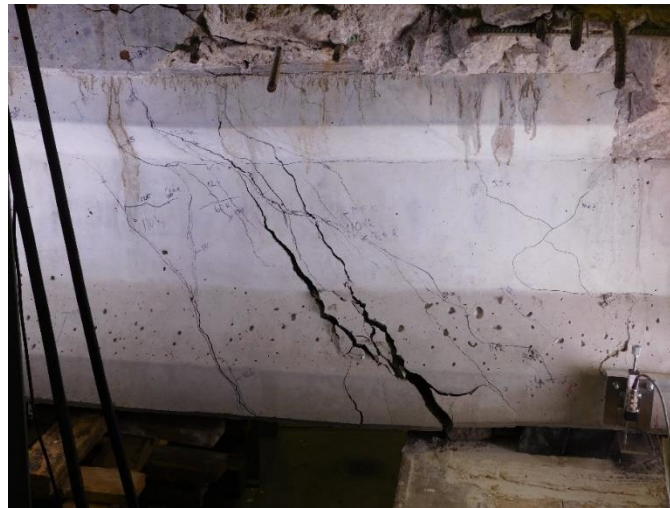
Figure 3.6 Control Specimen After Failure

Testing of the control and damaged specimens provided insight into the change in behavior caused by the deterioration of girder end regions. As previously described, for each test of the experimental program, load was applied to the girder at a distance of 45 in. from the support located at the end of the girder (further details of the test setup are provided in Section 3.5). For a girder in good condition, the loading was expected to cause the development of a diagonal strut between the applied load and the support. As shown in Figure 3.6, a diagonal strut did develop within the test region of the control specimen. The damaged specimen, however, exhibited a different behavior. The failure behavior of this specimen was controlled by the inability of the prestressing strands to develop tensile forces along the bottom flange. The primary failure crack of the damaged specimen, shown in Figure 3.7, was nearly vertical. A diagonal strut did not form within the test region due to the inability of the corroded prestressing strands to develop adequate tensile capacity in the bottom flange at the end of the member. The behaviors of the control and damaged specimens led to the observation that restoring the tensile capacity along the bottom flange is key to a successful repair. This observation influenced the details of the repair techniques included in the experimental program.

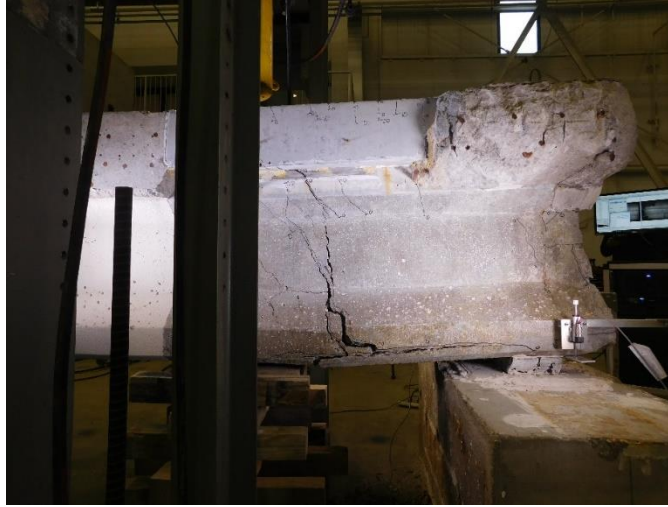
Figure 3.7 Damaged Specimen After Failure

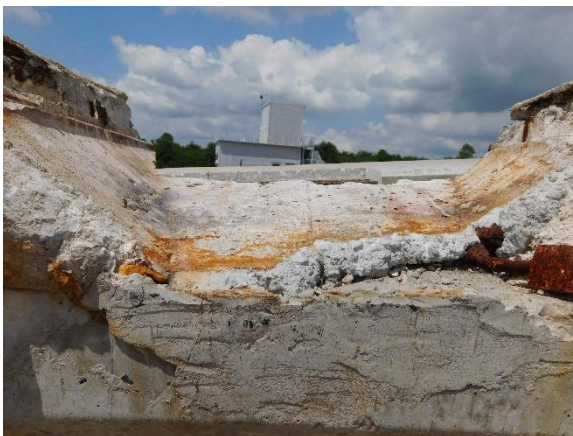
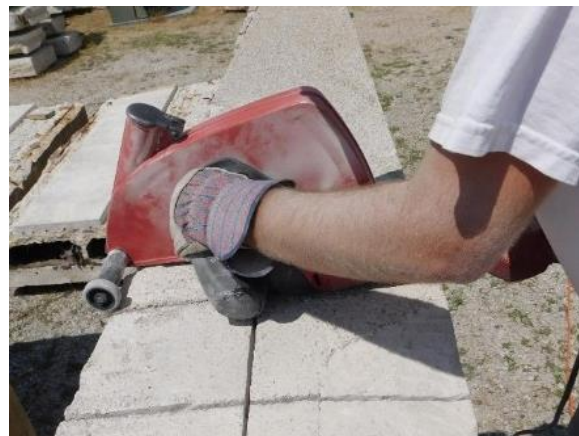
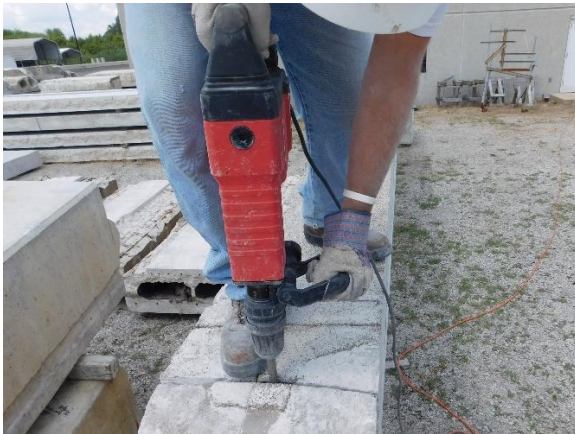
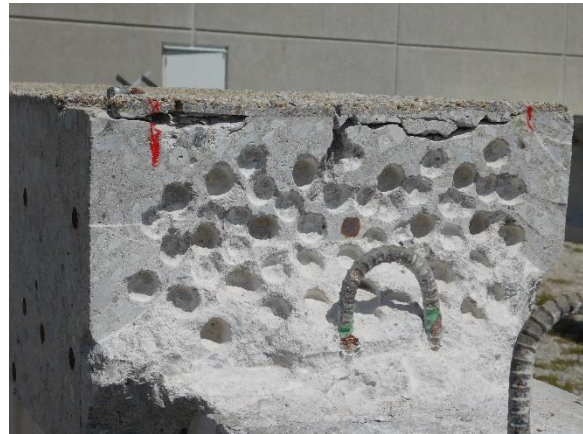
(a) Void Left After Drain Removal

(b) Sawing Concrete Deck

Figure 3.13 Drain and Deck Concrete Removal and Surface Roughening

(c) Removing Concrete to Create Rectangular Repair Area

(d) Roughened Surface at End of Repair Area

The space left within the deck after removal of a drain is shown in Figure 3.13(a). After drain removal, approximately 8 in. of concrete deck, measured from the edge of the former location of the drain toward the midspan of the girder, was removed using a concrete saw and chipping hammer (Figure 3.13(b and c)). Per ICRI Guideline No. 310.1R-2008, concrete was removed from the deck to form a rectangular repair area. A hammer drill with a 0.875-in. drill bit was used to roughen the concrete surface at the ends of the repair area as shown in Figure 3.13(d) to improve the bond between the original deck concrete and the repair concrete.

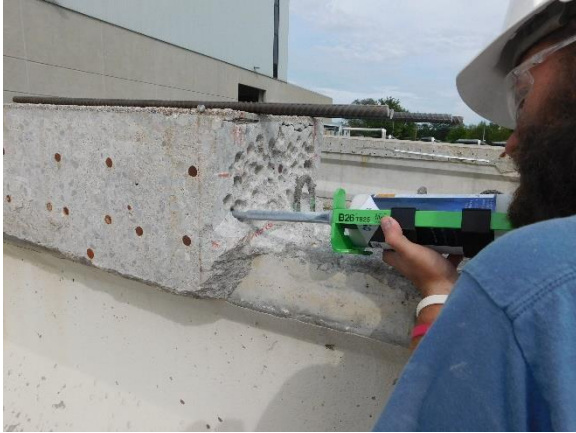
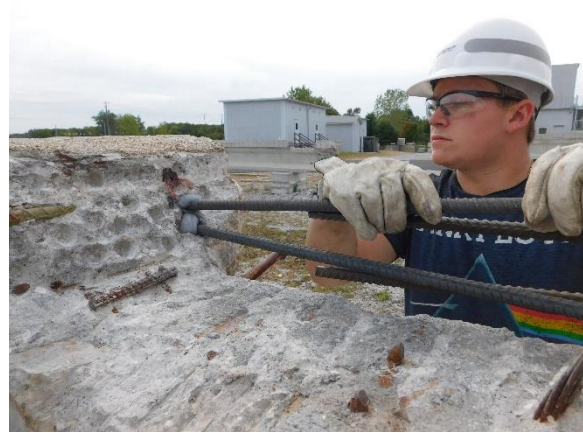
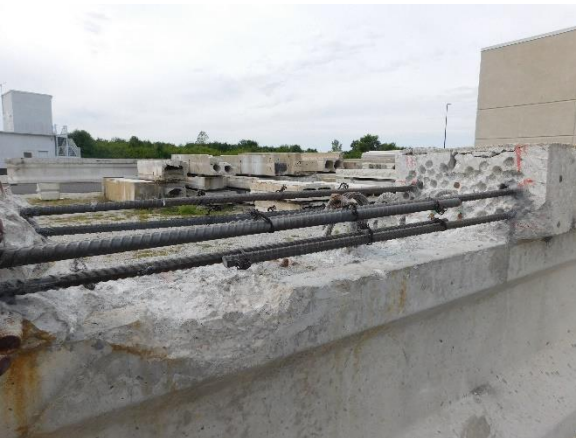
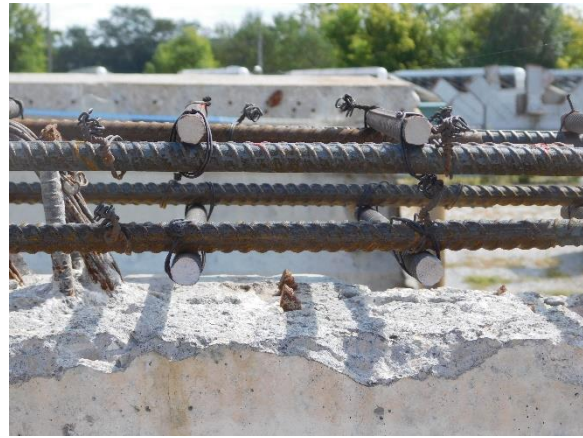
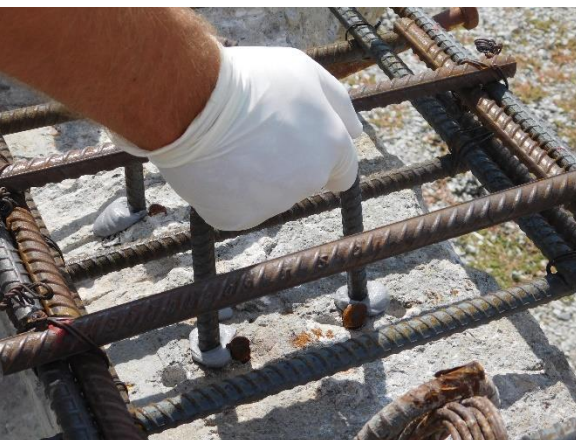
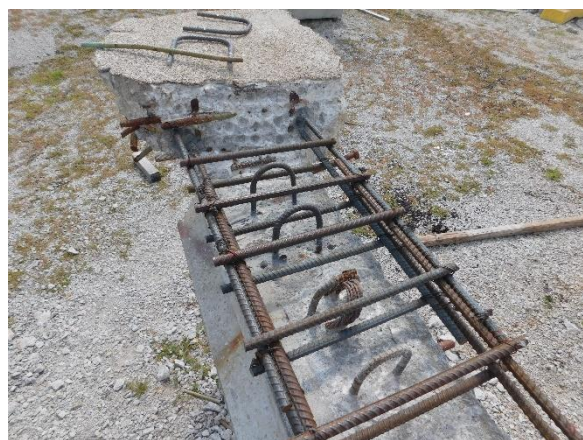
(a) Dispensing Epoxy for Anchorage of Longitudinal Reinforcement

(b) Inserting Longitudinal Reinforcement

(c) Longitudinal Reinforcement After Placement

(d) Transverse Reinforcement

(e) Installing U-Shaped Bars

(f) Completed Reinforcement

Figure 3.14 Reinforcement Installation Procedure for Deck Repair

Next, reinforcement was added to the region being prepared as shown in Figure 3.14. The reinforcement pattern matched the reinforcement pattern of the original deck: two layers of No. 5 Grade 60 longitudinal reinforcement with a 3.5-in. vertical center-to-center spacing and two layers of No. 5 Grade 60 transverse reinforcement with a 6-in. spacing measured along the length of the girder. The longitudinal reinforcement consisted of pairs of 24-in. long reinforcing bars with one end of each bar doveled into the original girder at the edge of the repair. Each bar was embedded approximately 3 in. into the deck concrete using an epoxy intended for anchoring reinforcing steel in hardened concrete (Figure 3.14(a and b)). This configuration resulted in a 14-in. contact lap splice at the center of the repair area (Figure 3.14(c)). The transverse reinforcement spaced at 6 in. was then positioned after the longitudinal bars were in place (Figure 3.14(d)). At the drain locations, the portion of two stirrups extending into the concrete deck had been either removed or bent to allow for installation of the drain. As such, supplemental reinforcement (No. 4 Grade 60 bars) was also added to replace the portion of the stirrups extending from the top surface of the precast girder to further improve the bond between the repair concrete and the original girder. The supplemental reinforcement was bent to form a U-shape in order to match the original stirrups. Each leg of the U-shaped bars was embedded approximately 4.5 in. into the top surface of the precast girder using epoxy (Figure 3.14(e and f)).

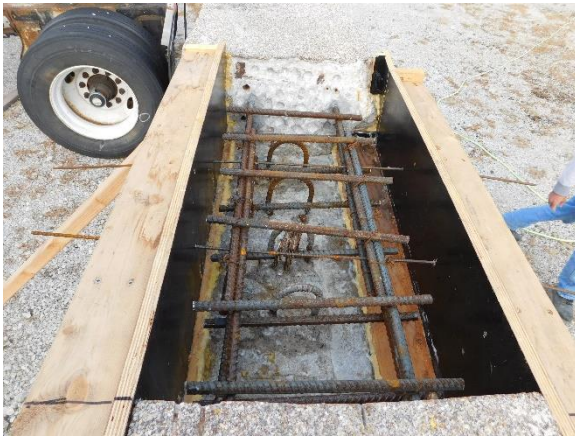
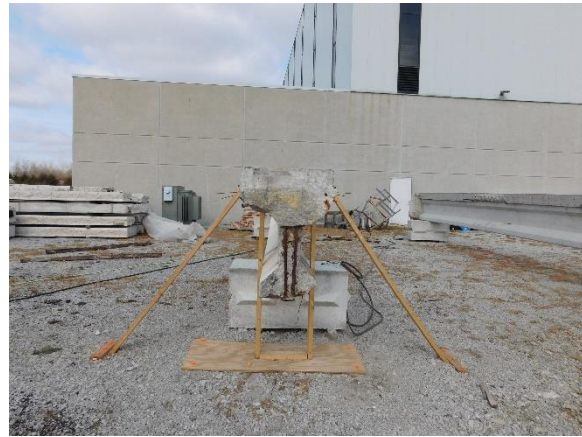
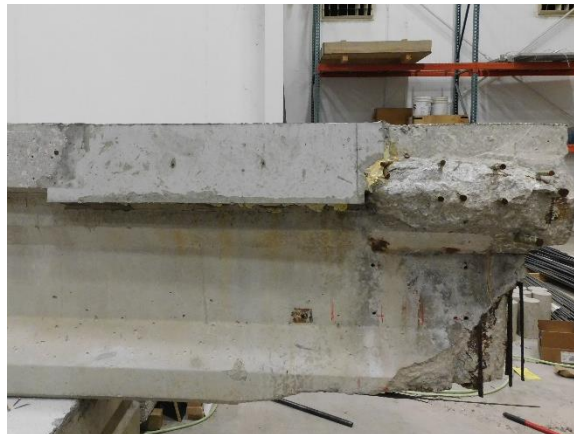
(a) Erected Formwork

(b) Formwork Supports

(c) Completed Deck Repair

Figure 3.15 Completion of Deck Repair Procedure

Finally, formwork was erected on each side of the repair area (Figure 3.15(a)). The formwork was installed such that the top surface of the repair area matched the slope of the original concrete deck. To resist lateral pressure, two 0.25-in. diameter threaded rods were inserted through the sidewalls of the formwork and anchored. Additionally, vertical and diagonal supports were attached to each piece of formwork (Figure 3.15(b)). Upon completion of the formwork, a high-slump INDOT Class C concrete was used to fill the repair area. The completed deck repair is shown in Figure 3.15(c), and the INDOT Class C concrete mixture design is provided in Table 3.6.

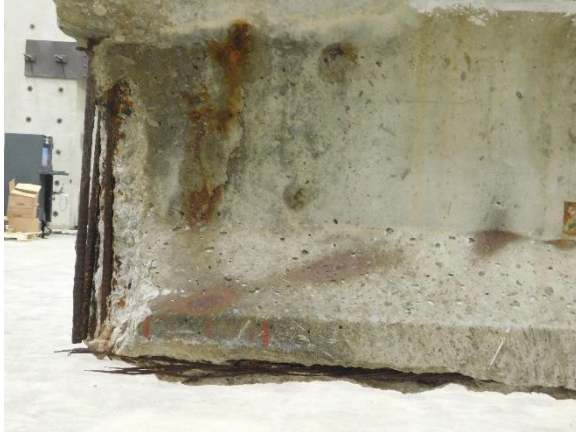
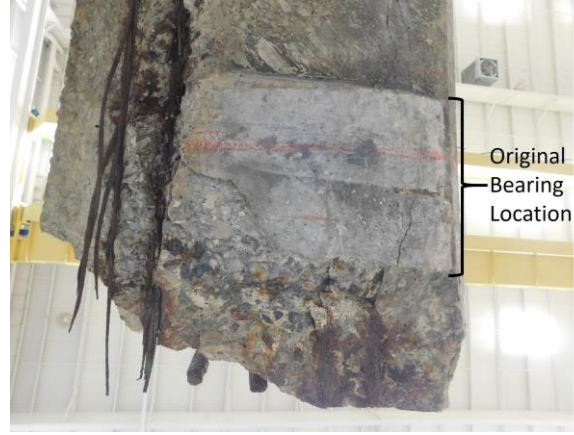
(a) Elevation

(b) Bottom Surface

Figure 3.16 Condition of Girder 20-C Prior to Bearing Repair

While extracting the bridge girders and then transporting them from the bridge site, loose concrete fell from the end regions of the member. Therefore, prior to testing Girder 20-C, reestablishing a bearing area for the girder was necessary. The condition of the girder prior to repairs is shown in Figure 3.16. As shown in Figure 3.5, the centerline of the bearing pad was located 6 in. from the end the member when the girder was in-service. This left 2.5 in. from the end of the girder to the edge of the pad. Restoring the bearing area at this location, however, would have required substantial repairs. Therefore, the bearing location was shifted 4 in. into the span of the girder for testing.

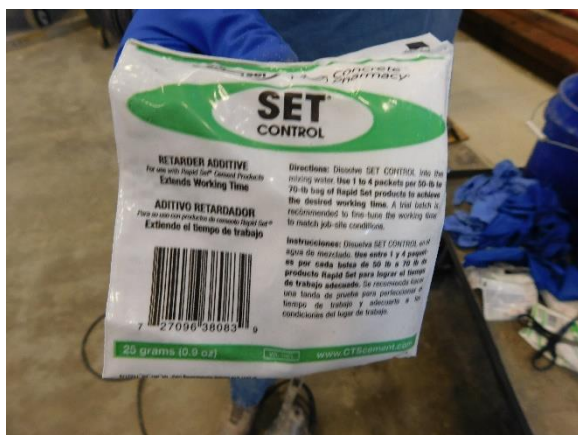
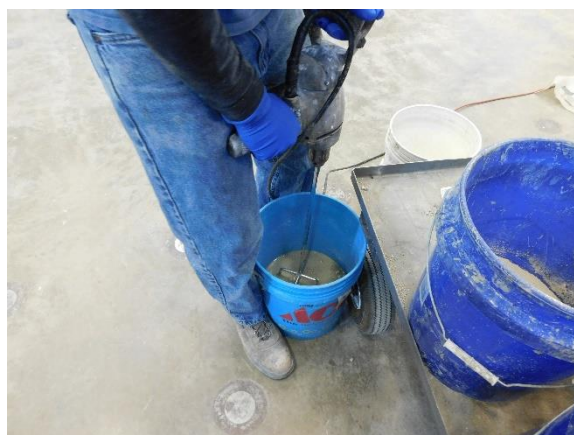
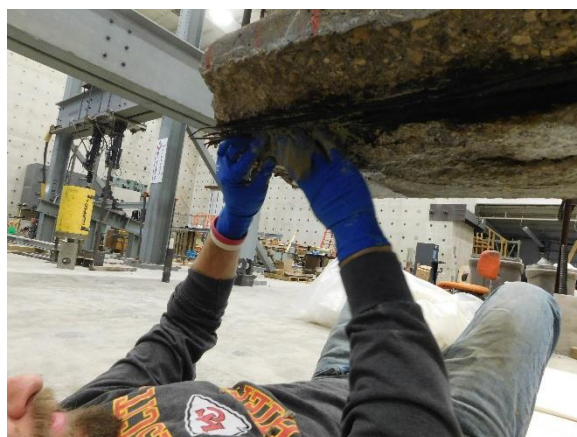
(a) Rapid Set® Set Control®

(b) Mixing Mortar

(c) Placing Mortar

Figure 3.17 Mortar Repair Procedure

The bearing area was restored using a fast-setting, low-shrinkage, high-strength mortar (CTS Cement Manufacturing Corp. Rapid Set[®] Mortar Mix). The mortar repair procedure is shown in Figure 3.17. To minimize wasted material, each 55-lb mortar bag was divided into identical 18.3-lb batches. The manufacturer suggested a mixing ratio between 3.0 and 3.75 quarts of water per 55 lbs. After trials were conducted, a mixing ratio of 3.5 quarts of water per 55-lb bag, with the addition of 1/3 of a 25-gram bag of Rapid Set[®] Set Control[®] (Figure 3.17(a)), yielded the best results. Dust and debris were removed from the repair area by pressurized air prior to mixing the water and mortar. The Rapid Set[®] Set Control[®] admixture was combined with the appropriate volume of water and then added to the proportioned mortar. An electric drill with a mixing paddle was used to mix the mortar until a uniform consistency was achieved (Figure 3.17(b)). The repair surface was wetted using a spray bottle to assist with the mortar application as the manufacturer suggested. Mortar was then placed and packed by hand until an adequate bearing area was restored (Figure 3.17(c)). Relevant properties of Rapid Set[®] Mortar Mix are displayed in Table 3.7.

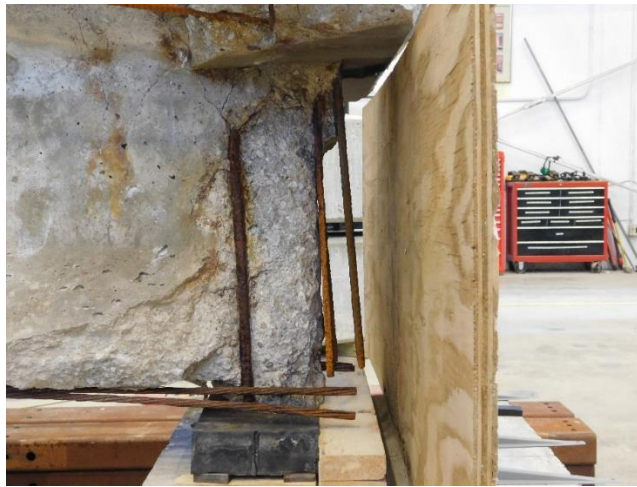
Figure 3.18 Simulated Mud Wall and Bearing Pad Location for Externally Bonded FRP Specimen

Using the details discussed in Section 3.3.2, a repair procedure was developed for the externally bonded FRP repair system. Careful considerations were made to ensure that the repair procedures were conducted in a manner as similar as possible to an in-field installation. To this end, a board was placed approximately 2 in. from the end of the girder to simulate the presence of a mud wall. Furthermore, a bearing pad was supported against the girder at its original location during the repair procedure. The simulated mud wall and placement of the bearing pad are shown in Figure 3.18.

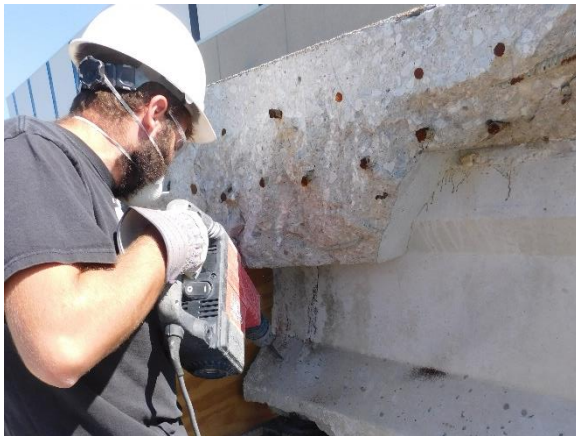
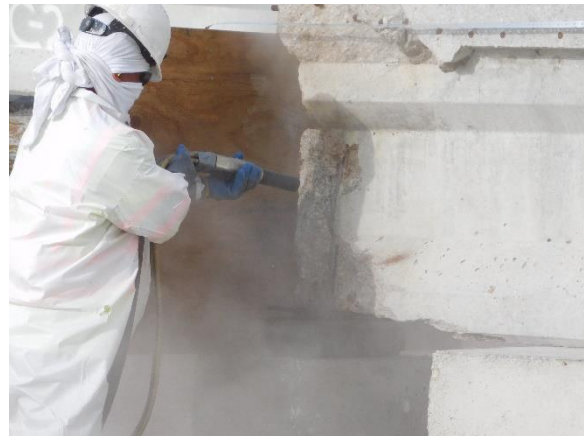
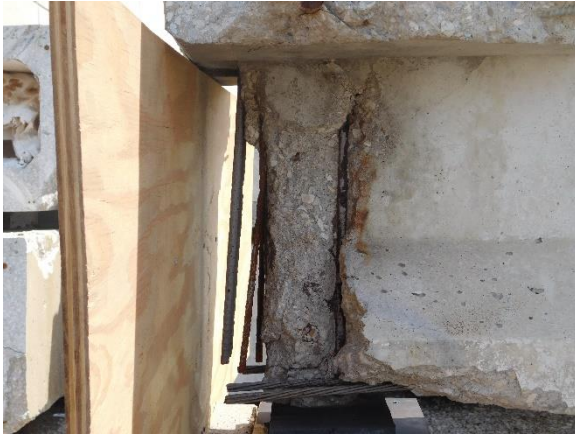
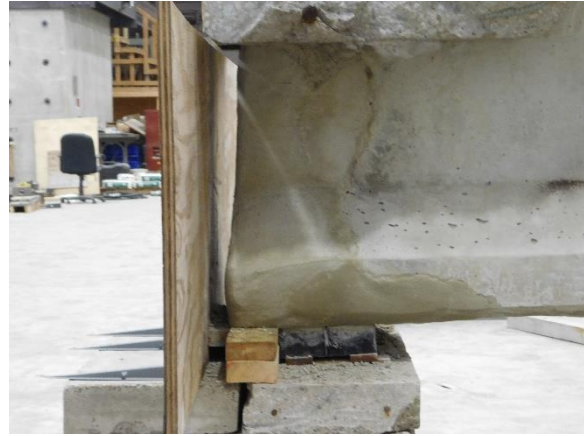
(a) Removing Delaminated Concrete

(b) Sandblasting to Remove Corrosion

Figure 3.19 Mortar Repair, Surface Preparation, and Drilling Anchor Holes

(c) Condition After Sandblasting

(d) Specimen After Mortar Repair

The process followed for repairing the end region with mortar and preparing the specimen for the application of the externally bonded FRP is displayed in Figure 3.19. The repair began by removing delaminated concrete from the end region using an electric chipping hammer until sound concrete was reached (Figure 3.19(a)). Care was taken to keep the regions from which concrete was removed as rectangular in shape as possible, per ICRI Guideline No. 310.1R-2008. To remove corrosion product and mitigate microcracking caused by the impact hammer, as recommended by ICRI Guideline No. 310.1R-2008, the regions where concrete was removed or had previously fallen from the specimen were sandblasted by an outside contractor (Figure 3.19(b)). The end of the specimen after sandblasting is shown in Figure 3.19(c). Next, the original cross section of the girder was restored using Rapid Set[®] Mortar Mix (Figure 3.19(d)). The mortar repair procedure as

outlined in Section 3.4.2 was again followed. After the mortar cured, the surface of the concrete to which FRP was to be applied was sandblasted to a concrete surface profile (CSP) of 3 per ICRI Guide No. 330.2-2016 and ACI 440.2R-17 (Figure 3.19(e)). A set of CSP chips were used as a reference to verify adequate surface roughness. As shown in Figure 3.19(f), prior to applying FRP to the concrete surface, a hammer drill with a 0.875-in. diameter drill bit was used to drill anchor holes at the locations indicated in Figure 3.8(b). It is recommended that the anchor holes which require drilling through the entirety of the web be drilled from both sides of the girder to mitigate concrete breakout. Based on a trial-and-error approach, a suggested procedure was developed for this process and is provided in Section 5.3 as a recommendation. Per ICRI Guide No. 330-2016 and ACI 440.2R-17, the edges of the anchor holes were rounded to a radius of 0.5 in. using a rotary tool to reduce stress concentrations (Figure 3.19(g)). Similarly, the edges of the girder over which the FRP sheet were applied were rounded to a radius of 0.5 in. (Figure 3.19(h)).

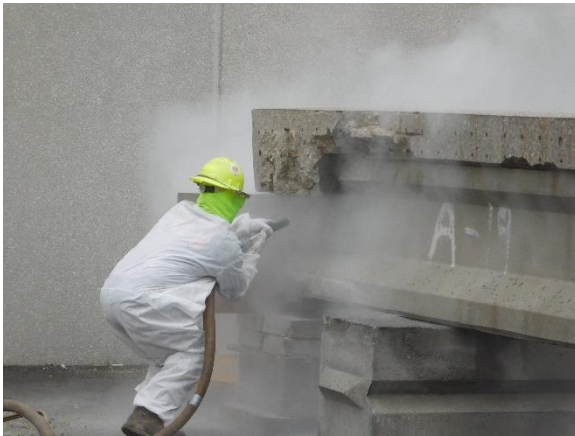
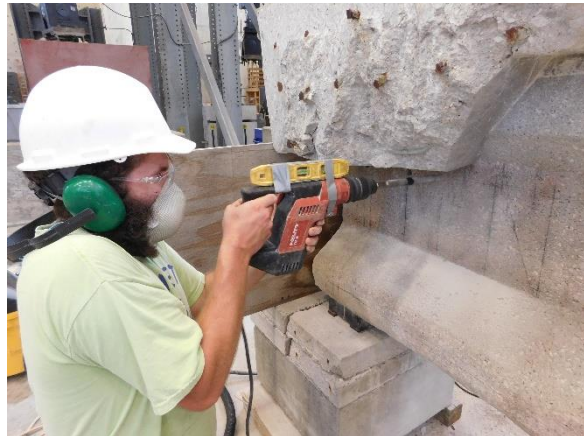
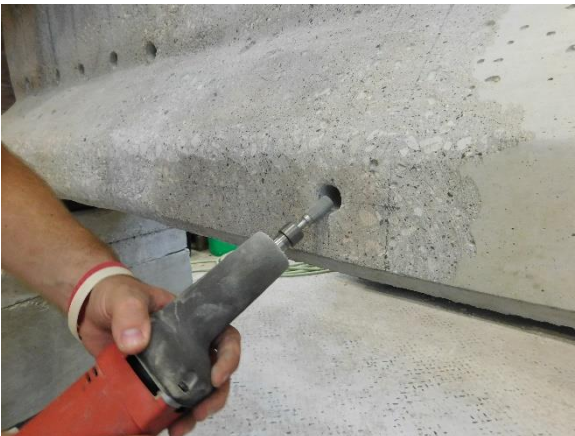
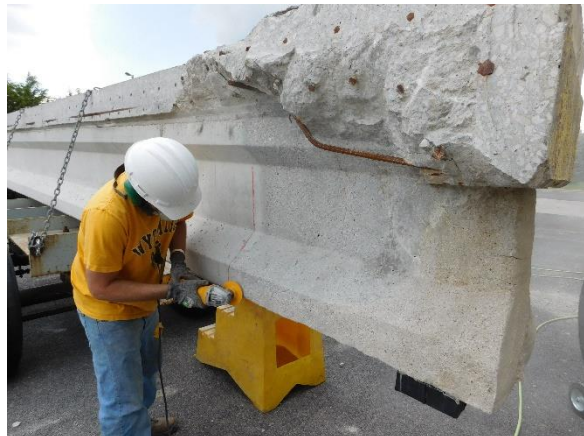
(e) Sandblasting for FRP Application

(f) Drilling Anchor Holes

(g) Rounding Edges of Anchor Holes

(h) Rounding Girder Edges

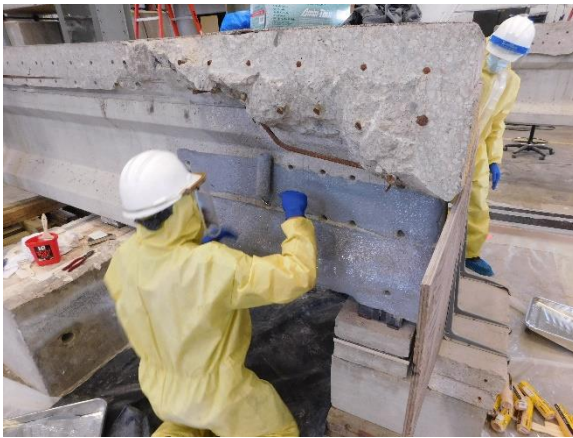
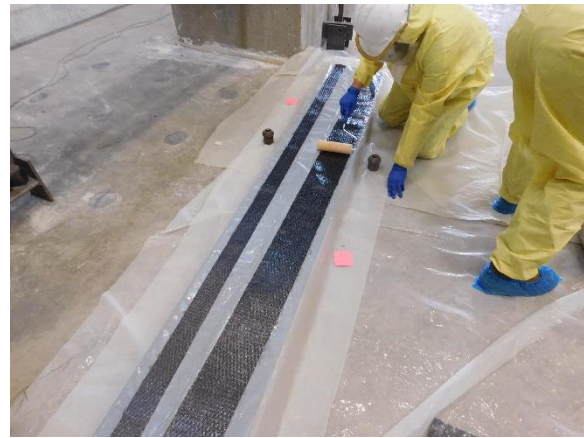
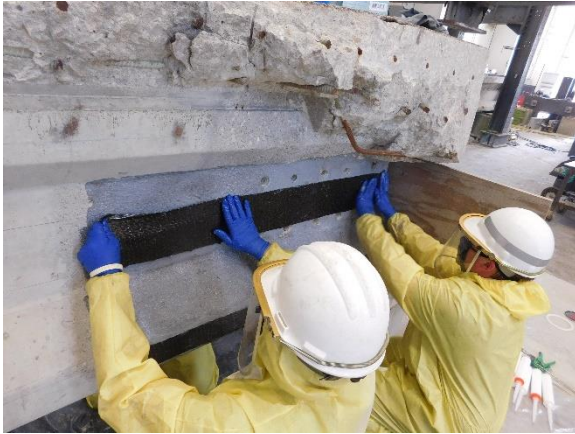
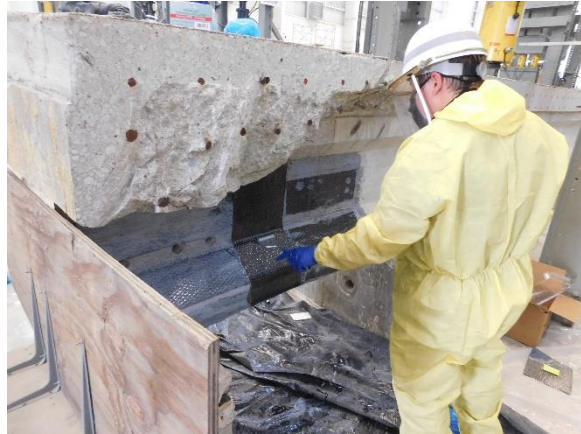
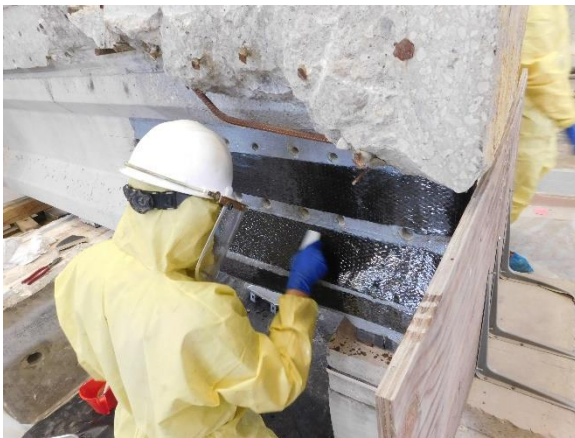
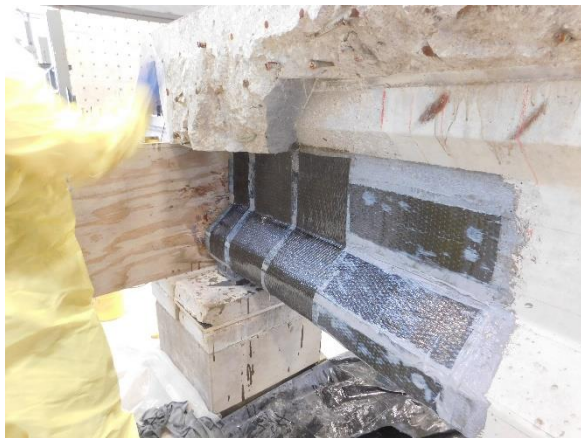
Figure 3.20 Application of Externally Bonded Strips/Sheets

(a) Sealing Concrete Surface

(b) Saturating Longitudinal FRP Strips

(c) Placing Longitudinal Strips

(d) Rolling FRP to Eliminate Air Pockets

(e) Removing Excess Epoxy with Squeegee

(f) Externally Bonded Strips/Sheets Applied to Specimen

As discussed in Sections 3.3.2, the externally bonded FRP was installed using a wet-layup application procedure. The steps followed for the girder specimen are presented in Figure 3.20. As

shown in Figure 3.20(a), paint rollers were used to seal the concrete surface with the appropriate epoxy resin (Sikadur[®] 330). Sealing the concrete surface with Sikadur[®] 330 eliminates air voids and ridges in the concrete surface and provides a tack coat to help prevent the fabric from sagging during installation. The longitudinal FRP fabric strips were then saturated with epoxy resin (Sikadur[®] 300) using plastic laminating rollers (Figure 3.20(b)). Next, the strips were applied to the primed concrete surface (Figure 3.20(c)) at the locations shown in Figure 3.8(a). Once in place, plastic laminating rollers were used to fully impregnate the longitudinal FRP strips and eliminate air voids (Figure 3.20(d)). Squeegees were then used to eliminate excess epoxy (Figure 3.20(e)). Once the longitudinal strips were in place, the vertically-oriented face-bonded sheets above the bearing support and the U-wraps were applied in the same manner to the appropriate locations shown in Figure 3.8(b). The end region of the specimen after all externally bonded strips/sheets were applied is shown in Figure 3.20(f).

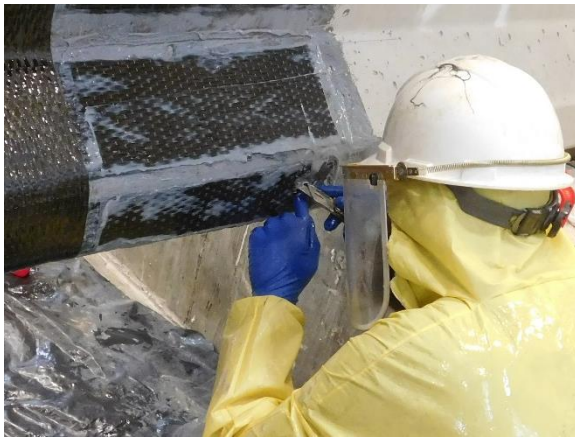
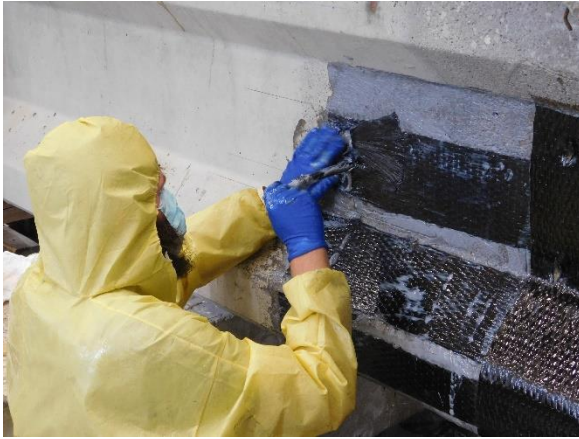
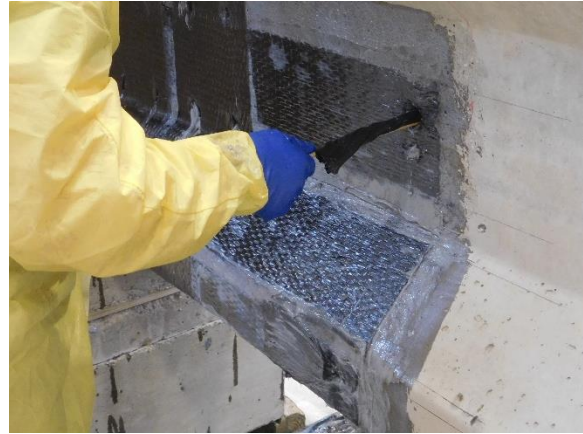
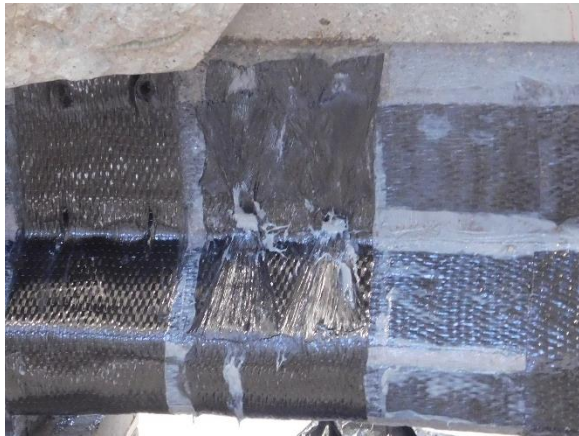
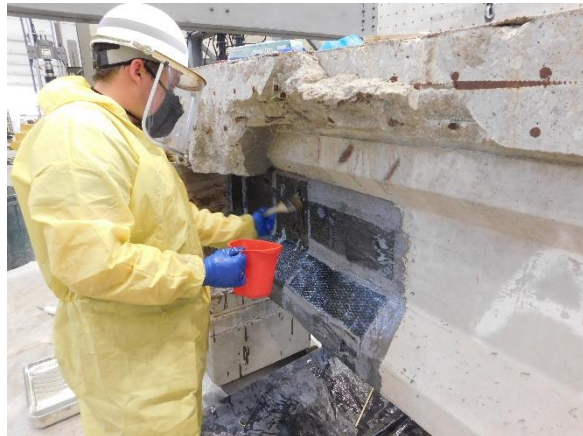
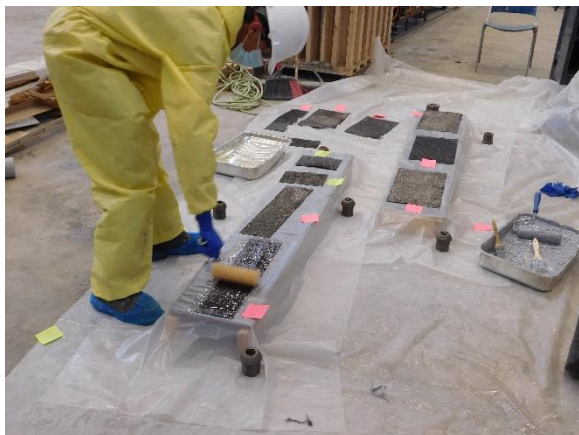
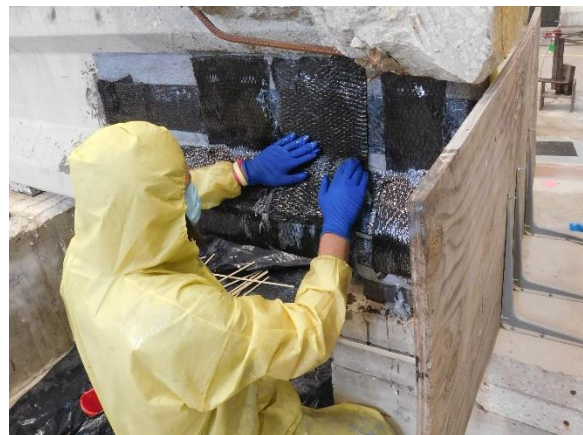
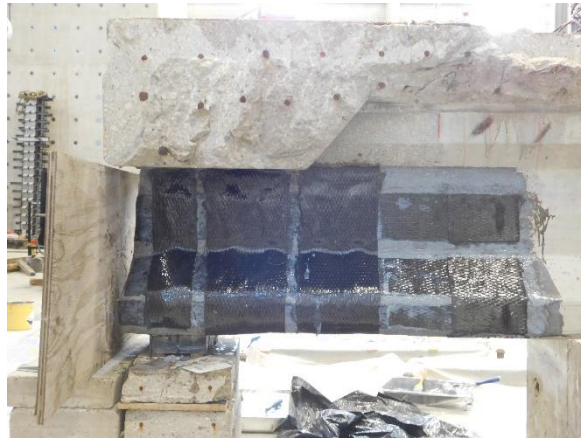
Figure 3.21 Spike Anchor Installation Procedure and Completed Externally Bonded FRP Repair System

(a) Separating Fibers with Razor Blade

(b) Injecting Anchor Hole with Epoxy

(c) Inserting Spike Anchor

(d) Removing Wooden Dowel

(e) Fanned-Out Anchors

(f) Saturating Anchors

(g) Saturating Patch Sheets

(h) Placing Patch Sheets

(i) Completed Externally Bonded FRP Repair System

The installation procedure for the FRP spike anchors is shown in Figure 3.21. For the FRP spike anchors that extended through the entirety of the web, a 1/8-in. wooden dowel was fastened within the spike anchors using zip-ties to aid in the installation process, as shown in Figure 3.22. To install the anchors, empty caulk tubes were first filled with the appropriate epoxy resin (Sikadur[®] 330). A razorblade was then used to separate the fibers of the FRP sheets (Figure 3.21(a)), and the caulk tube was inserted into the anchor hole (Figure 3.21(b)). For the anchors that extended through the web, the anchor hole was first filled half-way with epoxy and the spike anchor was then inserted, as shown in Figure 3.21(c). Next, the wooden dowel was removed from the anchor (Figure 3.21(d)), and the ends of the spike anchors were fanned out at a 60° angle (Figure 3.21(e)) on each side of the girder and saturated with epoxy (Figure 3.21(f)). Using the

filled caulk tube, additional epoxy was injected into the anchor holes to eliminate possible air voids. The same installation procedure was followed for the anchor holes in the bottom flange of the girder, except that the hole was filled entirely with epoxy prior to inserting the anchor and the anchors were folded in half, as shown in Figure 3.23, providing a nominal anchor cross-sectional area of approximately 0.31 in.² (see Section 3.3.2). However, as presented in Appendix B, the amount of material used for each anchor was determined by weight, not by area. Subsequently, the FRP patch sheets were saturated with epoxy (Sikadur[®] 300) (Figure 3.21(g)) and installed using the same procedure previously described for the externally bonded strips/sheets. Two FRP patch sheets, the first with the fibers orientated perpendicular to the fibers of the FRP sheets and the second with the fibers orientated parallel to the fibers of the FRP sheets, were applied over the installed anchors at the locations shown in Figure 3.8(c) (Figure 3.21(h)). The completed externally bonded FRP repair system installed on the girder specimen is shown in Figure 3.21(i).

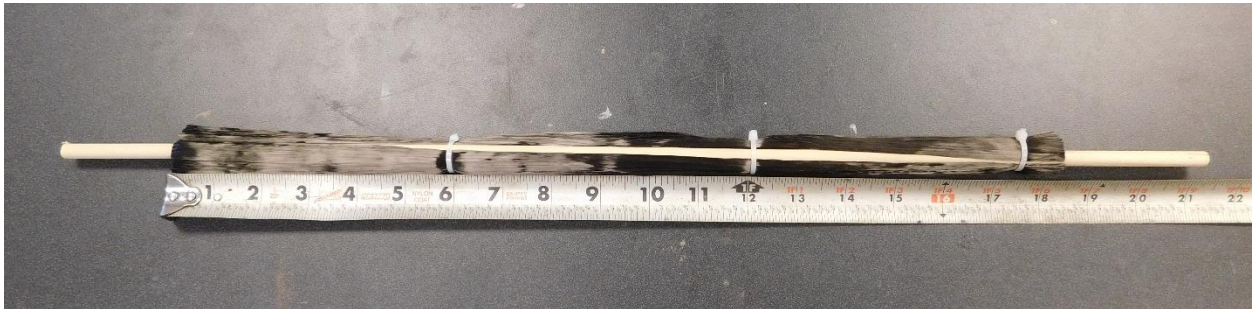
Figure 3.22 Assembled FRP Spike Anchor for Web Installation

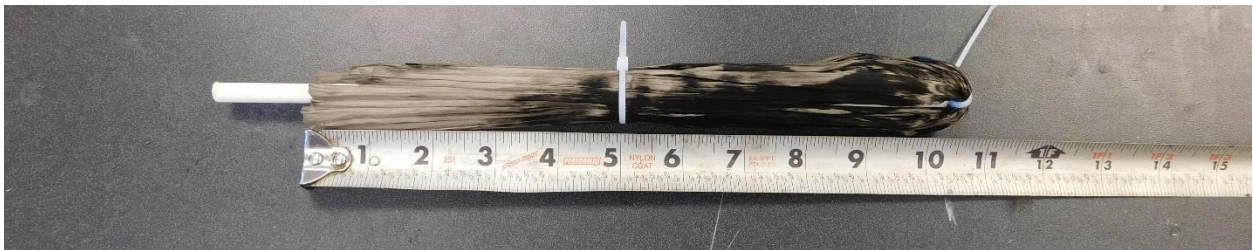
Figure 3.23 Assembled FRP Spike Anchor for Bottom Flange Installation

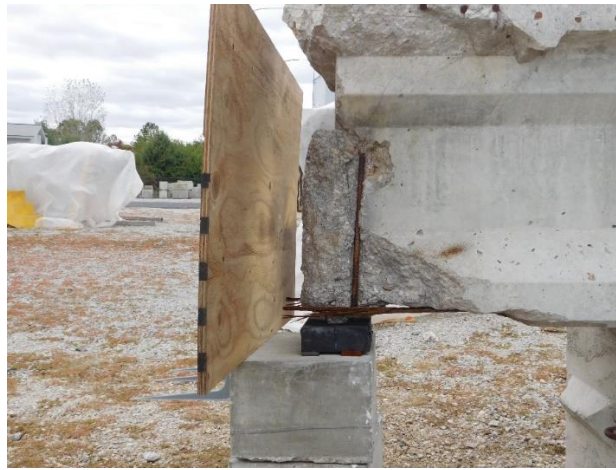
Figure 3.24 Simulated Mud Wall and Bearing Pad Location for NSM FRP Specimen

The repair procedure for the specimen tested to evaluate the NSM FRP repair described in Section 3.3.3 consisted of restoring the cross section of the girder with mortar followed by installation of the NSM strips. As with the specimen with externally bonded FRP, a board was placed at the end of the test specimen as shown in Figure 3.24 to simulate a mud wall while the

specimen was prepared for the mortar repair and while the mortar repair was performed. Furthermore, a bearing pad, also shown in Figure 3.24, was placed in its original position during the repair procedures. The procedures that were followed to prepare the end region for the mortar repair and the mortar repair itself were identical to the procedures followed for the specimen with externally bonded FRP. These procedures are outlined in Section 3.4.3. and are shown for the NSM FRP specimen in Figure 3.25. The key stages presented in Figure 3.25 include the removal of delaminated concrete, sandblasting in preparation for the mortar repair, and the end region after the cross section was restored using the same mortar that was previously described. Upon completion of the mortar repair, it was determined that the surface of the repair was too uneven to cut the required grooves at a uniform depth. Therefore, an additional thin layer of mortar was applied over the initial mortar repair to provide a smoother surface.
