**EXPERIMENTAL INVESTIGATION OF REPAIR TECHNIQUES FOR
DETERIORATED END REGIONS OF PRESTRESSED CONCRETE
BRIDGE GIRDERS**

Master of Science in Civil Engineering

Lyles School of Civil Engineering
West Lafayette, Indiana
May 2021

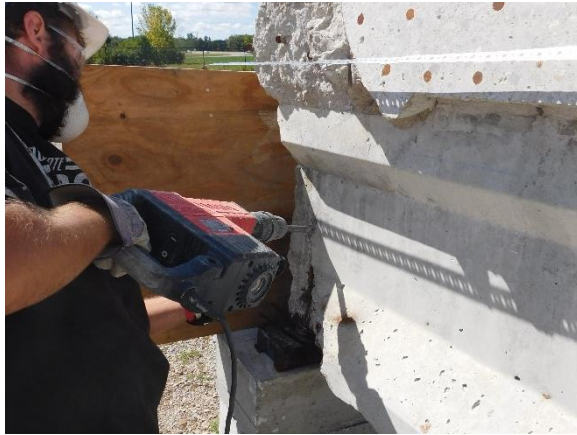
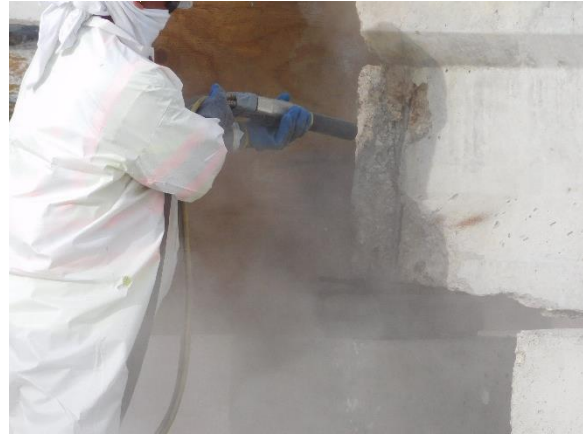
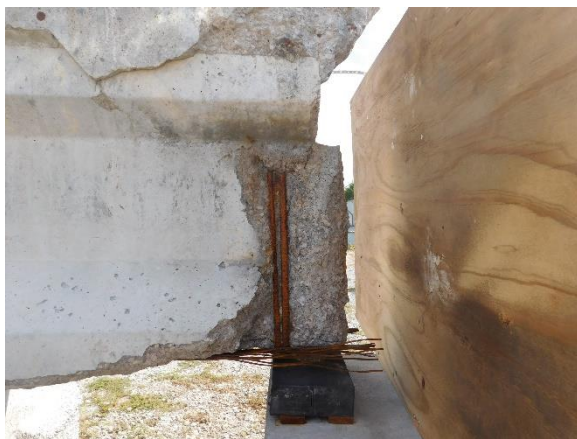
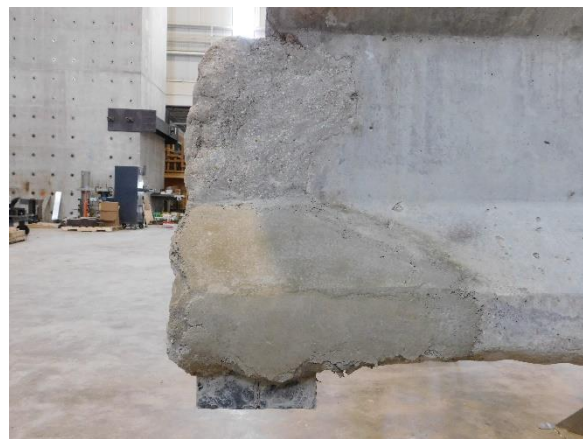
Figure 3.25 Mortar Repair Procedure for NSM FRP Specimen

(a) Removing Delaminated Concrete

(b) Sandblasting to Remove Corrosion

(c) Condition After Sandblasting

(d) Specimen After Mortar Repair

specimen was prepared for the mortar repair and while the mortar repair was performed. Furthermore, a bearing pad, also shown in Figure 3.24, was placed in its original position during the repair procedures. The procedures that were followed to prepare the end region for the mortar repair and the mortar repair itself were identical to the procedures followed for the specimen with externally bonded FRP. These procedures are outlined in Section 3.4.3. and are shown for the NSM FRP specimen in Figure 3.25. The key stages presented in Figure 3.25 include the removal of delaminated concrete, sandblasting in preparation for the mortar repair, and the end region after the cross section was restored using the same mortar that was previously described. Upon completion of the mortar repair, it was determined that the surface of the repair was too uneven to cut the required grooves at a uniform depth. Therefore, an additional thin layer of mortar was applied over the initial mortar repair to provide a smoother surface.

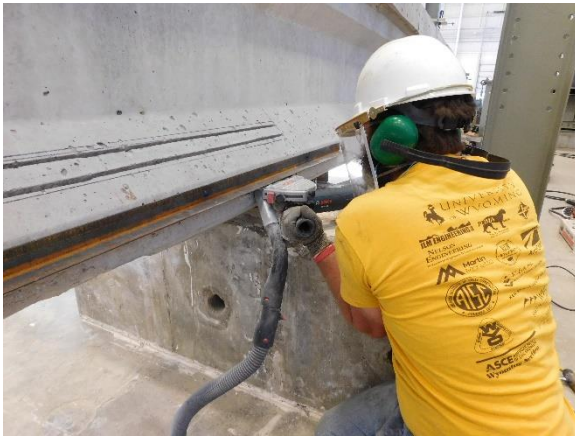
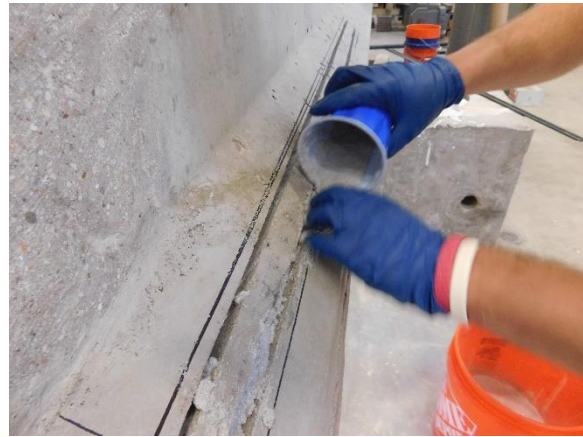
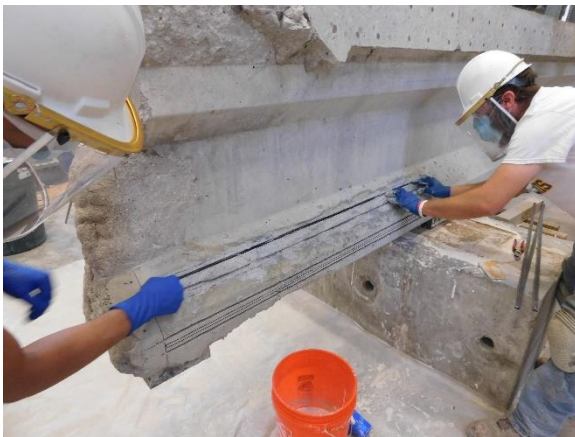
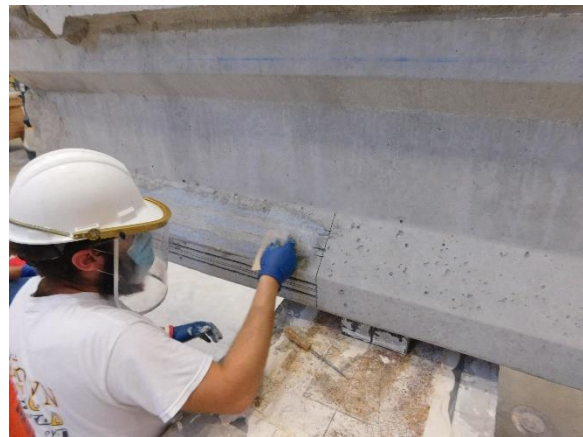
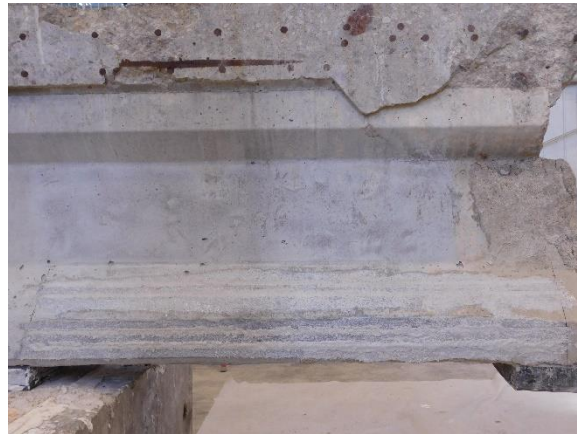
Figure 3.26 Installation of NSM FRP Strips

(a) Cutting NSM Groove

(b) Filling Groove with Epoxy Grout

(c) Inserting NSM Strip

(d) Leveling Off Excess Epoxy Grout

(e) Completed NSM Repair System

NSM FRP systems consist of bars or strips that are embedded into a concrete substrate. The process for installing the NSM FRP strips into the girder specimen of the test program is presented in Figure 3.26. As shown in Figure 3.26(a), a tuckpointing grinder with a 0.25-in. thick diamond cutting blade was used to cut grooves at the locations and with the dimensions specified in Figure 3.10. To ensure the grooves were cut straight and at a constant depth of 0.875-in., a steel angle was temporarily attached to the test specimen. Prior to installation of the FRP strips, compressed air was used to remove dust and debris from the grooves. Then, the installation of the NSM strips was conducted. This process was performed for two grooves (i.e., a pair of grooves on the same repair surface) at a time. First, approximately one-quarter of the grooves was filled with epoxy grout (Figure 3.26(b)). Next, an FRP strip was inserted into each of the two grooves (Figure 3.26(c)). To ensure an adequate bond between the epoxy grout, concrete substrate, and FRP strip,

the strips were inserted into the grooves using a sawing motion until they were centered at approximately the mid-depth of the grooves. The remainder of each groove was then filled with epoxy grout, and squeegees were used to level the epoxy grout to the surface of the test specimen (Figure 3.26(d)). The process was then repeated for the remaining pairs of grooves. The end region of the specimen after the repair was completed is shown in Figure 3.26(e).

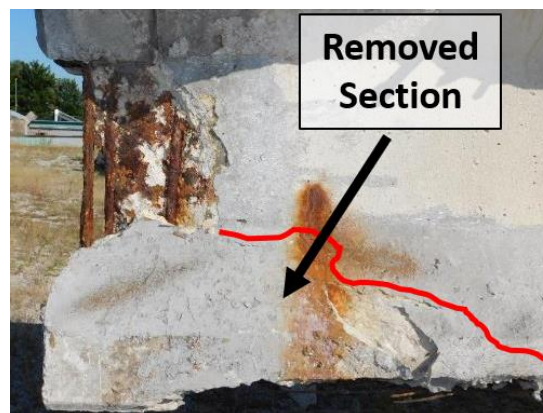
Figure 3.27 Flange Portion Removed from Supplement Diaphragm Specimen

The repair of the specimen with the supplemental diaphragm described in Section 3.3.4 involved minimal surface preparation and concrete chipping, unlike the specimens repaired with the FRP systems. Because the specimen was a fascia girder, one side of the member had been painted. The paint was removed within the end region of the member using a putty scraper. Furthermore, a patch material that had previously been applied to the bottom flange of the member in the field as a measure to mitigate deterioration was also removed. As indicated in Figure 3.27, it was also necessary to remove a large portion of the bottom flange prior to the repair. The portion was only bonded to a single stirrup and had separated from the surrounding concrete. The condition of the girder following the removal of this portion of concrete is shown in Figure 3.28.

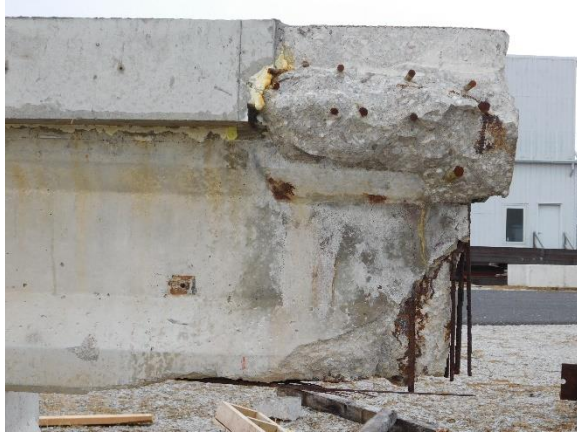
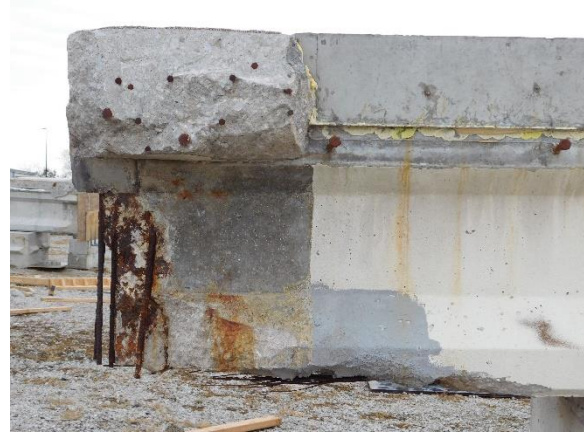
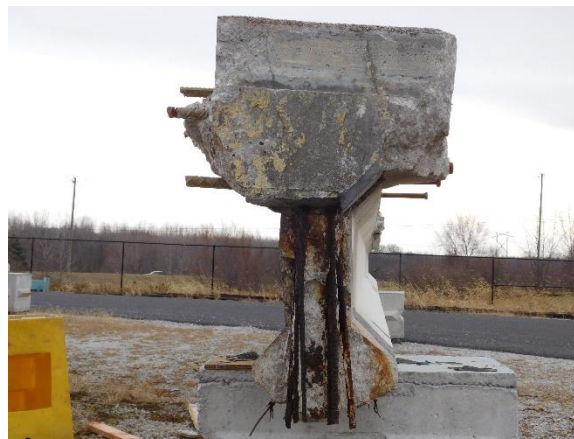
Figure 3.28 Condition of Specimen Prior to Supplemental Diaphragm Repair

(a) Elevation – Side 1

(b) Elevation – Side 2

(c) End View

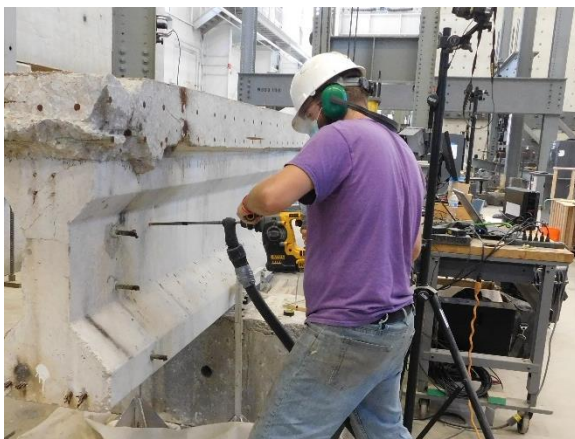
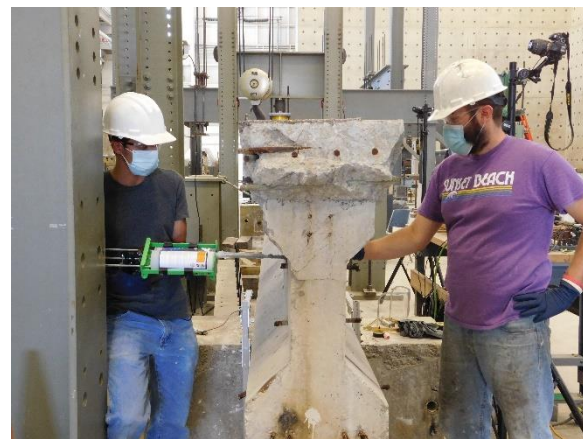
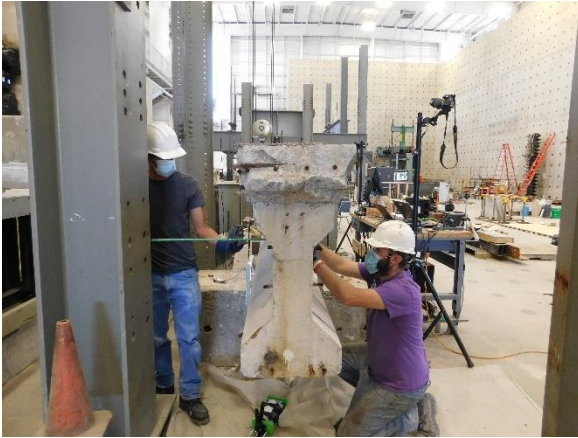
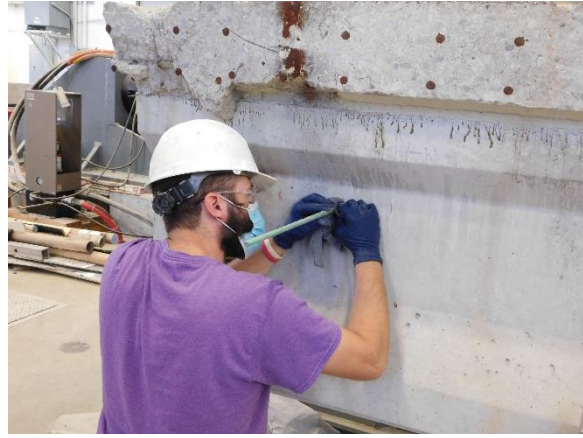
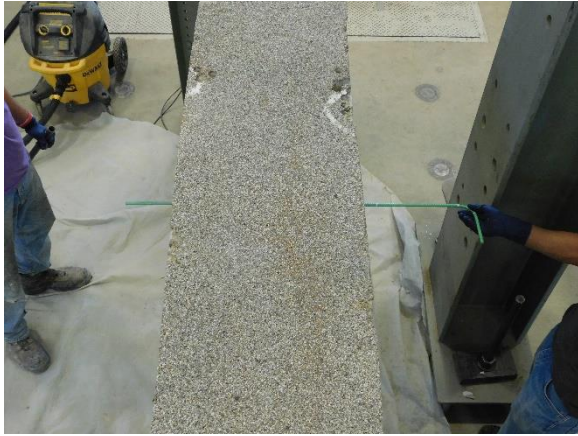
Figure 3.29 Supplemental Diaphragm Repair Procedure

(a) Drilling Holes for No. 3 Bars

(b) Injecting Hole with Epoxy

(c) Inserting No. 3 Bar Through Web

(d) No. 3 Bar Inserted Until Mark is Visible

(e) No. 3 Bar Oriented for Bending Operation

The procedure followed for the construction of the supplemental diaphragm is presented in Figure 3.29. It should be noted that some of the photographs illustrate the procedure being conducted near the undamaged end of a girder. However, the procedure used at the damaged end of the test specimen was the same. Assembly of the reinforcing cage for the supplemental diaphragm (Figure 3.11) began with drilling holes for the epoxy-coated No. 3 dowel bars. One end of the bar was pre-bent prior to installation, while the other end was bent after the bar was inserted through the girder web. Using a hammer drill with a 0.5-in. diameter drill bit, holes were drilled through the entire thickness of the web, as shown in Figure 3.29(a), at the locations indicated in Figure 3.11. While holding a finger over one end of the hole to plug it, epoxy (Unitex® Pro-Poxy™ 400) was injected into the hole (Figure 3.29(b)). With the No. 3 reinforcing bar marked at the termination point of the field bend and one end of the hole still plugged, the unbent end of the bar

was inserted into the hole (Figure 3.29(c)). When the bar reached the plugged end of the hole, the hole was unplugged, and the bar was pushed through the hole until the mark on the bar was visible (Figure 3.29(d)). To bend the bar, the bar was first rotated so that the hook extension at the pre-bent end of the bar was oriented horizontally and pointing toward the midspan of the girder (Figure 3.29(e)). To perform the 90° field bend, a steel pipe was inserted over the unbent end of the bar and, with the end of the pipe touching the concrete surface of the girder web, the pipe was forced toward the beam (Figure 3.29(f)). Once the end of the bar was bent, the position of the bar was adjusted so that the hooked ends of the bar were centered on the beam (Figure 3.29(g)). The bar was subsequently cleaned to remove excess epoxy. To eliminate air voids in the hole, more epoxy was injected into both sides of the hole (Figure 3.29(h)). The hook extension of the 90° field bend was then cut to the appropriate length (Figure 3.29(i)), resulting in the bar shown in Figure 3.29(j). After all four No. 3 dowel bars were installed, the remaining epoxy-coated No. 4 reinforcing bars were tied to the No. 3 dowel bars to complete the reinforcing cage, as shown in Figure 3.29(k and l). Formwork was then erected around the repair region. A closed-cell polystyrene board was used to form the bottom surface of the diaphragm as shown in Figure 3.29(m). When casting such a supplemental diaphragm in the field, a polystyrene board can be placed on the abutment in a similar manner to form the bottom of the diaphragm. The polystyrene board was used in the lab to simulate such field conditions. The completed formwork is shown in Figure 3.29(n). The SCC concrete mixture provided in Table 3.5 was poured directly into formwork from the concrete truck (Figure 3.29(o)). The completed diaphragm is presented in Figure 3.29(p).

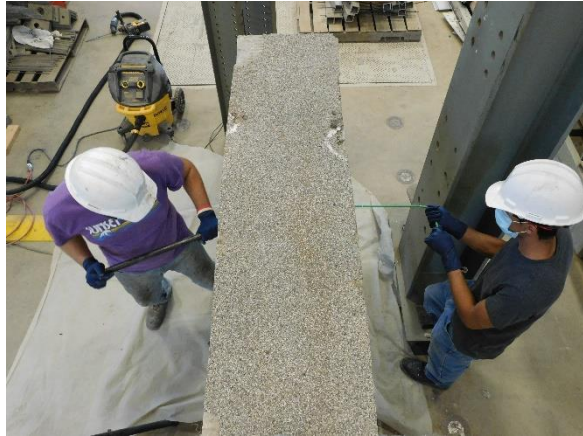
(f) Bending No. 3 Bar

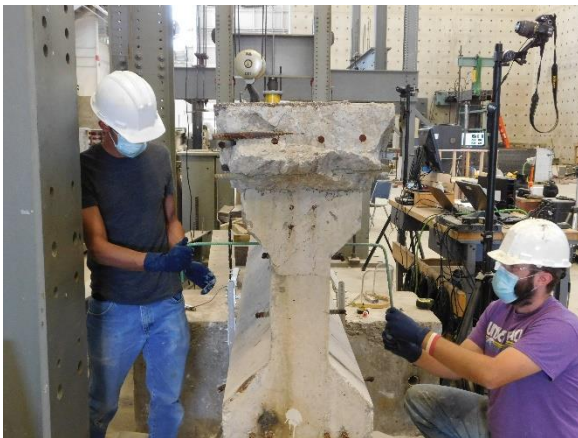
(g) Centering No. 3 Bar

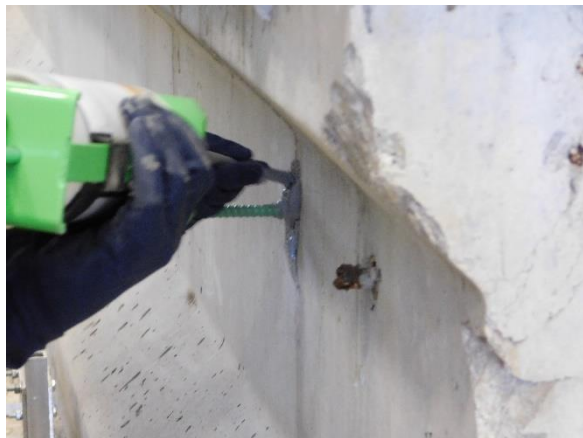
(h) Injecting Additional Epoxy

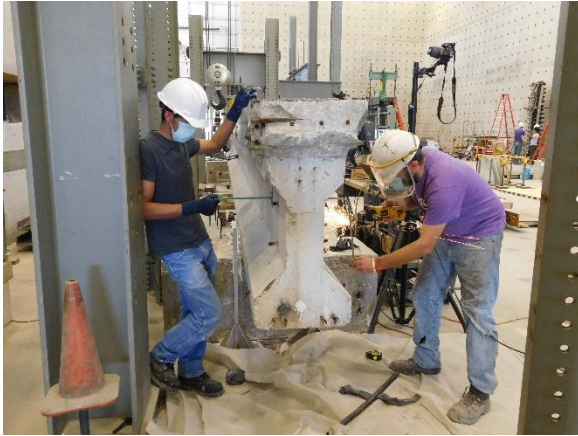
(i) Cutting Hook Extension to Length

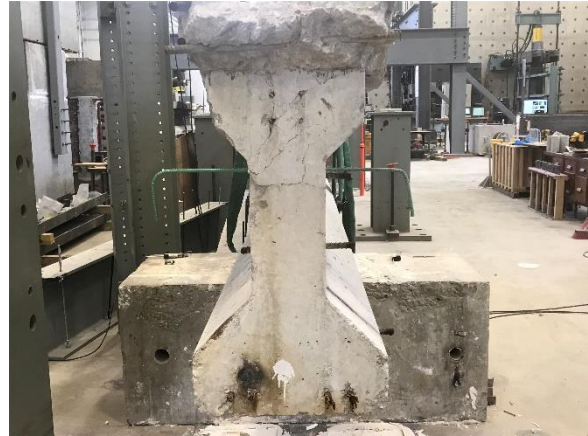
(j) Completed Installation of No. 3 Bar

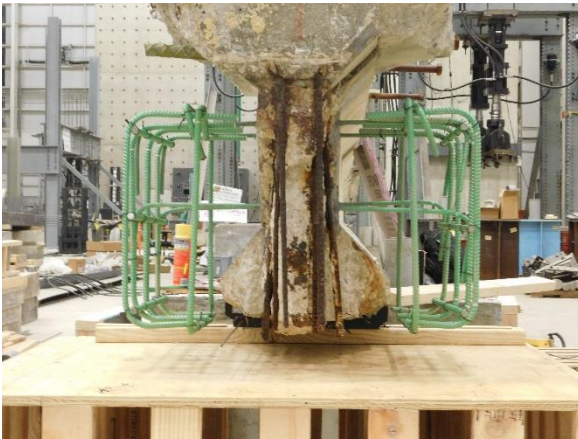
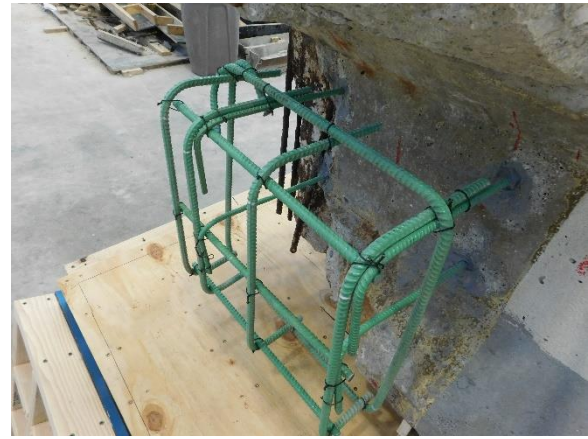
(k) Completed Reinforcing Cage

(l) Completed Reinforcing Cage

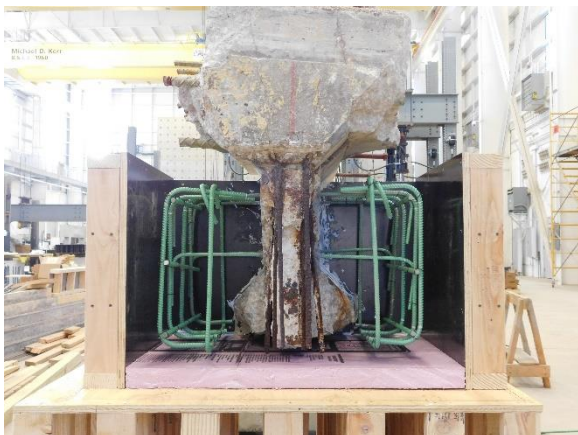
(m) Closed-Cell Polystyrene Board

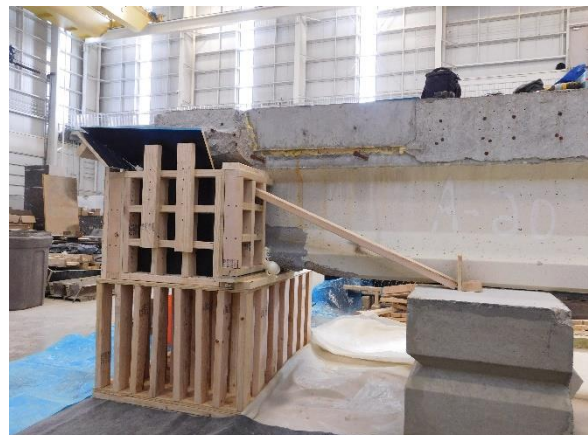
(n) Erected Formwork

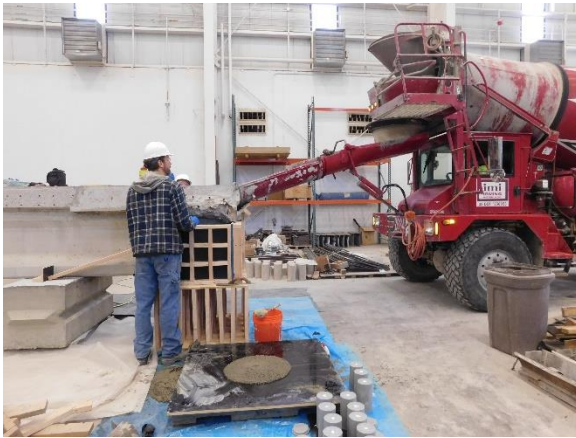
(o) Casting SCC

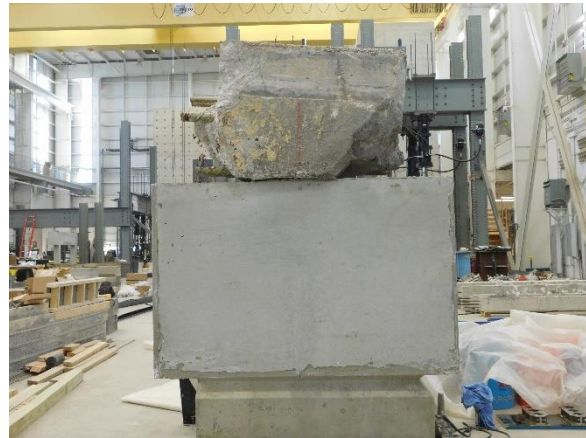
(p) Completed Supplemental Diaphragm Repair System

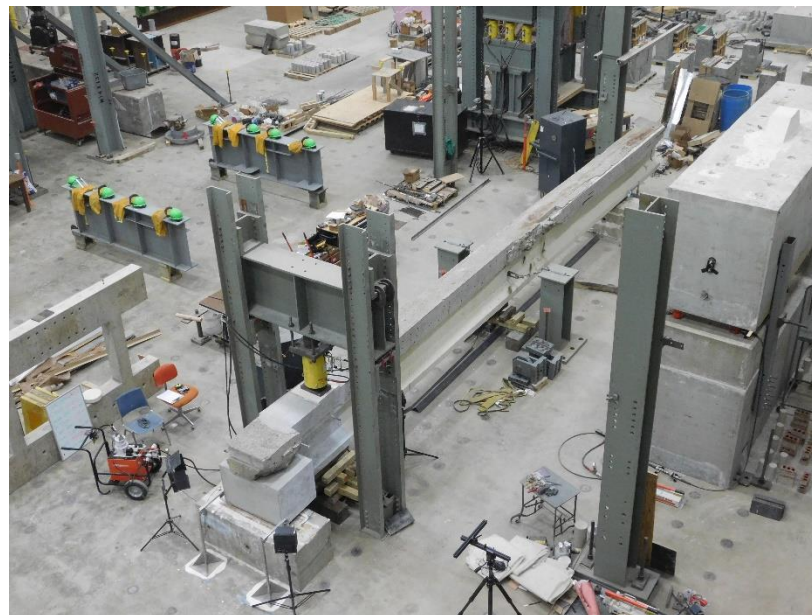
Figure 3.31 Specimen in Test Frame

The test specimens were loaded to failure using the loading configuration presented in Figure 3.30. A specimen in the test frame is shown in Figure 3.31. An a/d ratio of 1.25 (corresponding to a shear span of 45 in. as shown in Figure 3.30) was used for all five test specimens. The relatively short shear span was selected based on the observation that direct compressive stresses transferred from the load to the support would be critical for the end regions. Because the short shear span results in an a/d ratio less than 2.0, the entire test region is defined as a D-region. Thus, the behavior of the test region will be governed by deep beam behavior rather than sectional behavior. The far end of the girder opposite the test region was supported 60 in. from the end of the member to allowing for testing on the opposite end of the specimen if needed. The original elastomeric bearing pads acquired from the bridge were used to support the specimens. The bearing pads were 14-in. by 7-in. by 2.5-in. For the specimen with the supplemental diaphragm, one of the bearing pads was cut in two, and the member was supported at the supplemental diaphragm as described in Section 3.3.4. A slight modification was made to the test setups for the control and damaged specimens. Although the end region of the control specimen was in relatively good condition, cracking was present in the bottom flange near the end of the member. Therefore, the bearing pad was shifted 3 in. further into the span relative to the original bearing location to avoid the cracks, as shown in Figure 3.32. Moreover, as discussed in Section 3.4.2, the bearing pad for the damaged test specimen was shifted 4 in. further into the span to minimize required

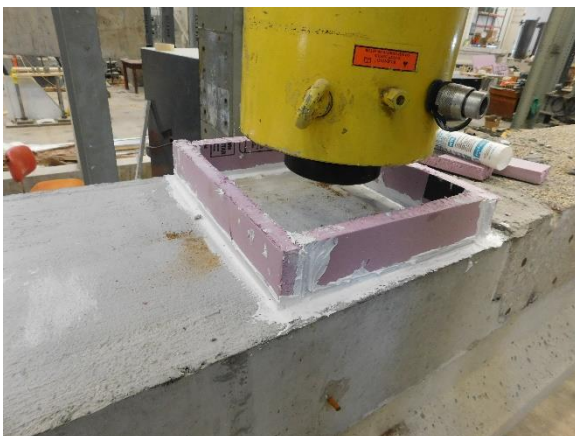
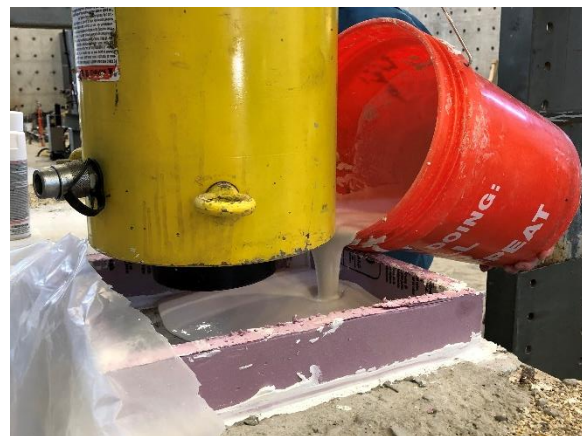
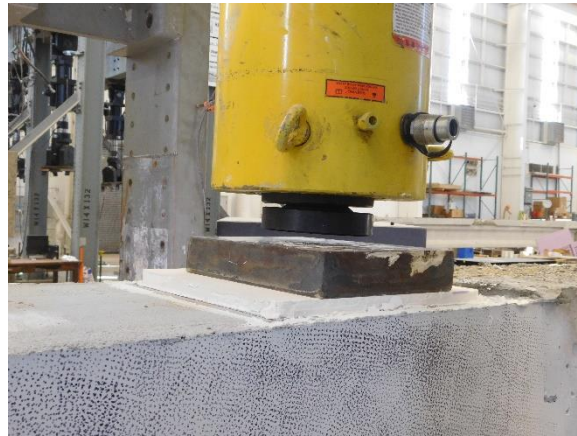
(a) Closed-Cell Polystyrene Formwork

(b) Pouring Gypsum Concrete

Figure 3.33 Preparing the Load Point

(c) Load Plate on Gypsum Concrete Wedge

Due to the sloped top surface of the deck, a gypsum concrete wedge was cast at the load point for each girder as shown in Figure 3.33. Using closed-cell polystyrene board, temporary formwork was erected around the loading area. The bottom of the formwork was sealed, and liquid gypsum concrete was poured into the formwork. After self-leveling and curing, the formwork was removed. A 12-in. by 8-in. by 2-in. A36 steel plate was subsequently placed on top of the wedge and centered over the top flange of the test specimen.

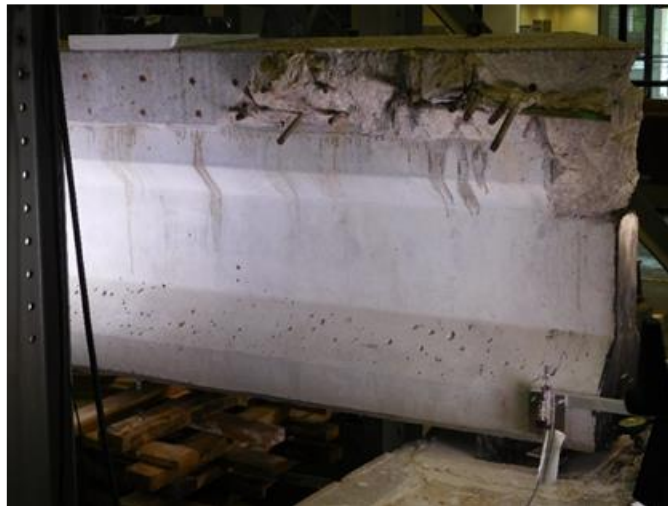
Figure 4.2 Control Specimen Prior to Testing

The condition of the girder prior to testing is displayed in Figure 4.2, and the condition of the girder after failure is shown in Figure 4.3. As discussed in Section 3.3.1, the failure of the control specimen was characterized by the formation of a diagonal strut within the test region, corresponding to a crack angle of approximately 43° measured from the horizontal, as shown in

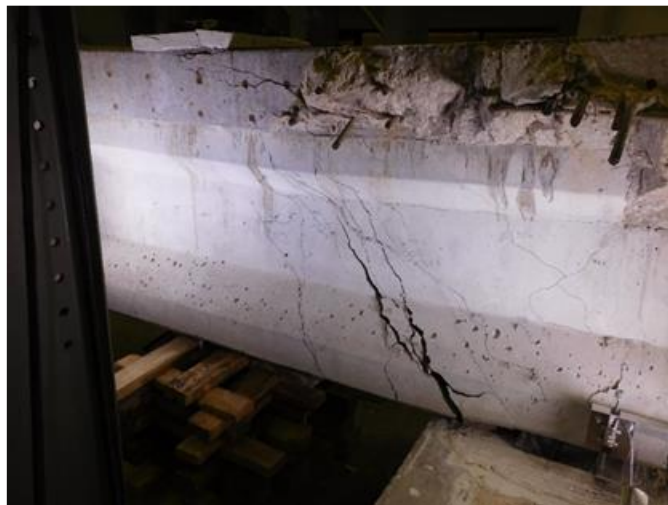
Figure 4.3 Control Specimen After Failure

Figure 4.3. The formation of the strut is consistent with D-region shear behavior. Failure of the specimen was defined by a gradual decrease in load-carrying capacity along with the progressive widening of the diagonal cracks that formed along the strut. Furthermore, as the cracks widened and the specimen continued to deflect, the prestressing strands in the bottom flange experienced slippage. The ends of the strands slipped approximately 1.25 in. into the girder by the end of the test, measured using a caliper after completion of the test. The sudden loss in load-carrying capacity shown in Figure 4.1 at a beam deflection of 1.24 in. is believed to be due to strand slip.

The condition of the specimen prior to testing is shown in Figure 4.6, and the condition of girder following testing is displayed in Figure 4.7. Unlike the control specimen, load was not transferred within the test region through a diagonal strut extending from the load point to the support. Instead, a vertical crack initiated at the bottom of the member approximately 3.5 ft from the end of the specimen. Upon further loading, the crack propagated vertically through the web of the member. Then, the crack propagated diagonally through the top flange and deck toward the load point. Additionally, unlike the control specimen, the failure of the damaged specimen was defined by an abrupt drop in the load-carrying capacity. Comparing Figure 4.7(a and b) with Figure 4.3, the failure mechanisms between the control and damaged girders are significantly different,

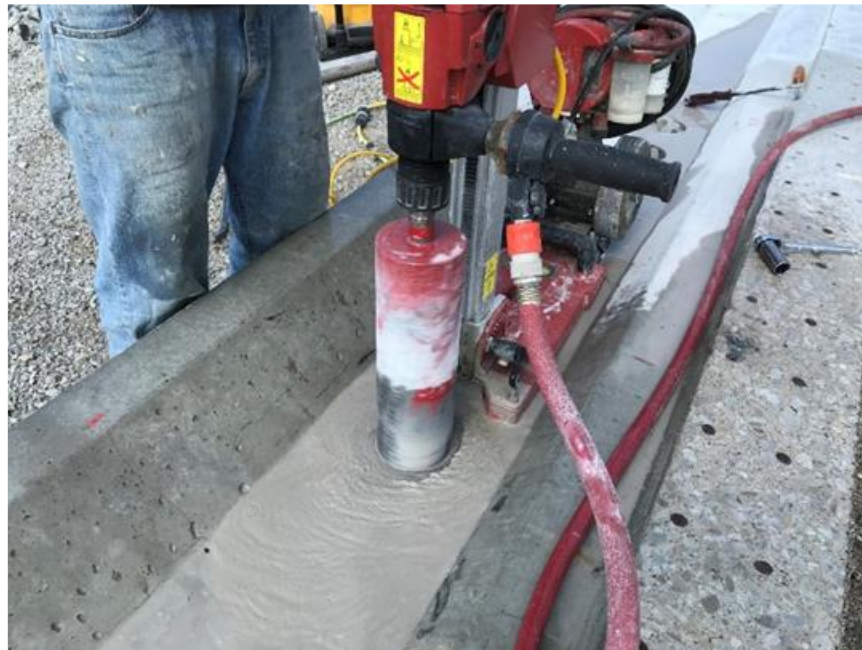
Figure 4.4 Coring Web of Test Specimen

After testing the girder, 4-in. by 6-in. cores were removed from the web of the specimen to determine the compressive strength of the concrete at the time of testing. As shown in Figure 4.4, the test specimen was rotated to allow for the cores to be taken vertically. Cores were removed from an undamaged portion of the web located as close as possible to the test region. This procedure was followed for all five girders of the test program. The four cores from the control specimen were tested in compression in accordance with ASTM C42 and yielded an average compressive strength of 7270 psi, as provided in Table 4.1.

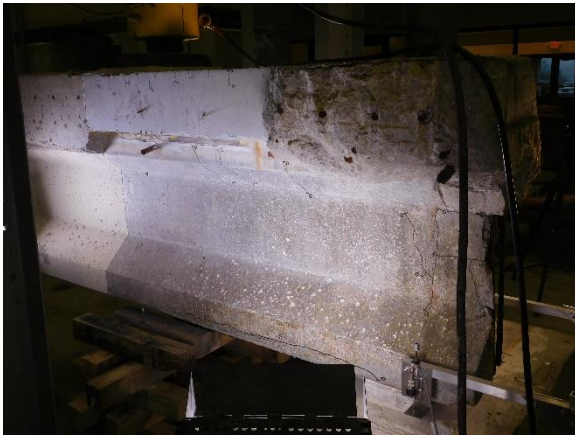
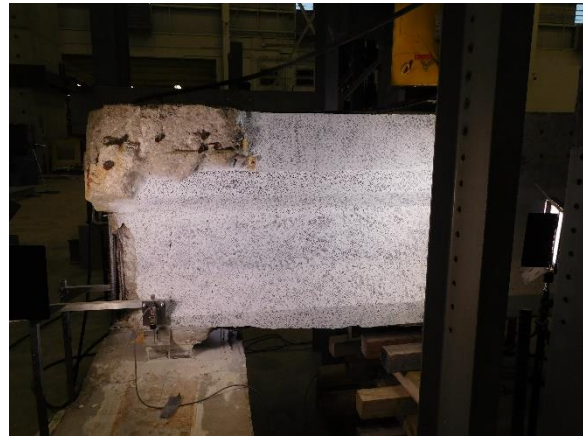
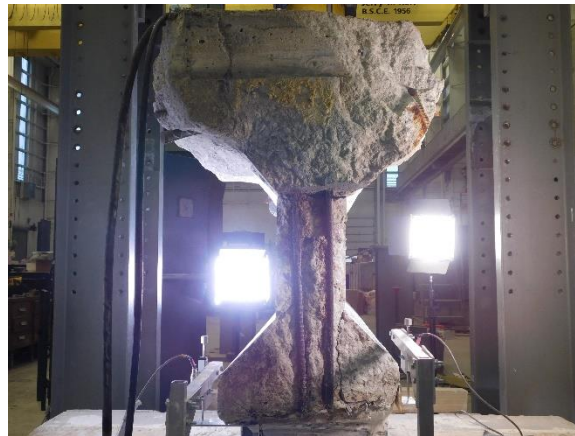
(a) West Side

(b) East Side

(c) Girder End

Figure 4.6 Damaged Specimen Prior to Testing

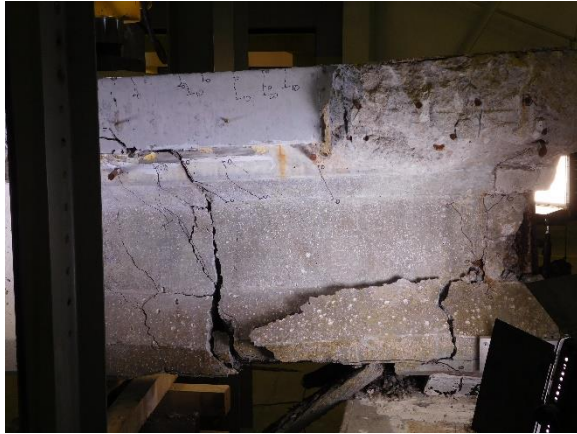
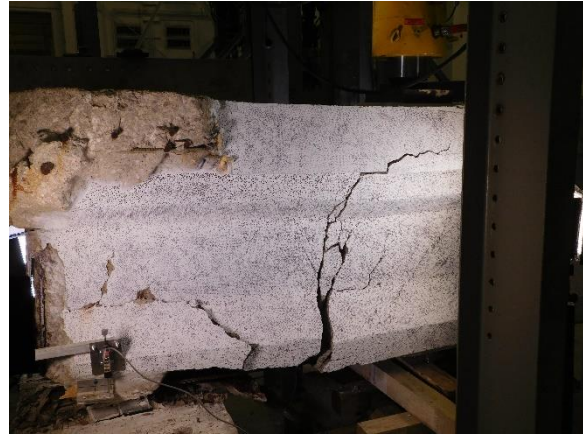
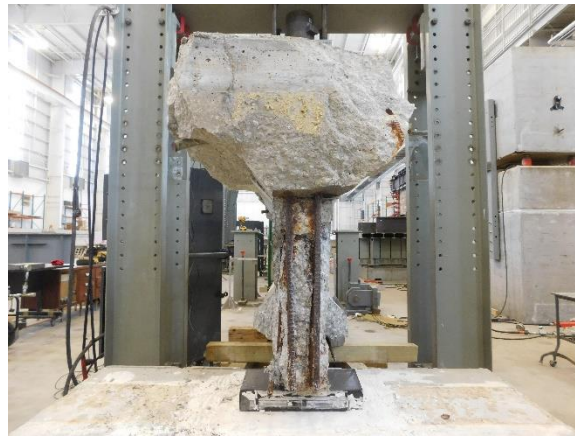
(a) West Side

(b) East Side

(c) Girder End

Figure 4.7 Damaged Specimen After Failure

with the primary failure crack(s) oriented at approximately 43° from the horizontal for the control specimen and at approximately 90° for the damaged specimen. The behavior of the damaged specimen was a result of the lost tensile capacity within the bottom flange due to the deteriorated and ineffective prestressing strands. Furthermore, as shown in Figure 4.7(c), the portions of the bottom flange outside of the web detached from the specimen at the support. Through destructive evaluation after the test, it was discovered that the individual wires of one of the harped strands had untwisted from one another.

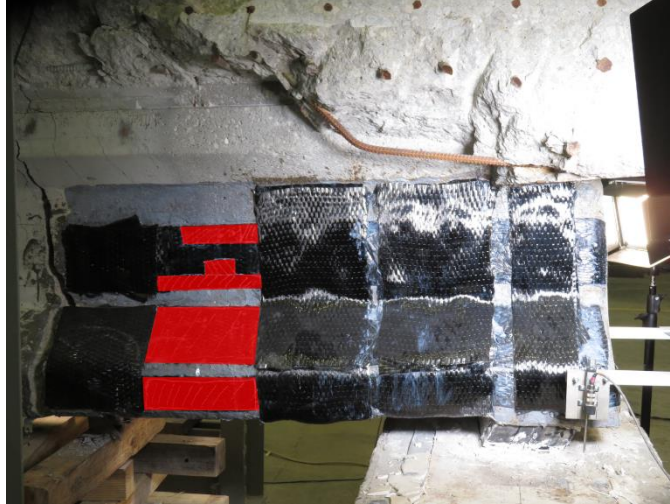
Figure 4.11 Externally Bonded FRP Specimen After Failure

The condition of the specimen prior to testing is presented in Figure 4.10, and the condition of the girder after failure is shown in Figure 4.11. The specimen experienced a flexural failure characterized by the fracture of two prestressing strands in the bottom flange (see Figure 4.12) at the termination of the FRP sheets. The strands fractured at the location of a wide flexural crack at the end of the repaired region as shown in Figure 4.13. The red lines in Figure 4.13 indicate the termination of the FRP strips. The sudden loss in load-carrying capacity at a deflection of 1.39 in. is believed to coincide with the fracture of one of the prestressing strands. The specimen continued to be loaded after this event and maintained a shear force of approximately 100 kips until it is believed another strand in the bottom flange fractured at a deflection of 2.35 in. Concrete crushing was observed in the deck beneath the load point. During the test, minor diagonal cracking was observed near the load point in the region not covered by FRP sheets. The crack was oriented at an angle of approximately 46° from the horizontal. The crack did not widen significantly after formation, however, and the propagation of the crack toward the support is unknown due to the presence of the FRP. Considering the failure behavior of the specimen, the repair system restored sufficient shear capacity so that a flexural failure outside of the damaged region occurred. The FRP

Minimal FRP delamination was observed during testing, further indicating a successful FRP repair. Indications of delamination were first noted at a shear force of 106 kips when minor popping sounds were heard. At the end of the test, the delamination was confined to the area along the longitudinal strips between the termination of the patch sheets located at the ends of the strips and the first U-wrap sheet, as indicated by the red areas in Figure 4.11. No other damage to the FRP within the repaired region was observed.

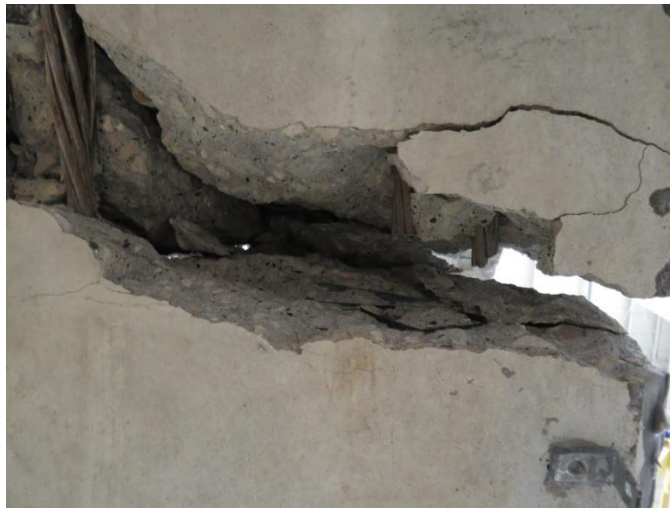
Figure 4.12 Fractured Prestressing Strands in Bottom Flange After Testing

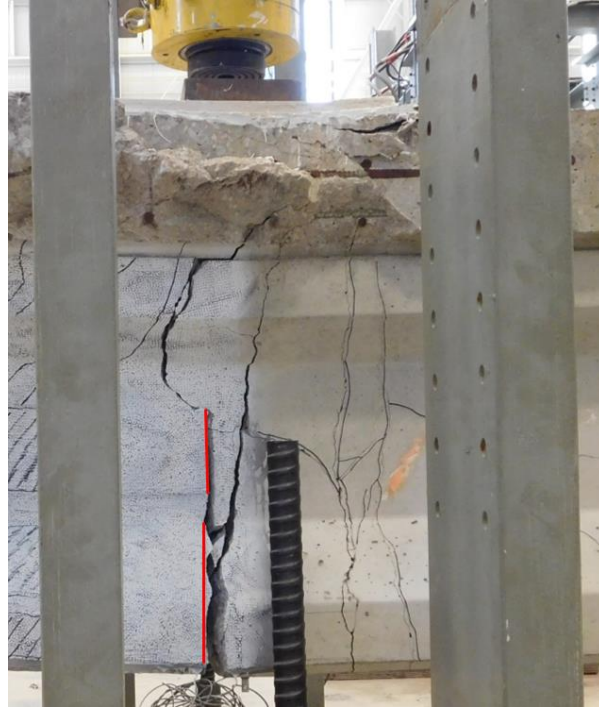
Figure 4.13 Critical Flexural Crack of Externally Bonded FRP Specimen After Failure

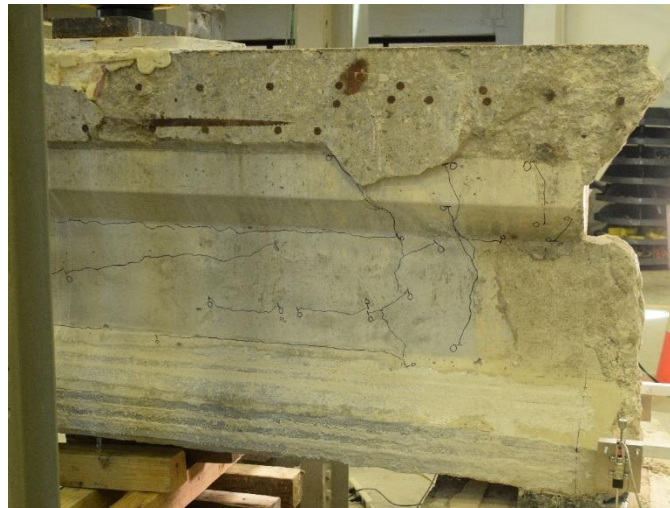
Figure 4.15 NSM FRP Specimen Prior to Testing

The condition of the specimen prior to testing is presented in Figure 4.15, and the condition of the specimen following testing is displayed in Figure 4.16. The hairline cracks marked in Figure 4.15 were preexisting. At a shear force of 31 kips, the portion of the web located above the support

The bridge from which the test girders were extracted included a transverse edge beam located within the notch at the ends of the girders. This edge beam was cast monolithically with the bridge deck. As shown in the previous figures of the specimen with the NSM strips (e.g., Figure 4.15 and Figure 4.16), the transverse edge beam was not intact but separated from the girder at some point during the extraction of the beam from the bridge or during transportation. At least a portion of the edge beam remained intact for the other specimens of the test program. The lack of the edge beam on the specimen with NSM strips may have contributed to the splitting in the vicinity of the notch observed during the test.

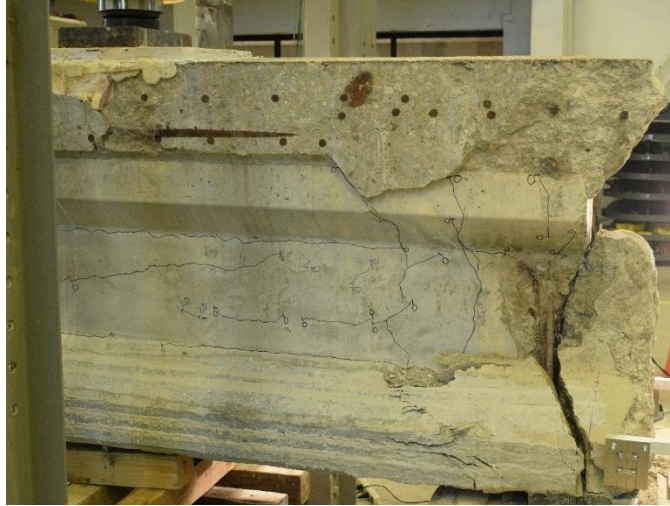
Figure 4.16 NSM Specimen After Failure

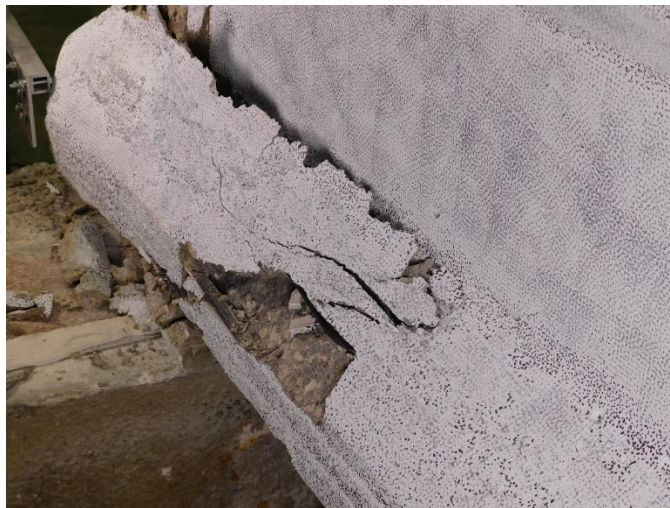
(a) Elevation View

Figure 4.17 Flange Separated from NSM Specimen

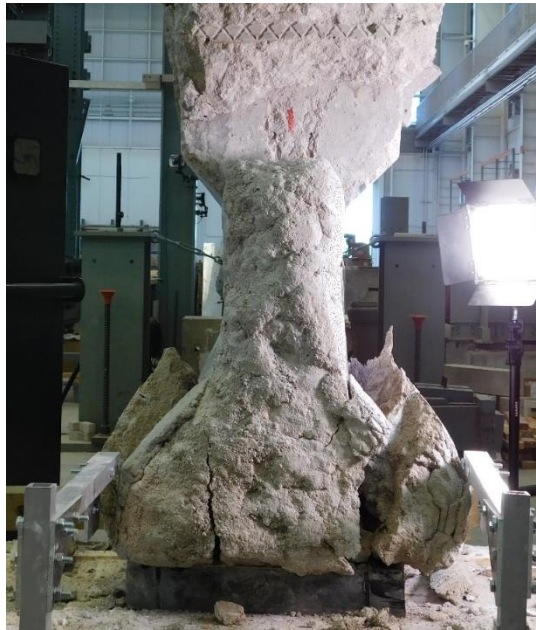
(b) Girder End

Figure 4.17 continued

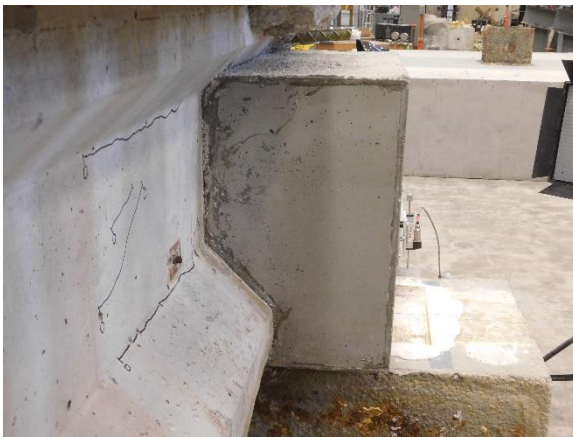
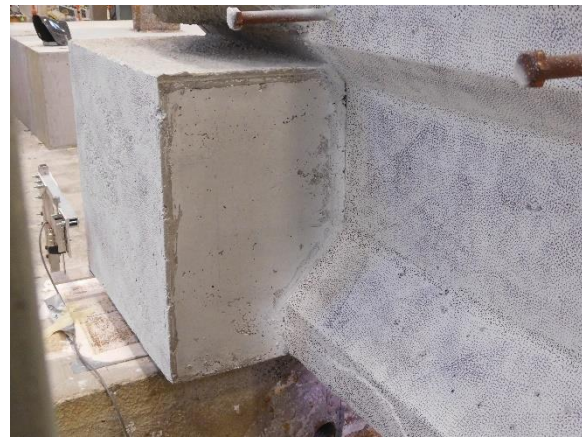
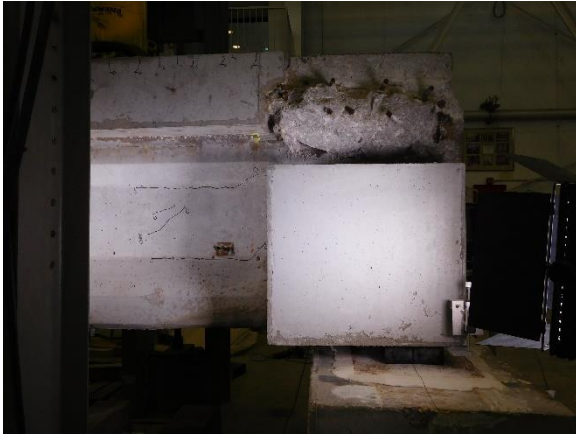
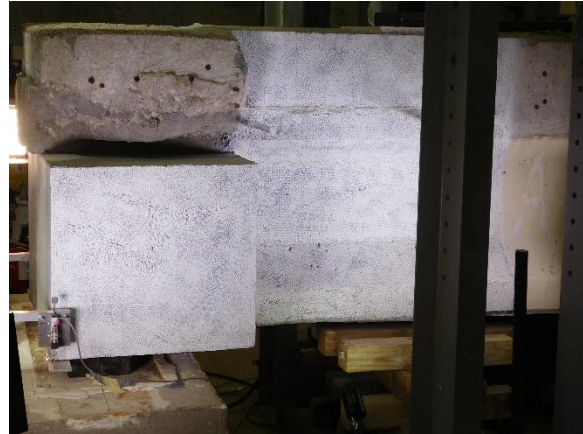
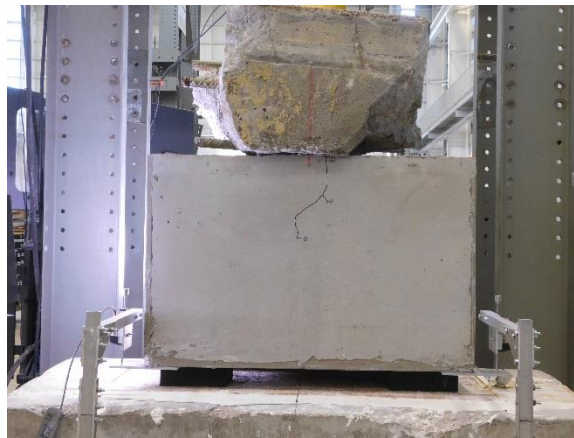
Figure 4.19 Supplemental Diaphragm Specimen Prior to Testing

The condition of the girder prior to the test is shown in Figure 4.19. The hairline cracks marked in Figure 4.19 were present before testing. As discussed above, at shear forces as low as 8.9 kips, cracking was observed on the end face of the supplemental diaphragm, and cracking was observed on the bottom surface of the supplemental diaphragm at a shear force of 35 kips. As shown in Figure 4.20, at a shear force of 44 kips, these cracks had propagated along the entire length of both faces. The formation of the cracks at a relatively low shear force (less than half of V_{cr} for the control specimen) was caused by the transfer of load through the diaphragm to the two bearing pads. In other words, the behavior resulted from the elimination of the original center bearing pad of the girder. Furthermore, the absence of continuous reinforcement near the bottom (i.e., tension face) of the diaphragm caused the splitting of the diaphragm along the cracks shown in Figure 4.20 to quickly increase in severity upon further loading. Such reinforcement is needed to restrain the cracks and provide tensile capacity in order to transfer loads to the two bearing pads. Additionally, as the test continued, the interface between the supplemental diaphragm and the original girder concrete failed (i.e., the supplemental diaphragm separated from the original girder concrete), and rotation of the diaphragm was observed, as shown in Figure 4.21(a through d). The end of the girder after the test is shown in Figure 4.21(e). Outside of the supplemental diaphragm, a diagonal crack (see Figure 4.22) initiated at a shear force of approximately 53 kips. The crack extended from the bottom of the diaphragm toward the load point at an angle of approximately 55° from the horizontal. This indicated the general orientation of compressive stresses in this portion of the member.

(a) West Side Interface

(b) East Side Interface

(c) West Side

(d) East Side

(e) Girder End

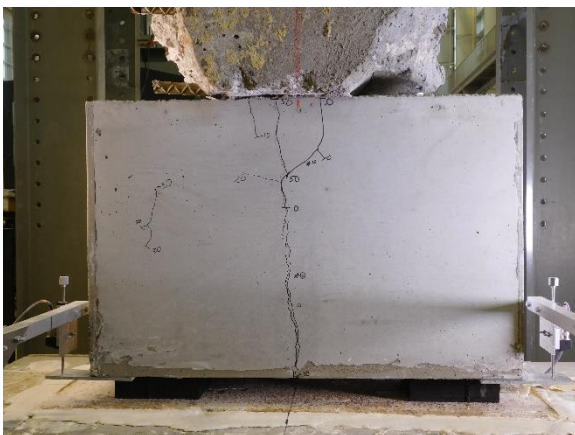
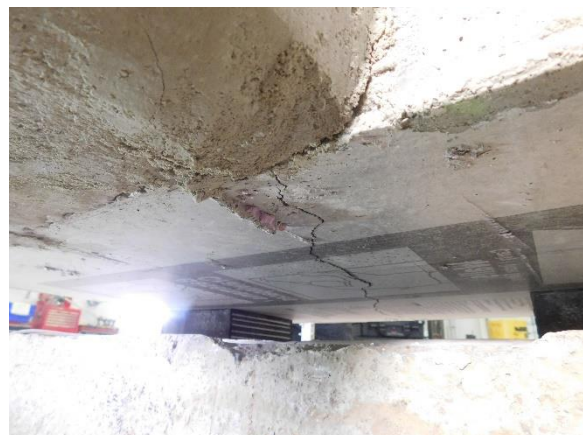
Figure 4.20 Splitting Behavior of Supplemental Diaphragm

(a) End Face of Diaphragm at Shear Force of 44 Kips

(b) Bottom Surface of Diaphragm at Shear Force of 44 Kips

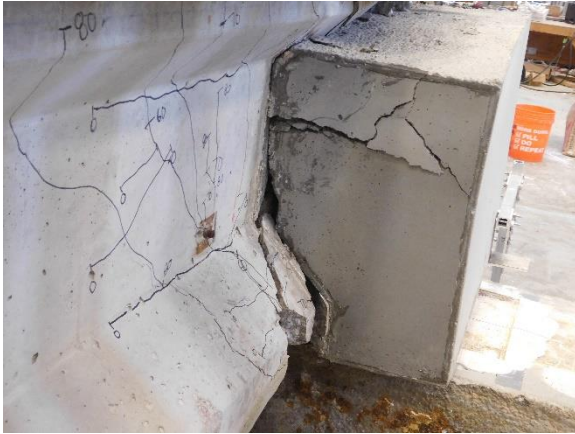
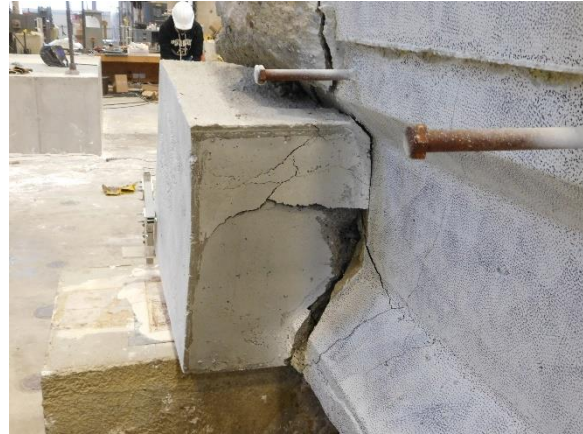
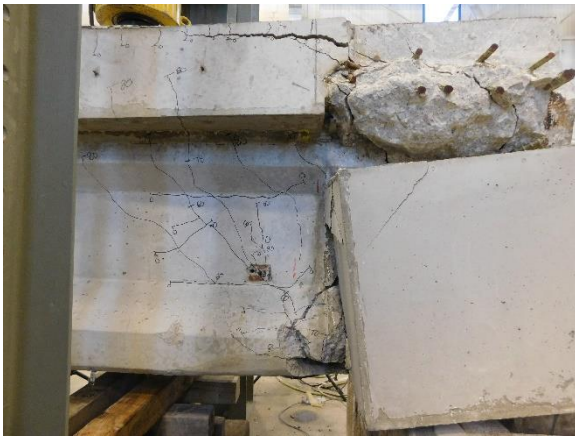
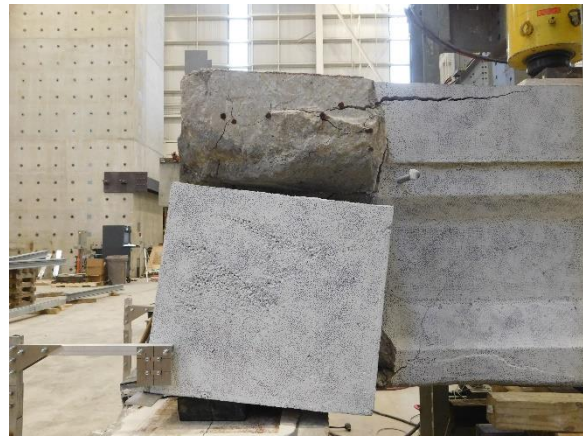
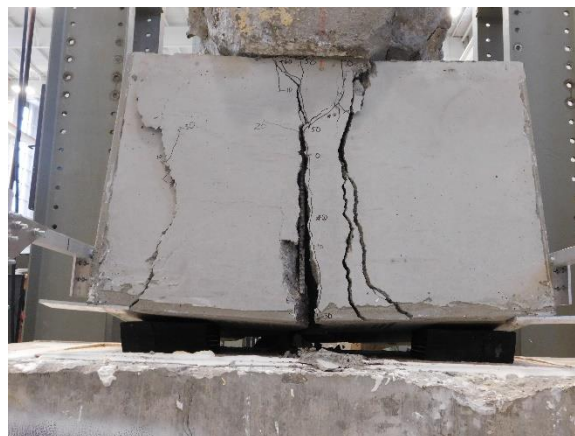
Figure 4.21 Supplemental Diaphragm Specimen After Failure

(a) West Side Interface

(b) East Side Interface

(c) West Side

(d) East Side

(e) Girder End
