CORROSION MITIGATION STRATEGIES FOR FLANGE SPLICE CONNECTIONS IN STEEL BRIDGES

A Thesis

Master of Science in Civil Engineering

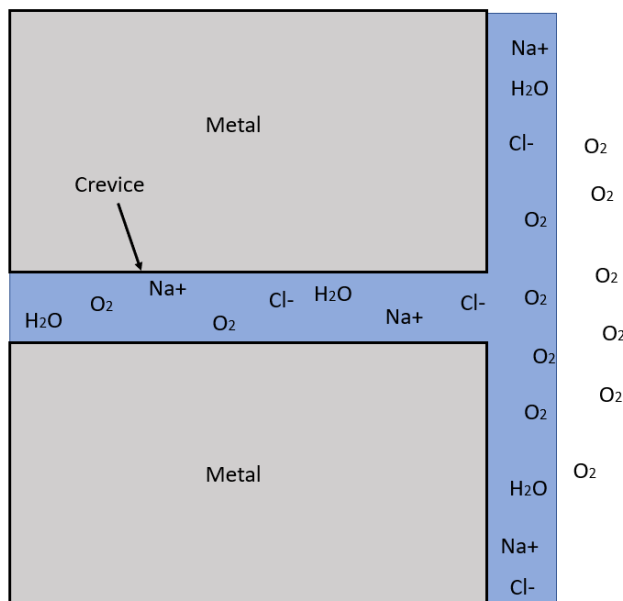
- 1) Dissolved oxygen is consumed with the metal ions at the deep portions of the crevice while the exterior has a plentiful supply of oxygen and, consequently, a differential aeration cell is formed. This differential aeration mechanism starts the corrosion process [3]. Figure 2.1 illustrates the first stage.

Figure 2.1. First stage of crevice corrosion.

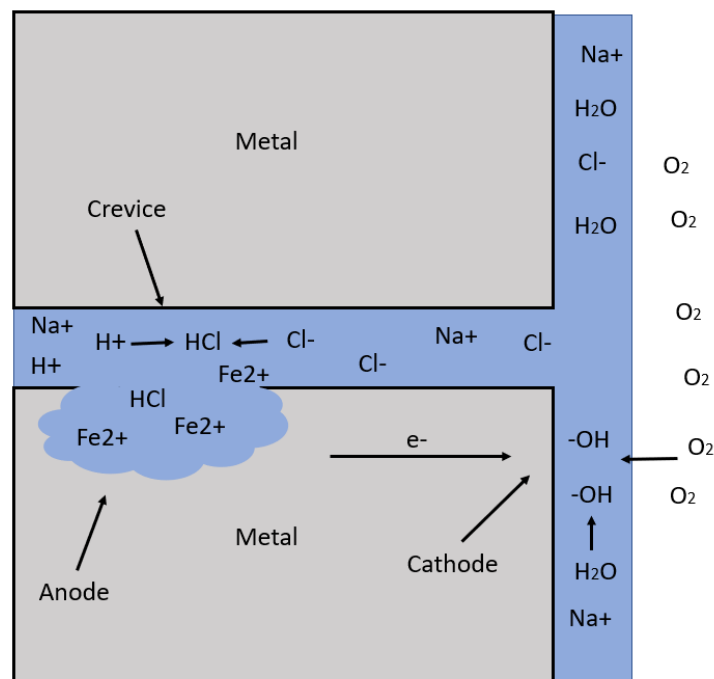
- 2) Inside the crevice, the metal goes under anodic dissolution where the metal loses an “n” number of electrons. These metal ions combine with the anions from the salts to go under hydrolysis and form hydrochloric acid (HCl) and consequently the pH in the deep crevice is low (acid). The increasing concentration of this acid speeds up the rate at which more electrons are scraped off and this phenomenon dissolves more metals into ions plus hydrogen gas (H_2). In the exterior of the crevice, the oxygen, water, and the electrons combine to form hydroxyl ($-OH$) and, consequently, the pH becomes neutral or basic [4]. Thus, since the metal is releasing electrons and these are moving towards the mouth of the crevice, an electric dipole is formed, where the deep portion of the crevice becomes the anode (negatively charged) and the mouth of the crevice becomes the cathode (positively charged). Figure 2.2 illustrates the second stage.

Figure 2.2. Second stage of crevice corrosion.

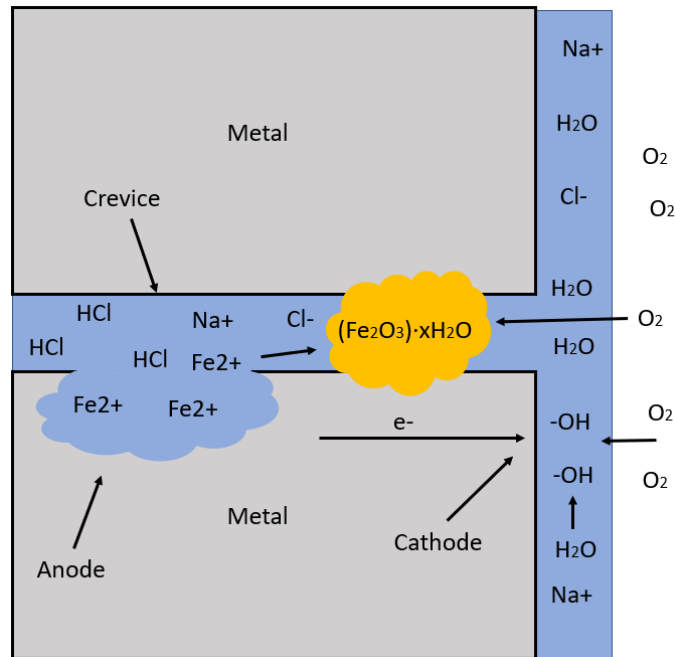
- 3) There is a constant electron movement and current, which forms a potential difference across the crevice. These electrons move from the anode to the cathode under a repeating cycle, while pack rust is formed at the mouth of the crevice due to the reaction of metal ions with oxygen. Figure 2.3 illustrates the third stage.

Figure 2.3. Third stage of crevice corrosion.

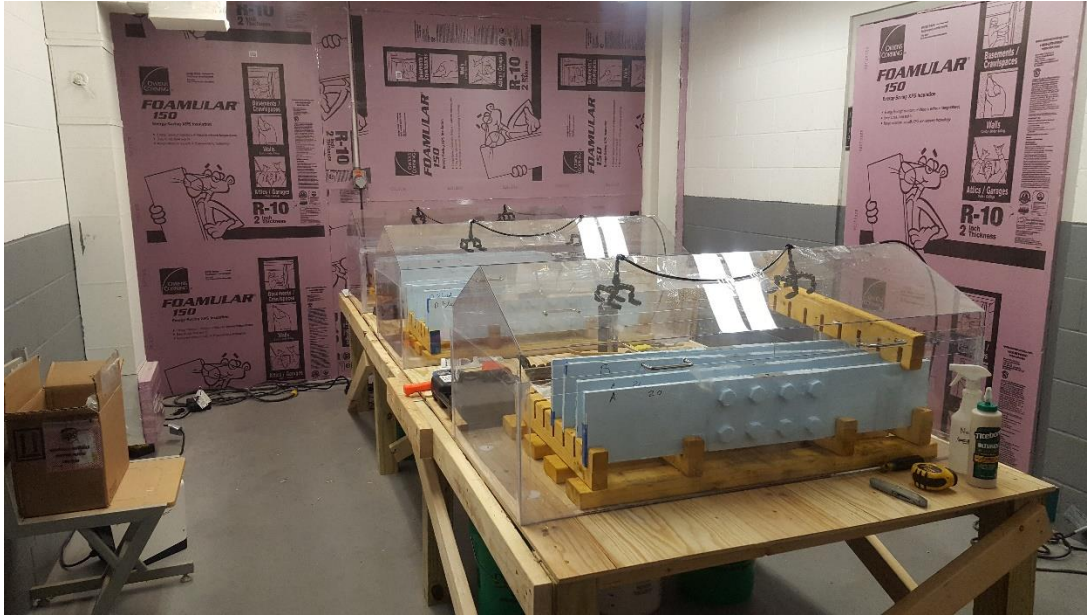
The first task of the experimental program was to create a corrosive environment so that the mitigation strategies could be tested for different periods of time and circumstances. The testing room temperature requirements were based on ASTM B117-18. The room was isolated with 2-in isolation foam sheets on the exterior wall and any opening that could lead to heat loss. At the beginning, two 5100 BTU industrial heaters and temperature controllers were employed to maintain temperature requirements. Nevertheless, during the cold months some modifications were implemented due to the difficulty to keep the temperature requirements. First, a third heater was incorporated in the testing room. Second, the encapsulating space of the specimens was reduced by building a frame around the table containing the specimens and wrapping the frame with plastic sheets.

Figure 4.1. Initial set up of the testing room.

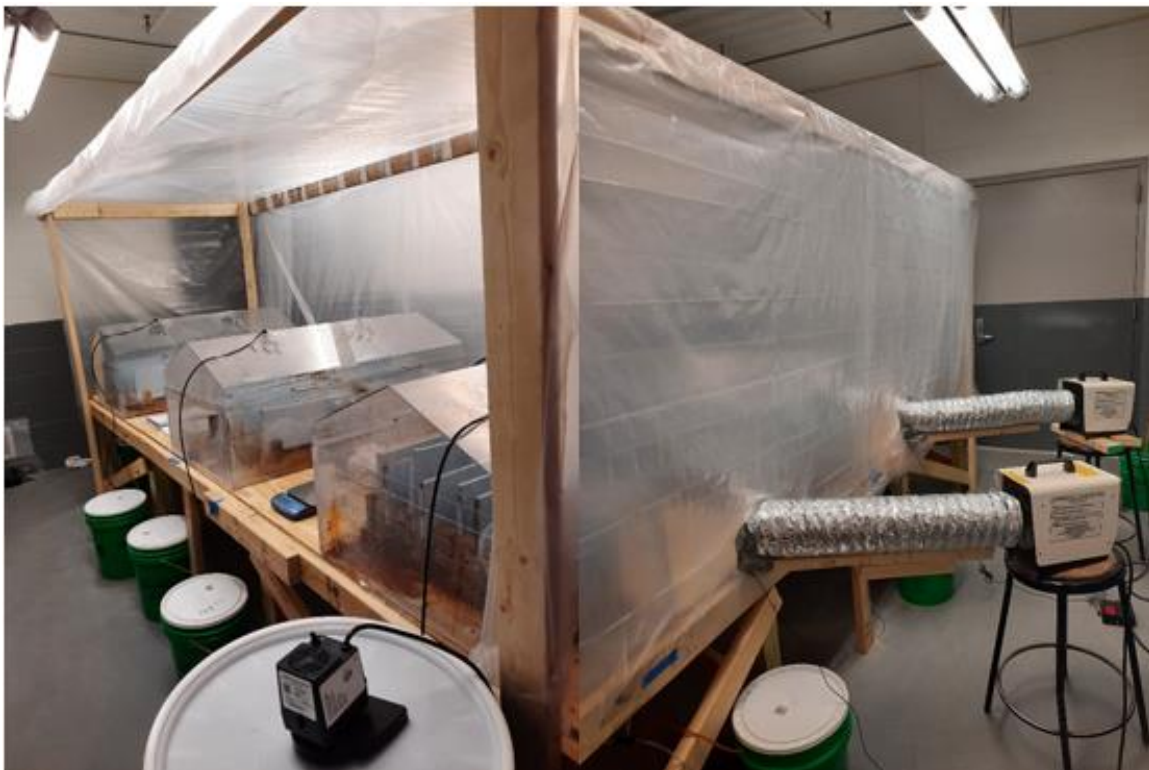
Figure 4.2. Modified set up of the testing room.

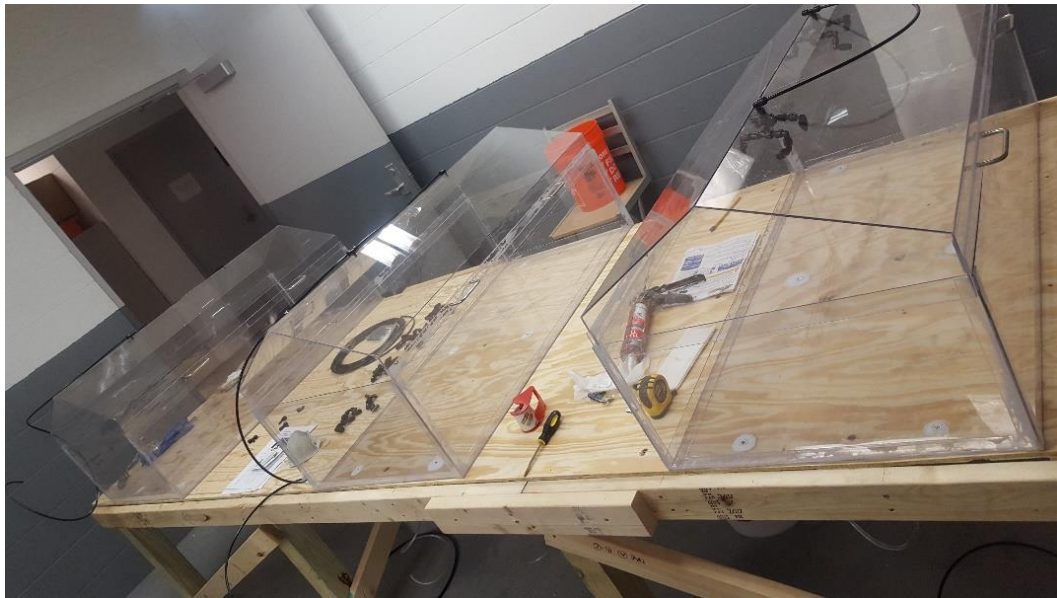
Three Lexan boxes were used to store the steel specimens during the accelerated corrosion test. Each one of these boxes is capable of handling 8 specimens at a time. The dimensions of these boxes are 24 inches wide, 48 inches long and 20 inches tall. Each box contains six ½ inch diameter drain holes to let the residual solution escape for collection and disposal. Also, two 9/32-inch diameter holes were placed in the roof to secure the atomizers, and provide access for the supply tubes.

Figure 4.3. Lexan boxes.

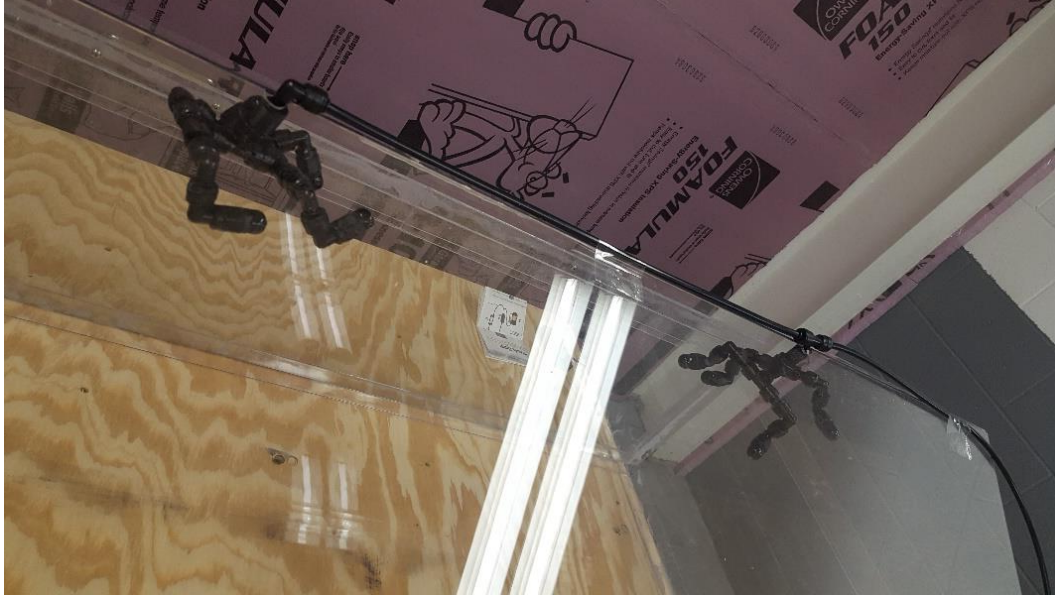
Figure 4.4. Roof of Lexan boxes holding the atomizers.

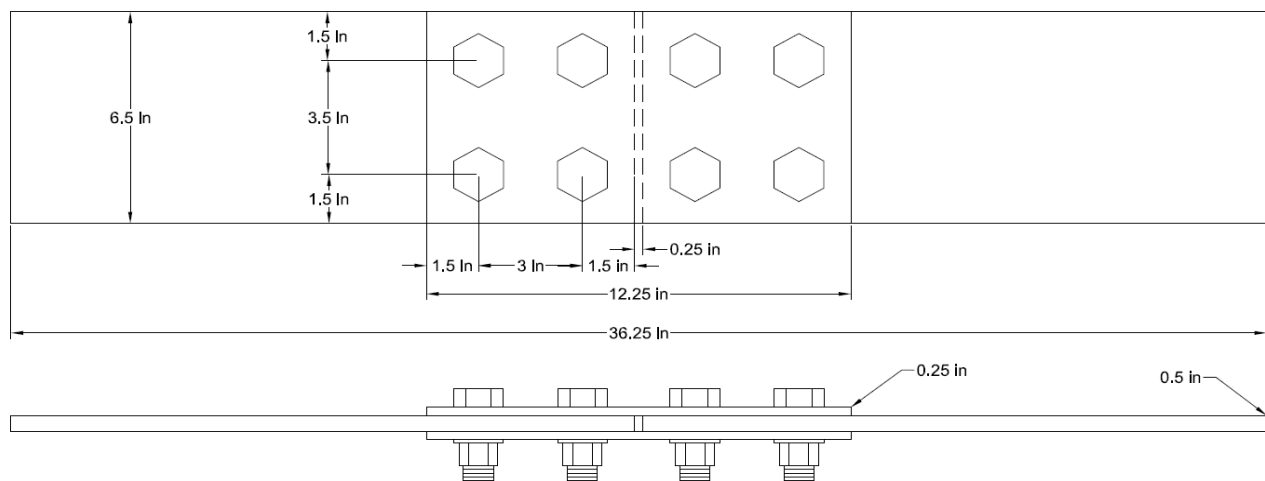
Figure 4.5. Dimensions of the 1/4 in. gap splice connection specimen.

The geometric detailing is shown in Figure 4.5 and Figure 4.6. The diameter of standard holes was determined to be 15/16 in. since 7/8 in. bolts were used in this project. The center-to-center distance between bolts is three inches for both the 1/4 in. and the 1/2 in. gap specimens. Finally, the minimum edge distance was 1.5 inches and 1.375 inches, respectively, for the 1/4 in. and the 1/2 in. gap specimens. Both types of specimens met the minimum distance requirements per the standards [8]. Bolts, nuts and washers meet the requirements and recommendations of ASTM F3125/3125M, A563, and F436/F436M, respectively [30] [31] [32]. The following elements were used in the specimens:

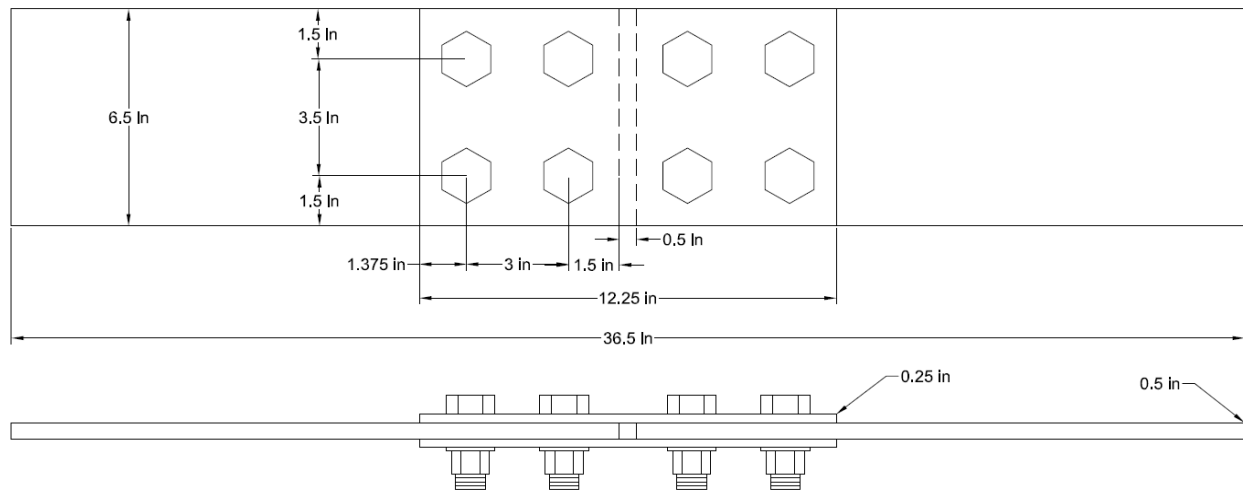
Figure 4.6. Dimensions of the 1/2 in. gap splice connection specimen.

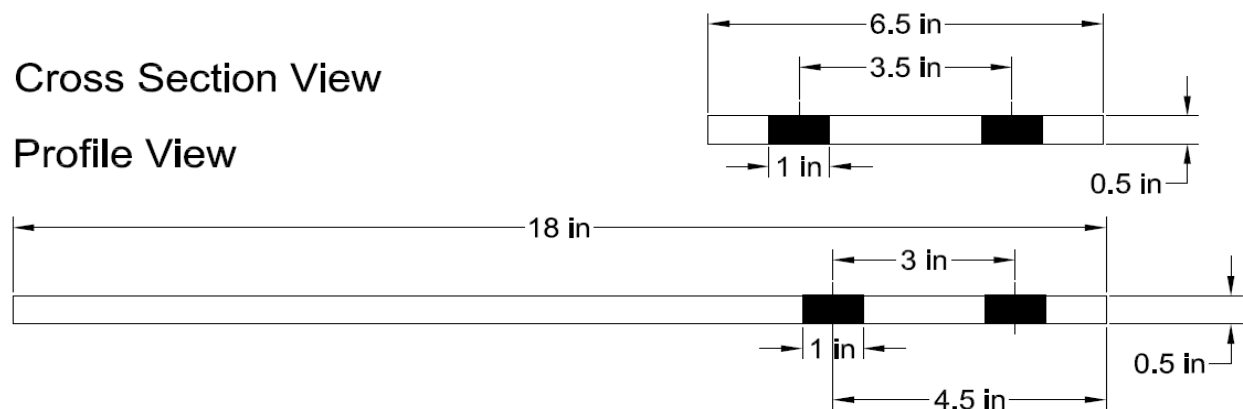
Figure 4.7. Typical cross section and profile of middle Plates.

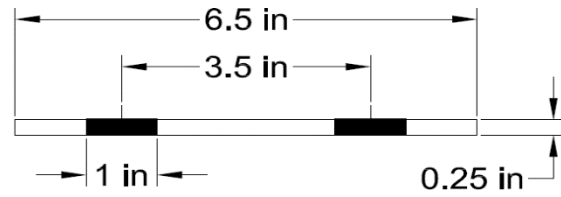
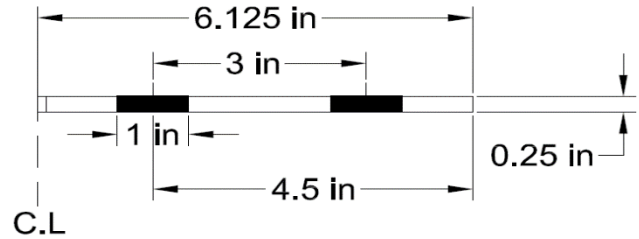
Figure 4.8. Typical cross section and profile of splice plates.

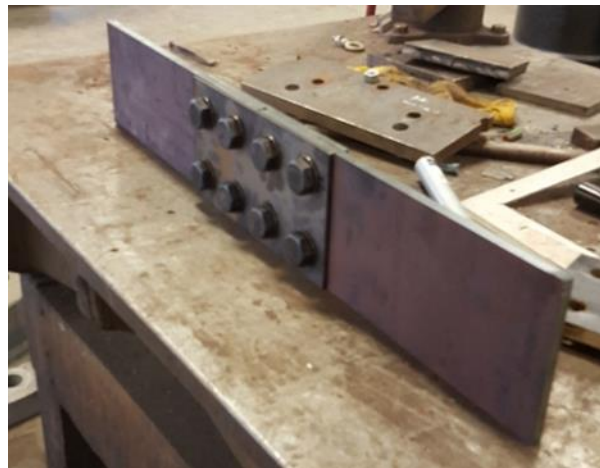
Figure 4.9. Uncoated specimen.

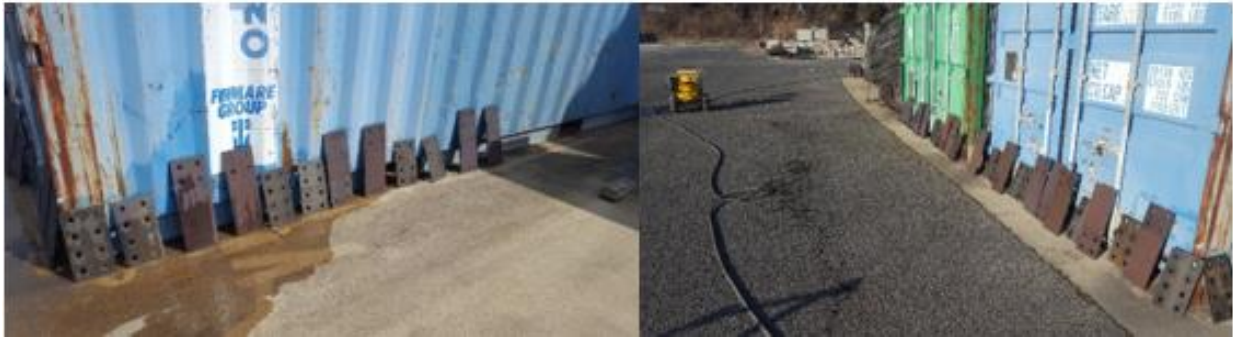
1. In order to remove the dust and mill scale in a more time efficient way, the plates were pressured washed at 3800 psi. They were placed in a vertical position to let the water run downwards and avoid puddles of water. The pressure wand was at a distance of 6 to 12 inches from the plate and the angle of the nozzle was 15 degrees.
2. After the plates dried, Klean Strip Acetone was applied with rags to remove paint stains, remaining dirt, rust stains, and any oily substance from the surface. Each plate was wiped with acetone at least twice.
3. Finally, the plates were brushed with a stiff bristle brush to remove any dust and cotton left from the rags. Once they dried, they were ready to be painted.

Figure 4.10. Plate's dirt removal with a 3800-psi pressure washer.

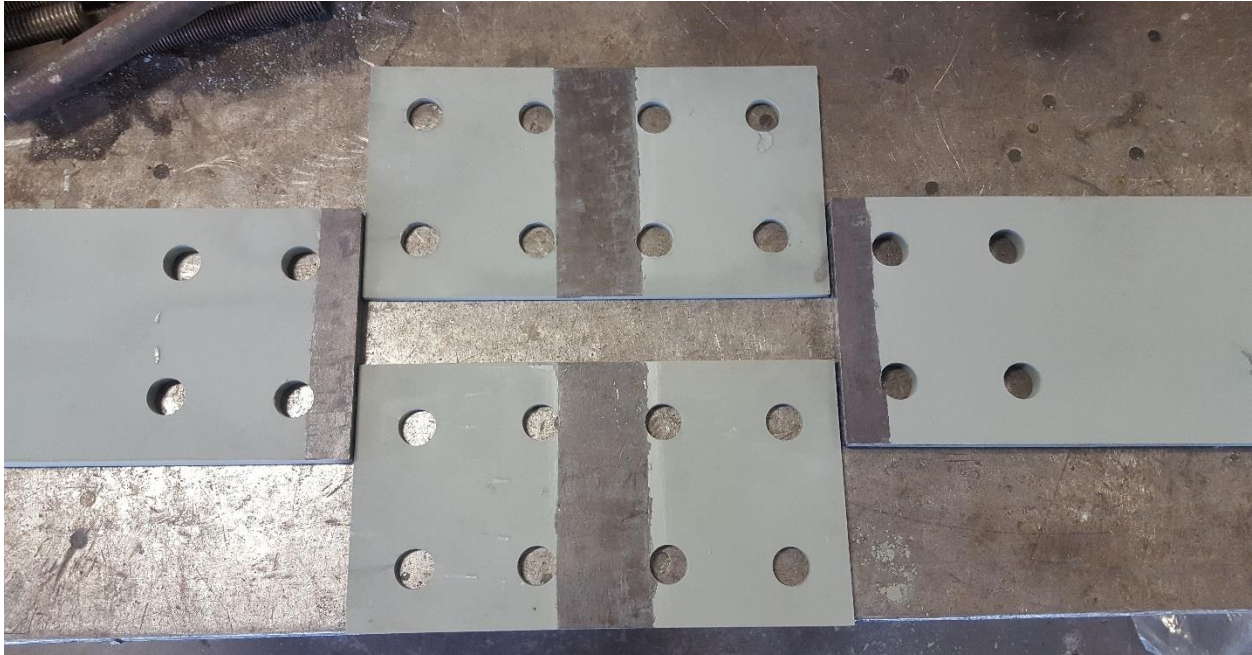
Since the goal of the project is to assess different approaches that can mitigate pack rust, a strip of approximately 3 inches along the length of the crevice was not coated to isolate the portion of the specimen being studied (Figure 4.11). The gap was left as bare steel to accelerate corrosion in that part of the specimen. The rest of the specimen was painted with the 3-coat system. It should be noted that the normal practice for bridges in Indiana is to apply the primer coat in the shop, and then the intermediate and top coats are applied in the field after the bridge is erected. Consequently, the gap region of the splice connection would normally contain the primer coat only. The difference for the test specimens was that the gap region was not coated at all to help accelerate the development of corrosion in the gap region.

Figure 4.11. Portion of the specimen being isolated for accelerated corrosion.

1. Approximately, three mils of the Zinc primer were applied on the steel plates except on the areas isolated with duct tape (Figure 4.11). The zinc primer was applied with a spray gun and with brush. After the primer dried, the thickness of the primer was measured with a DFT gauge (Elpidan E200). Measurements were performed on four different randomly selected spots on each one of the four plates of the specimens, and averages were computed.
2. After measuring the thicknesses, the plates were assembled and the bolts were tightened using the Turn-of-Nut bolting method.
3. Approximately, four mils of epoxy were applied on the splice connections except on the areas covered with tape to avoid coating seeping into the gap. This coating was applied

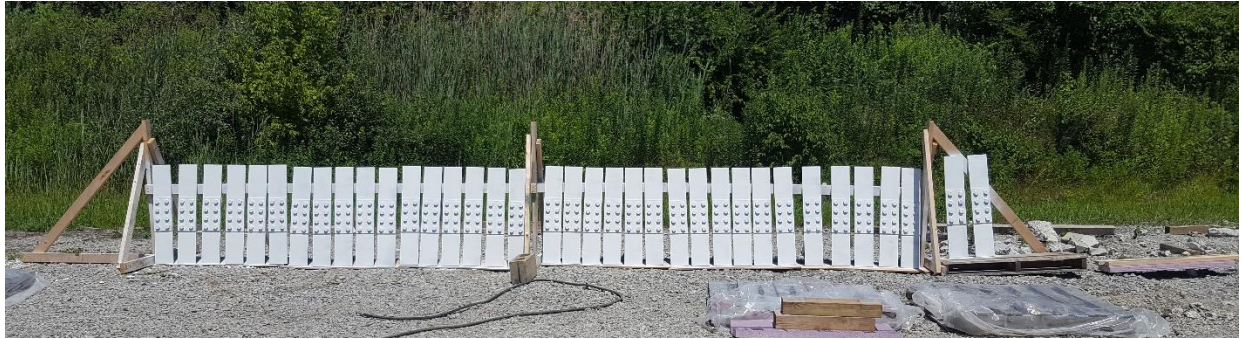
Figure 4.12. Application of epoxy layer.

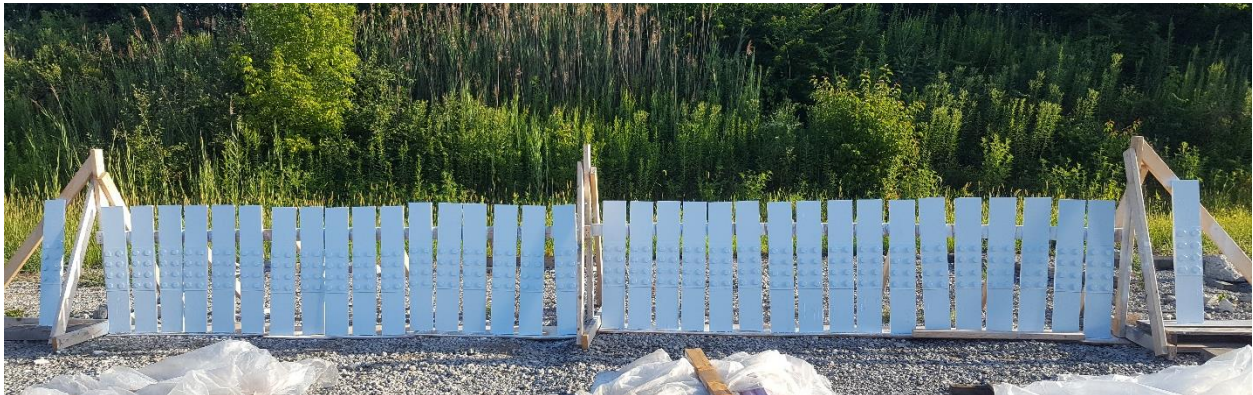
4. Finally, approximately three mils of polyurethane were applied with a brush on the splice specimens except on the gap areas covered with tape. Similarly, dry film thicknesses were measured after the layer dried.

Figure 4.13. Application of polyurethane layer.

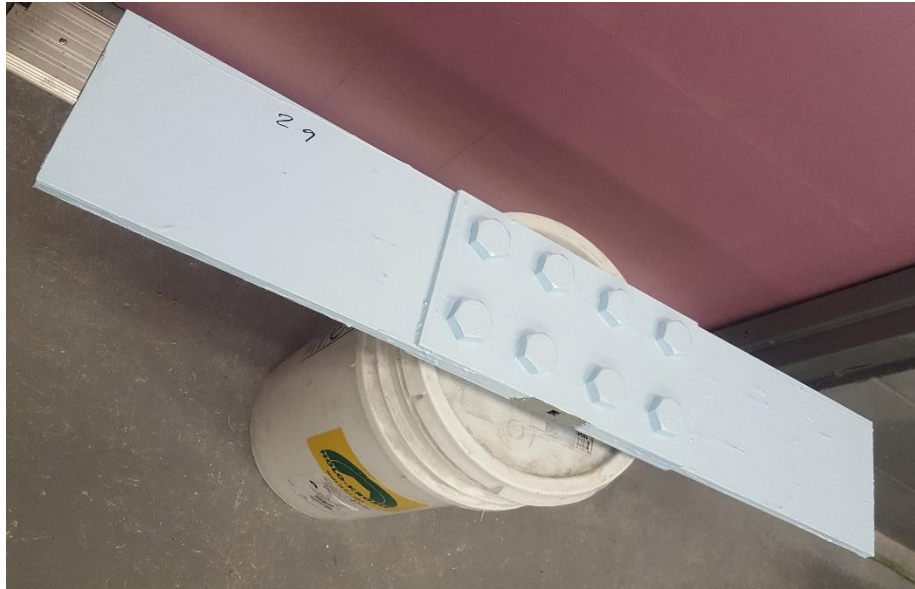
Figure 4.14. Final coated specimen

Figure 4.14 shows the final product after the application of the coating system. Moreover, the area outside the gap was only painted with zinc primer as shown in Figure 4.15. Table B.2 shows the coating thickness information for each one of the specimens.

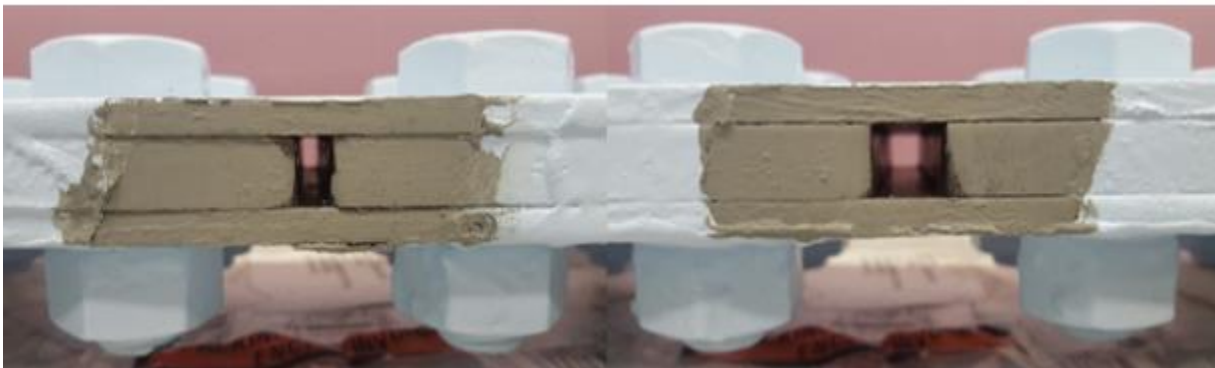
Figure 4.15. Close up image of the 1/4 in. gap specimen and 1/2 in. gap specimen.

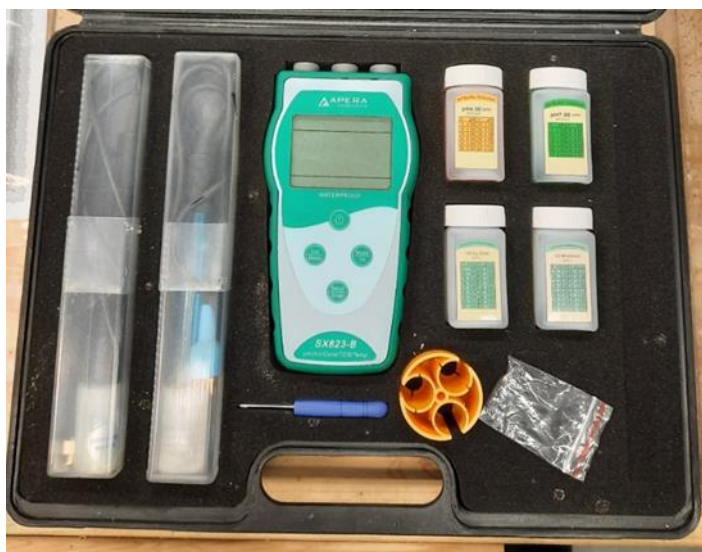
Figure 4.16. SX823-B portable multi parameter meter.

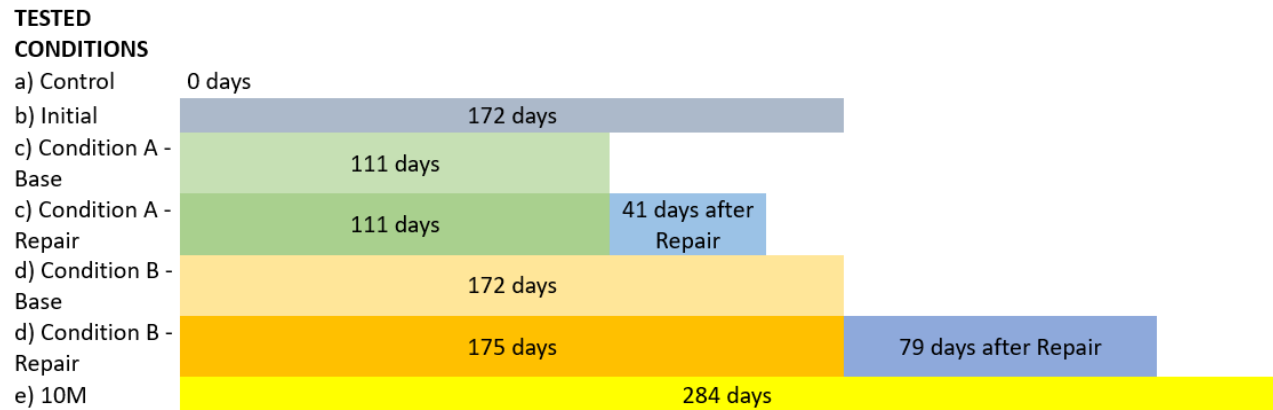
Figure 4.17. Conditions Tested.

The following lines describe the different tested conditions. Figure 4.17 helps to visualize the different conditions tested in this experiment.

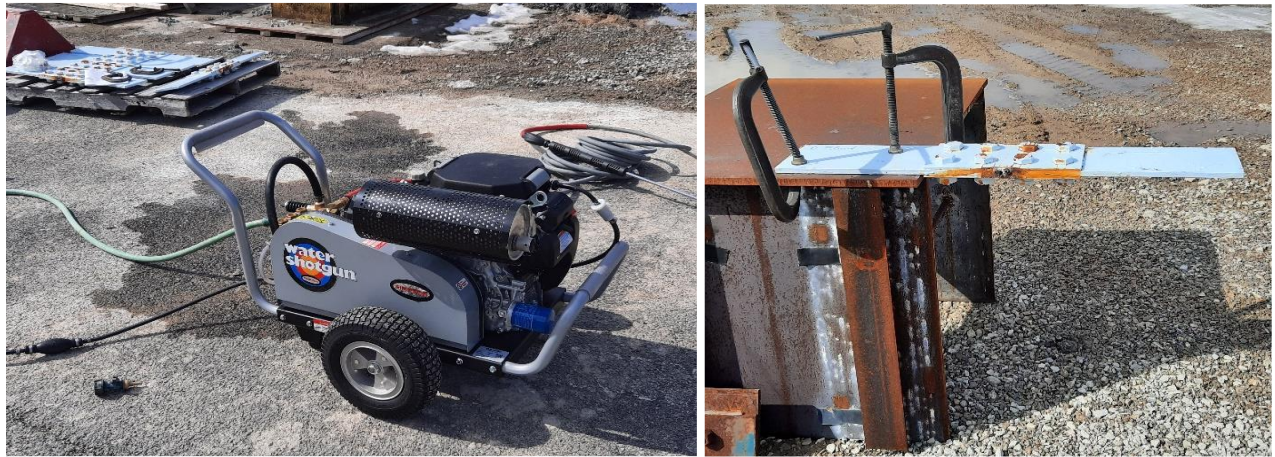
For Condition B specimens, this mix was sprayed and poured into the crevice due to technical difficulties with the pressure washer. For Condition A, the specimens were pressure washed with the mix without any problem. At least for this project, results seem not to be affected by the difference in the application of Chlor*Rid. After pressure washing, the crevice of the specimens was dried with compressed air while the areas surrounding the mouth of the crevice were dried

Figure 4.18. Pressure washer and pack rust removal set up.

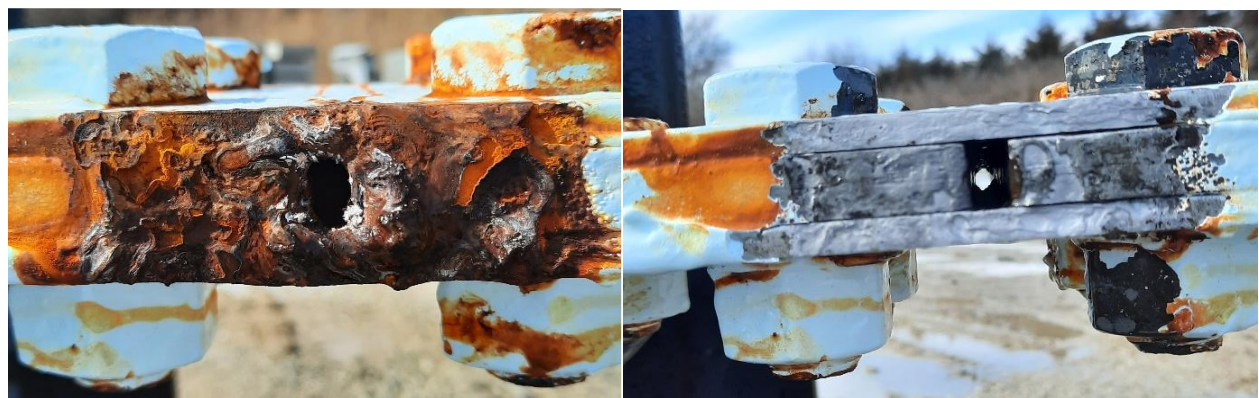
Figure 4.19. Surface and gap condition before and after pressure washing the connection.

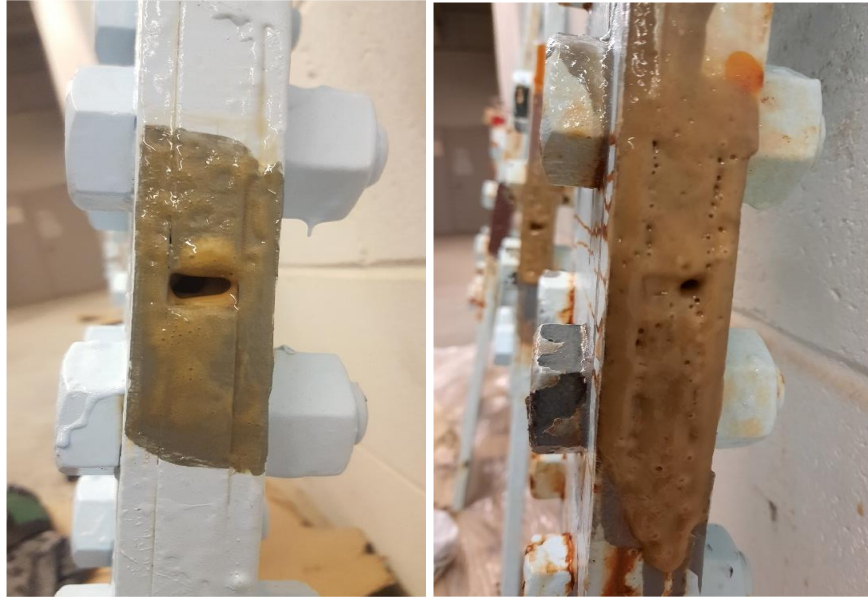
Due to the size of the areas being treated, aerosol cans were used to apply this product. This spray has a 5 to 6 in. long wand which makes the application easier. To apply the product, the wand was inserted into the gap and the product was applied until it would overflow. This was done to make sure the product was applied over the entire inner surfaces. Then, the specimens were turned upside down to apply the product in the same way, but on the other end of the gap. Additionally, fluid film was applied on the surfaces surrounding the mouth of the gap. In most cases the gap was sealed during the application of the product, but the thin wall sealing the gap would break during or after curing.

Figure 4.20. Fluid Film application for initial and repair condition.

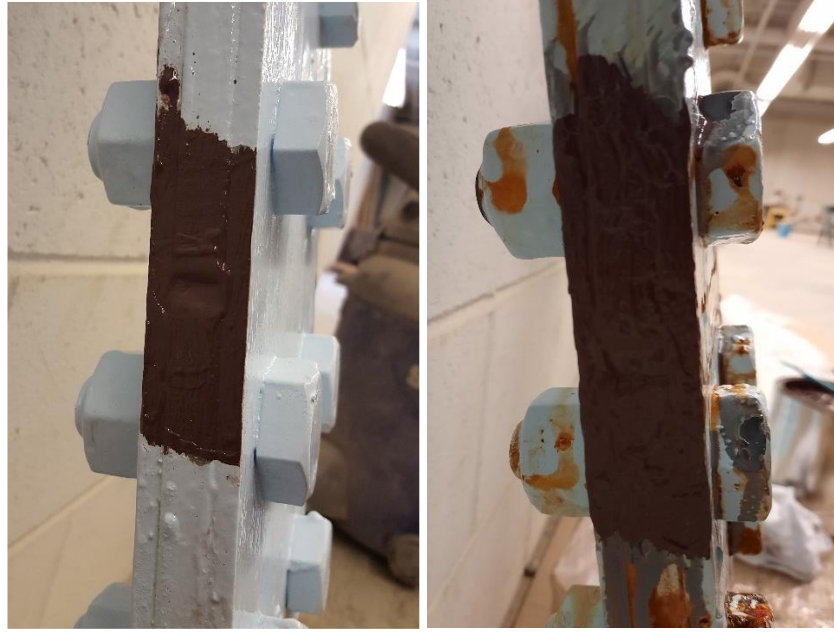
Termarust was applied in a manner similar to Fluid Film. A syringe was used to insert 30 milliliters of penetrating sealer TR 2200HS into the gap and between the overlapping surfaces. This penetrating sealer was applied from both ends of the gap until it would overflow on the opposite end (giving a total of 30 milliliters usage). Same procedure was used to insert 10 milliliters of TR 2100 (topcoat) into the gap, but due to the high viscosity of the topcoat material, full coverage of the inner surfaces was not guaranteed. Finally, the topcoat was applied with a brush on the areas surrounding the mouth of the crevice. The gap of the specimens was typically sealed during brushing, but throughout or after curing it would open up.

Figure 4.21. Termarust application for initial and repair condition.

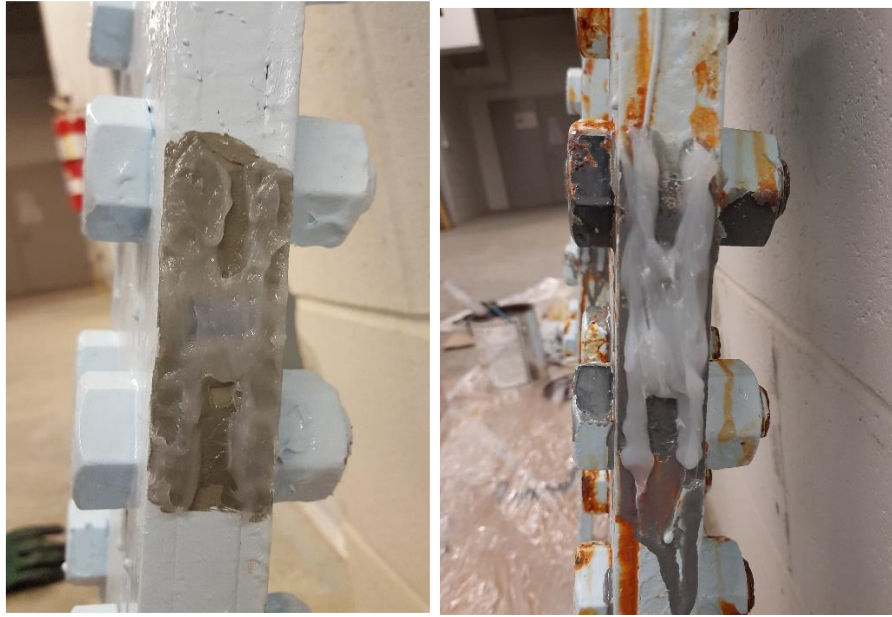
Using a caulking gun, GE Silicone caulk was applied along the interfaces of the overlapping plates close to the mouth of the gap. Additionally, a small amount of caulk was pushed into the gap to create a small barrier between the mouth of the gap and the inner portion of it. The thickness of the bead was approximately $\frac{1}{4}$ in.

Figure 4.22. Caulk application for initial and repair conditions.

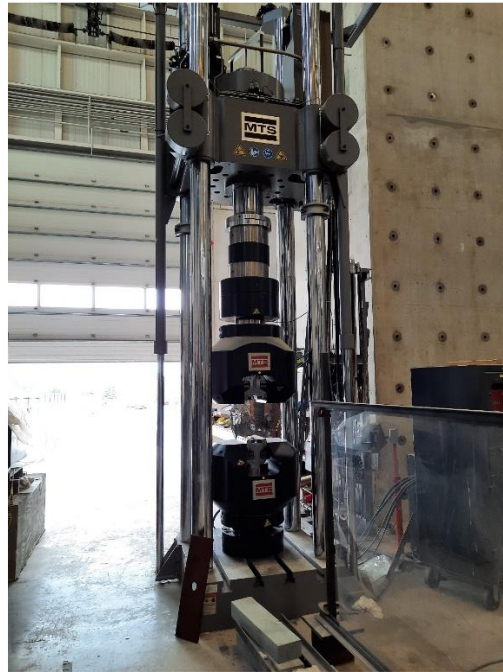
Figure 4.23. MTS machine used for strength testing.

These tests were performed to determine the tensile strength of the splice connection specimens at different pack rust conditions. Estimating the level of strength deterioration due to pack rust is an important parameter to study since it can help to approximate the remaining service life of a structure and to anticipate any unsafe event. Usually, it is expected to have a decrease in strength in the structural element when it goes under the effects of corrosion because of the loss of cross section. Moreover, in the case of a bolted connection, excessive pack rust that exhibits bulging can create high pressure and exert tensile or pulling forces in the direction normal to the plates, which can lead to bolts coming off. For this test, a 700-kip MTS machine was used to pull the plates to failure. The load rate for the load control portion of the test was 10 kip/min until a load of 80 kip was reached. After this, the test was switched to displacement control with a rate of 0.1 in/min. Two points of interest were obtained from the load vs displacement plot: a) Load at slippage and b) Ultimate load. Load at slippage is the load at the early stages where significant displacement is

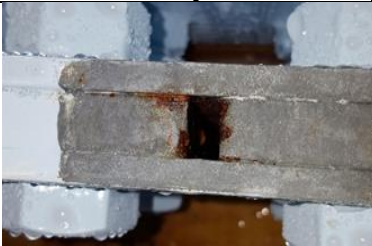
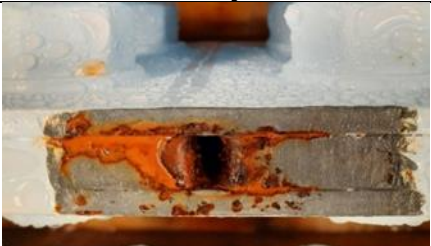
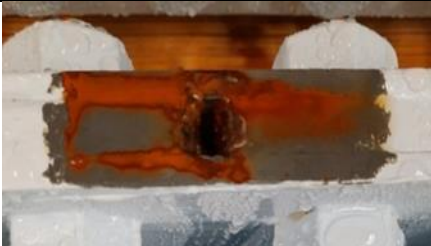
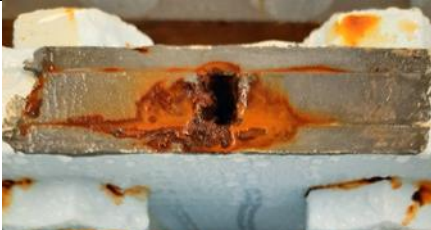
Table 5.2. Comparison of corrosion stages for non-treated specimens.

Condition/ Specimens	Time of exposure			
	0 days	7 days	60 days	90 days (Splices Flipped)
Control (3,13,14,15) A Base: 1,2,5,6. Specimen 5 shown in the pictures.

B Base: 7,8,9,10. Specimen 8 shown in the pictures.

10M: 18,19. Specimen 19 shown in pictures

Remarks	Specimen has not been exposed to corrosion.	Small corrosion staining and rust dots are observed mostly inside the crevice.	Corrosion staining is mostly happening at the interface of the plates and near the mouth of the gap. Inside the gap, small bumps are observed.	Corrosion spread over the surrounding area of the mouth on the top ends (top images). More corrosion and “spikes” formed on the bottom gap end.

Table 5.2 shows the development of corrosion on the Base and 10M specimens at different points in time. Additionally, Table 5.3 shows the cross section of the specimens at different stages. The control specimens show no corrosion formation since they were not exposed to misting. Condition A specimens exhibit orange/yellow and black rust. Iron oxide-hydroxide ($\text{FeO}(\text{OH})\text{H}_2\text{O}$) is the orange/yellow type of rust and it is produced as a result of high moisture content [42] [43]. On the other hand, iron (II) oxide (Fe_3O_4) is a black colored corrosion product, also known as magnetite,

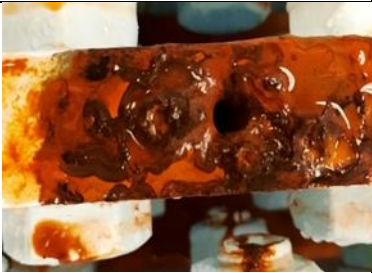
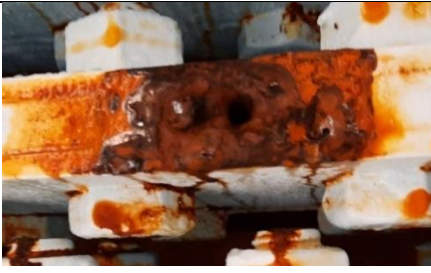
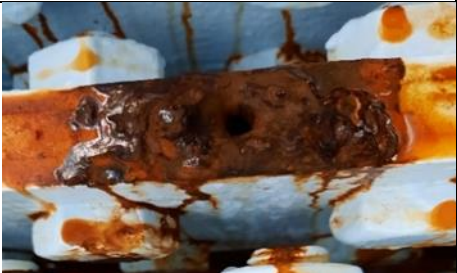
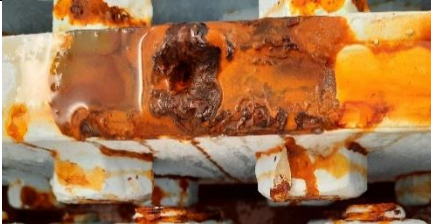
Table 5.2. Continued.

Condition/ Specimens	Time of exposure			
	111 days/Testing Day	120 days	165 days	172 days/Testing Day
A Base: 1,2,5,6. Specimen 5 shown in the pictures.

B Base: 7,8,9,10. Specimen 8 shown in the pictures.

10M: 18,19. Specimen 19 shown in pictures

Remarks	Built up material was present on the surface surrounding the mouth of the gap. The gap was completely sealed so it was not possible to see through it.	The gap is completely filled for all specimens. Swelling edges are observed at the middle of the splice plates. Slight bulging seems to start for some specimens.	Very small change in bulging and corrosion formation was observed with respect to the last stage.	No change was observed with respect to the last stage.

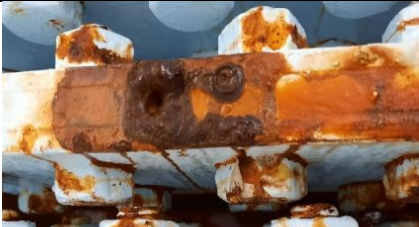
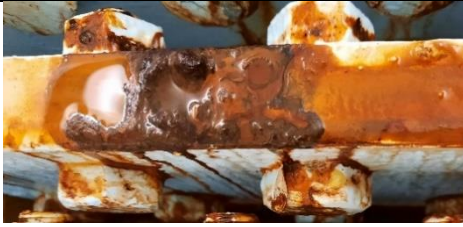
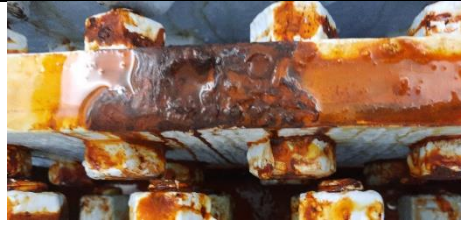
Table 5.2. Continued.

Condition/ Specimens	Time of exposure		
	210 days	240 days	284 days/Testing Day
A Base: 1,2,5,6. Specimen 5 shown in the pictures.			
B Base: 7,8,9,10. Specimen 8 shown in the pictures.			
10M: 18,19. Specimen 19 shown in pictures

Remarks	Rate of corrosion formation seemed to decrease since not much change is observed for a long period of time.	Salt solution is stagnant at the mouth of the crevice. A slight increase of bowing of the plates is observed.	No significant change is observed in the specimens. A slight increase of bowing of the plates is measured.

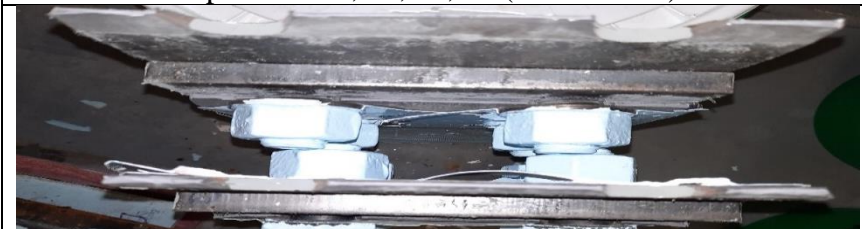
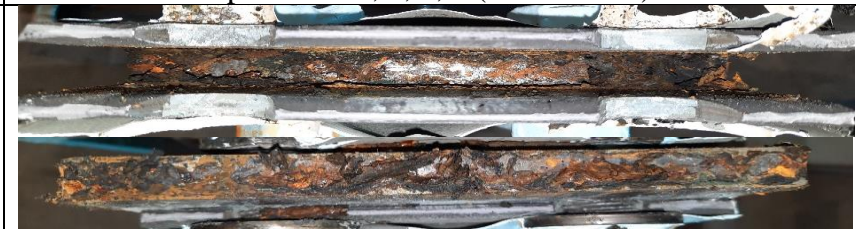
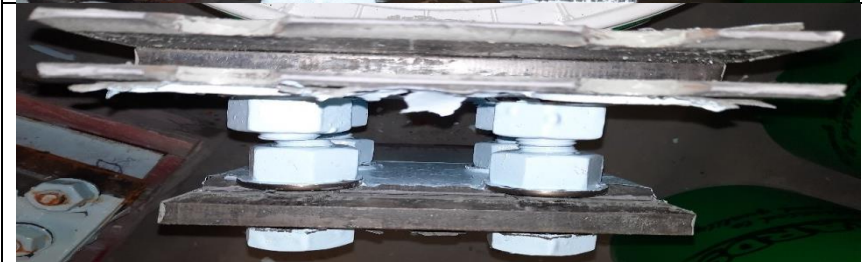
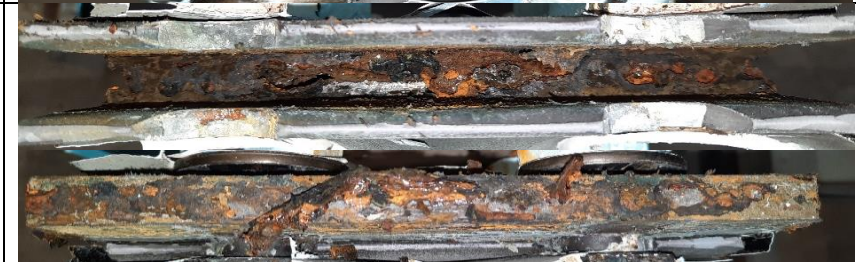
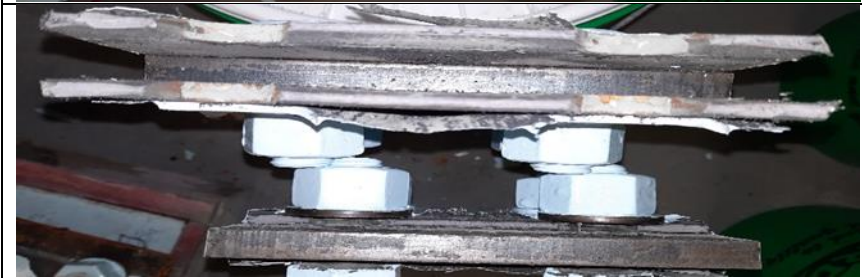
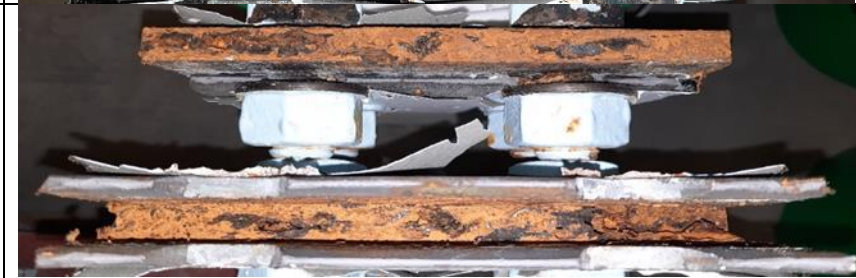
Table 5.3. Rust formation in the cross section of non-treated specimens.

Condition/Time of exposure	
Control/0 days	A Base/111 days
Specimens 3, 13, 14, 15 (Downwards)	Specimens 1, 2, 5, 6 (Downwards)

and it is produced due to an environment with limited oxygen [3] [44]. The black rust was mostly observed in specimens 1 and 2, meaning that the gap was sealed by the time they were tested for strength. Conversely, specimens 5 and 6 show more orange/yellow type of rust, meaning that oxygen was able to travel through the gap. The difference between these two sets of specimens is related to the corrosion formation rate. Specimens 1 and 2 sealed faster than specimens 5 and 6, allowing black rust to form quicker and in more quantities. The pH of the collectors was found to be lower during the second period of misting (January 9th, 2021 to June 21st, 2021). Specimens 1 and 2 were placed in the chambers during this period. In accordance with the theoretical review, high concentrations of hydrochloric acid and low pH increase the corrosion formation rate. The pH measurements are attached in the appendix section.

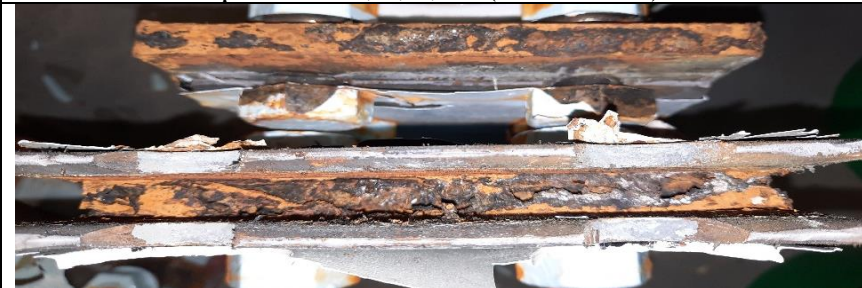
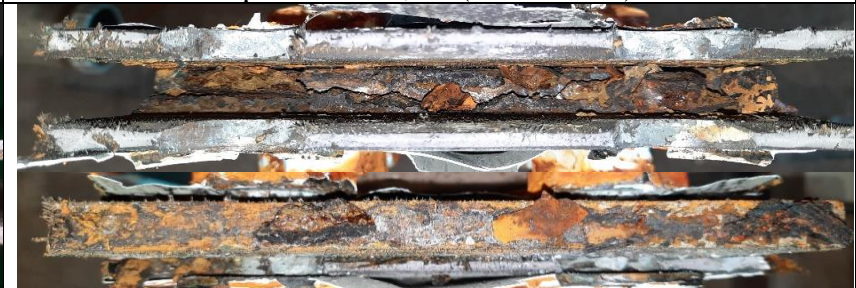
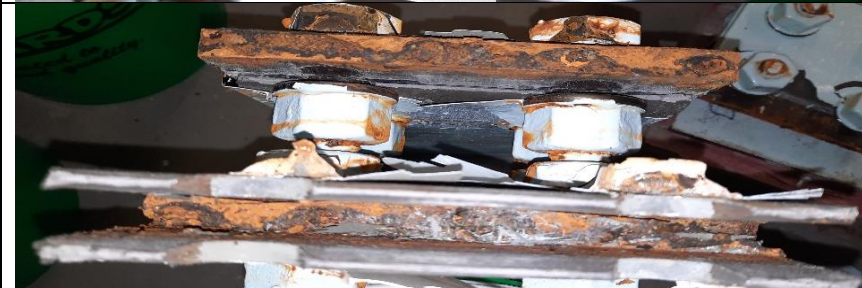
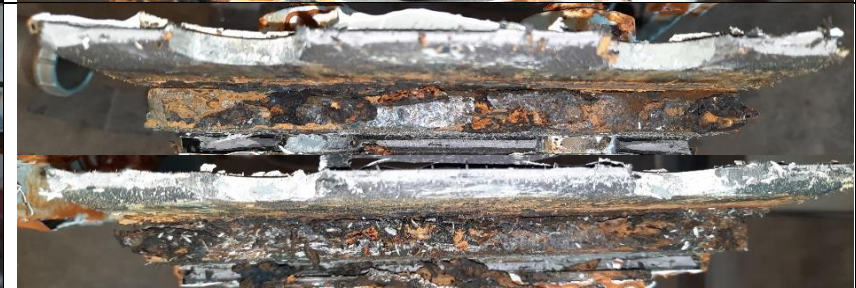
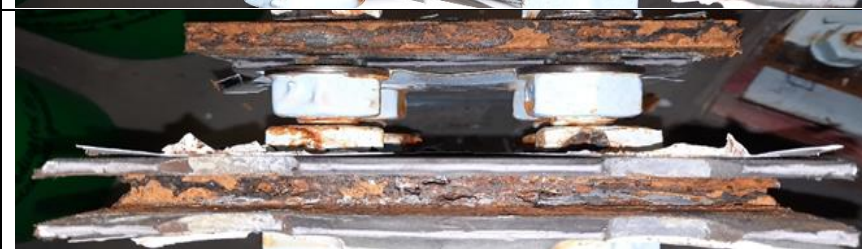
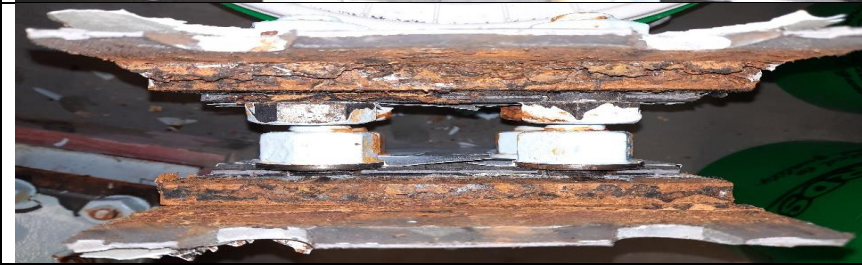
Table 5.3. Continued.

Condition/Time of exposure	
B Base/172 days	10M/284 days
Specimens 7, 8, 9, 10 (Downwards)	Specimens 18, 19 (Downwards)

Specimens that reached condition B (7,8,9, 10) showed a similar pattern in the rust formation along the cross section when compared to condition A (5, 6). These six specimens were placed in the chambers during the first period of misting (August 12th, 2020 to December 16th). The only difference for condition B specimens is that the orange color of the rust turned darker. Specimens under condition 10M exhibited more formation of black rust, which can be attributed to longer misting exposure time and “sealed” time (i.e., the time of period during misting after the gap sealed with corrosion material).

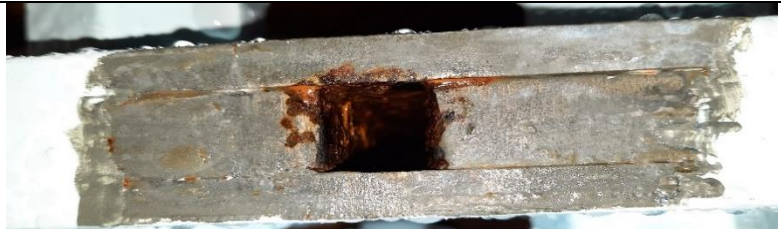
Table 5.4. Corrosion development for ½ in. gap specimens.

Time of Exposure	Specimen 32
14 days

A photograph of a metal specimen with a central gap. The metal surface is relatively clean and grey, with some minor brown staining around the gap.
1 Month

Specimens 30, 31 and 32 were half inch gap specimens exposed for a period of time to reach condition A. These specimens can be compared with the specimens with a one-quarter inch gap. In a similar way, a steady formation of rust was observed between the interface of the overlapping plates for the first three months followed by a slow corrosion formation between the third and fourth month. The orangey formation of rust around the surface of the mouth is similar to that observed for the specimens with a quarter inch gap. The only difference is the formation of corrosion inside the gap. Since there is more space for corrosion to develop, it would take more time to seal the gap. At 111 days (approximately 4 months), the gap was not sealed. This was not the case for the quarter inch gap specimens in which the gap sealed by the end of the third month. Increasing the space within the gap does not affect the corrosion rate, but it delays sealing of the gap, which can be beneficial for future maintenance practices. However, further research is required to obtain more conclusive results. Table 5.4 shows the corrosion development of one of the specimens (Specimen 32) at different points in time.

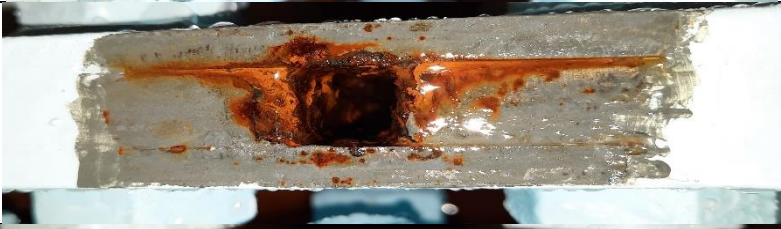
A photograph of the same specimen after one month. The area around the gap is more heavily stained with a reddish-brown color, indicating the start of corrosion.
2 Months
