CORROSION MITIGATION STRATEGIES FOR FLANGE SPLICE CONNECTIONS IN STEEL BRIDGES

A Thesis

Master of Science in Civil Engineering

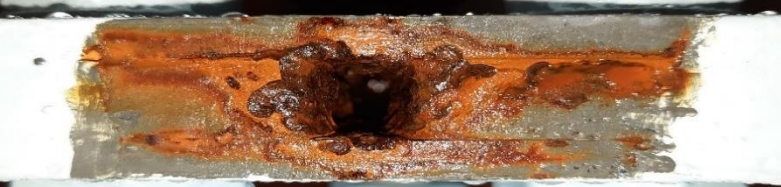
A photograph of the specimen after two months. The corrosion is more pronounced, with a larger area of reddish-brown rust surrounding the gap.
3 Months

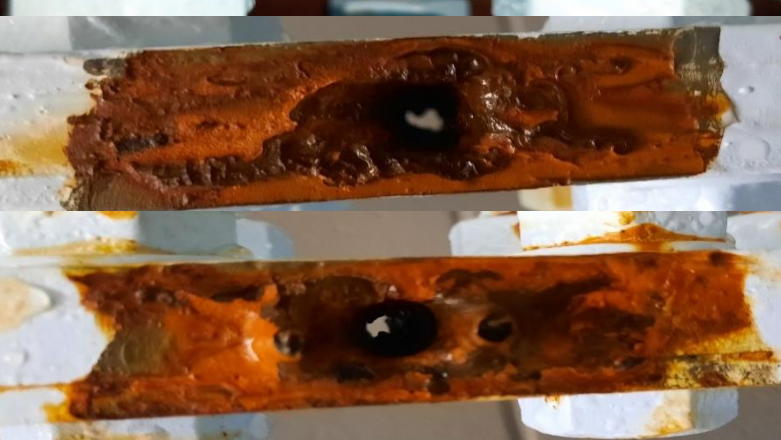
Two photographs of the specimen after three months. The top photo shows a significant area of dark, porous corrosion product around the gap. The bottom photo shows a similar view with even more extensive rusting and some yellowish staining on the surrounding metal.
4 Months

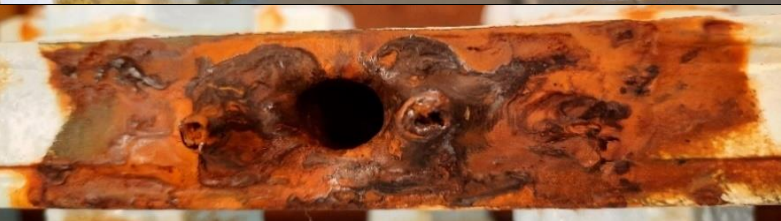
A photograph of the specimen after four months. The corrosion is very severe, with a large, dark, irregular mass of rust completely obscuring the gap and spreading across a large portion of the specimen's surface.

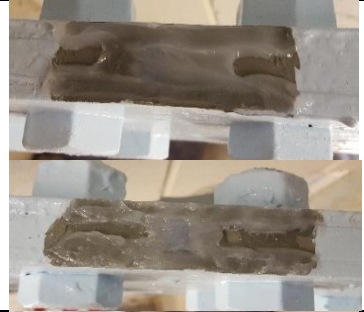
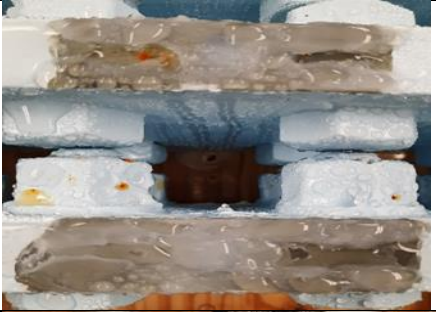
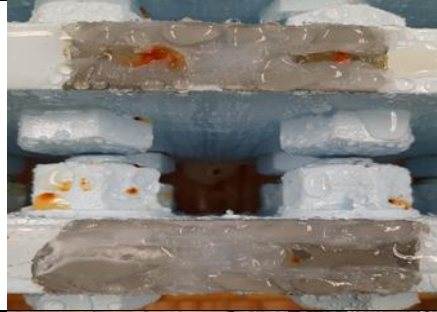
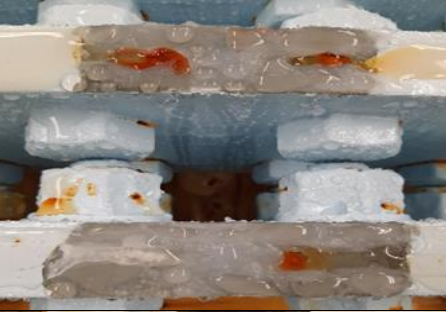
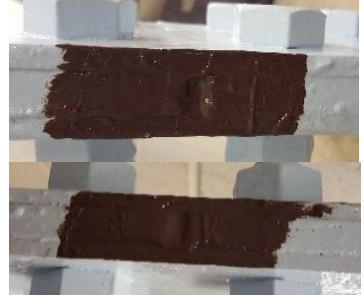
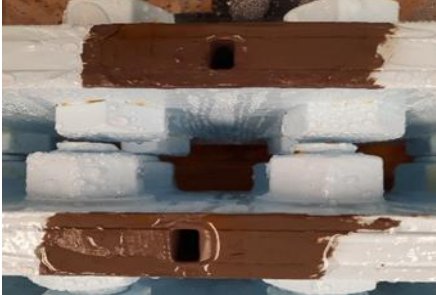
Table 5.5. Comparison between mitigation strategies for specimens initially treated.

Condition/ Specimens	Time of exposure			
	0 days	21 days	30 days	60 days
Caulk: 17 and 24 (Top).

Termarust: 25 and 26 (Top).

Remarks	The specimens have not been exposed to corrosion.	Small rust dots are formed around the caulk and on the surface of the Fluid Film specimens.	Rust dots are increasing in size, but there is no caulk deterioration. Termarust specimens have little corrosion staining. Fluid Film rust spots have not increased in size.	Rust dots are progressive, but there is no caulk degradation. Termarust staining is intensifying. Fluid film staining had a significant development over the last 30 days.

By the end of the first three weeks, small orange rust dots were visible on the Fluid Film and caulked specimens. For caulked Specimen 24, these rust spots were noticed around the caulk application area and not on the caulk. Moving towards day 30th, some visible surface corrosion is observed on all specimens that were initially treated. This surface corrosion worsened after 60 days of misting exposure, especially for the Fluid Film and Termarust protected specimens. Specimens were flipped after 90 days. Visual inspection showed that the Termarust specimens had runoff of material on the bottom end of the gap. This means that the material did not cure properly. Orange rust was observed on both ends of the gap for the Fluid Film and Termarust specimens. Additionally, small black dots were observed on the bottom end of the caulked specimens. The infiltration of moisture and lack of oxygen of the caulked-sealed gap produced the chemical conditions to form black rust. From day 120 to day 172, Termarust did not exhibit further corrosion on the surface around the mouth of the crevice. On the other hand, Fluid Film exhibited an increase in surface corrosion, which later stabilized. Furthermore, GE caulk did not show signs of deterioration or discoloration by the end of the exposure period.

Table 5.5 shows the corrosion development over time while Table 5.6 shows the cross-section photographs of the specimens. For the caulked specimens, the surfaces inside were in good condition. Only small staining and some dark spots are observed. For the Fluid Film specimens, the wax material of this mitigating product worked as a sacrificial layer. The photographs showed an orange material similar to rust. However, opposite to rust, this material is not “crunchy” and can be easily removed with rags. The wax seemed to absorb the acidic solution and to turn orange due to rust staining. For Termarust, two different scenarios were present. One of the specimens (25) was effectively protected by the combination of the penetrating sealer and the topcoat while the other (26) suffered severe corrosion. The failure of Specimen 26 can be attributed to curing problems. However, both specimens were treated at the same time and with the same procedure. For the specimen that performed effectively, the topcoat appeared to adhere to the metallic surface without problem for most of the crevice surface. Some orange and dark spots were still visible within the cross section, but overall, the surface was well protected.

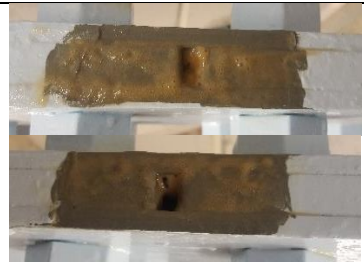
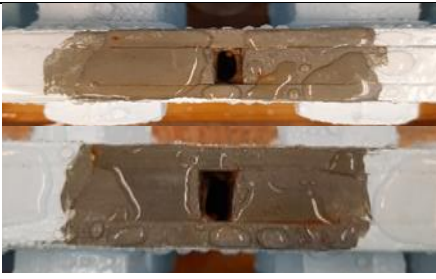
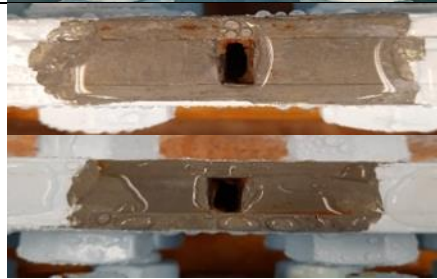
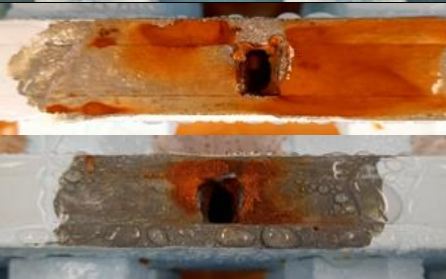
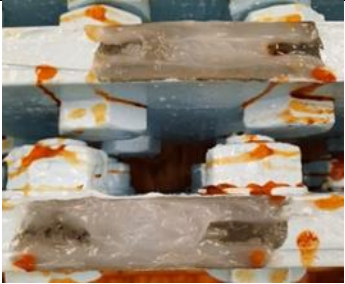
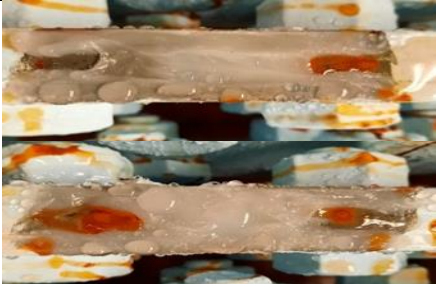
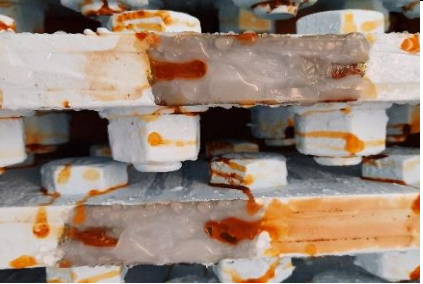
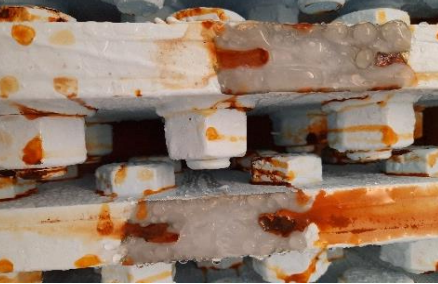
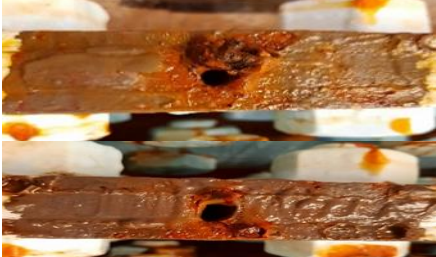
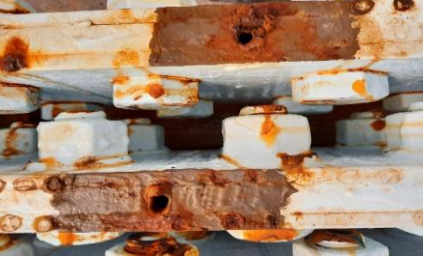
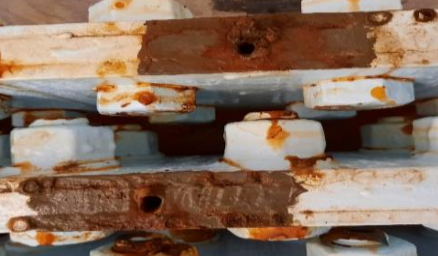
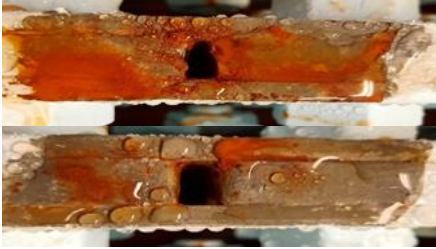
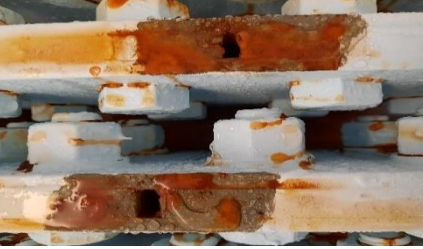
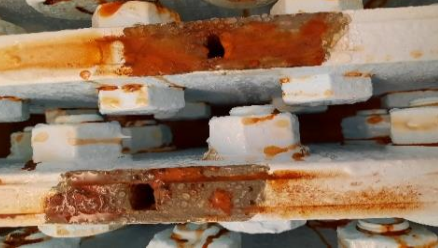
Fluid Film: 27 and 29 (Top).

Condition/ Specimens	Time of exposure			
	90 days (Splices Flipped)	120 days	165 days	172 days/Testing Day
Caulk: 17 and 24 (Top).

Termarust: 25 and 26 (Top).

Remarks	Specimens have been flipped. Black rust dots are observed around the caulk. Termarust has material runoff and some corrosion built up. Fluid Film specimens show some rust staining.	Orange staining appears around the caulk while a few black dots remain, but the caulk shows no degradation. Termarust specimens do not show significant change. Fluid Film staining increases significantly over the last 30 days.	Orange staining around caulk intensifies. Termarust and Fluid Film specimens do not show significant change with respect to the previous stage.	Ultimately, the caulk did not show visible deterioration. Termarust and Fluid Film specimens did not have notable changes in the last 50 days. The level of corrosion staining on the Fluid Film specimens is higher than on Termarust specimens.

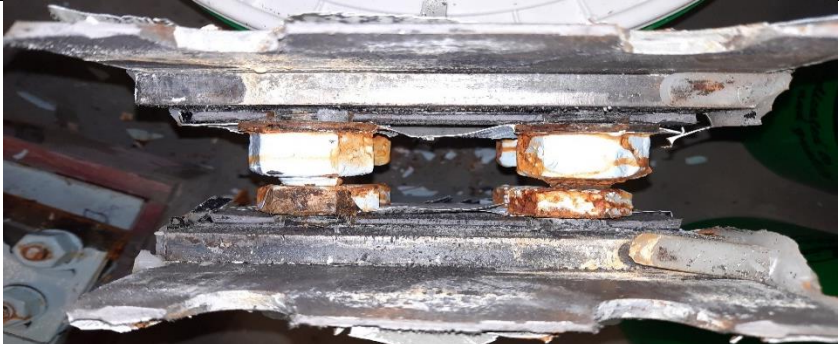
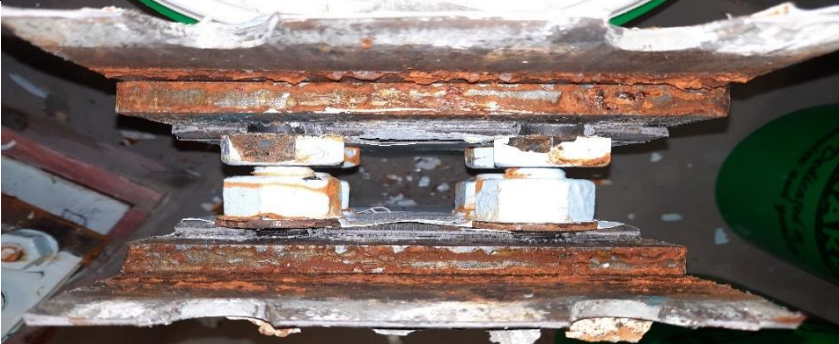
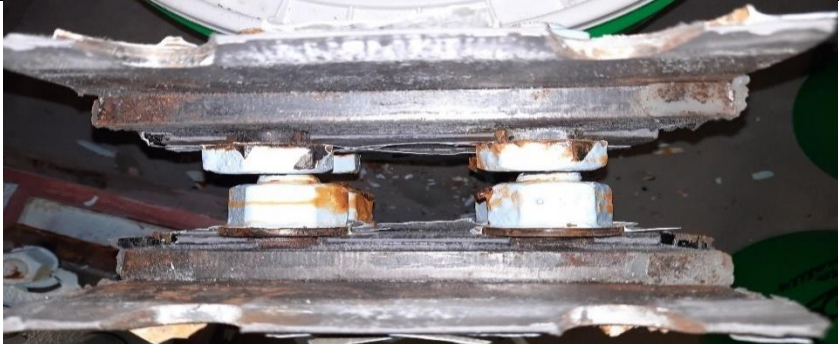
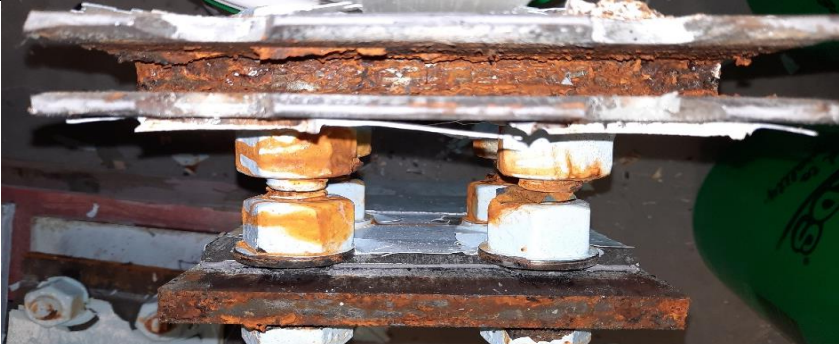
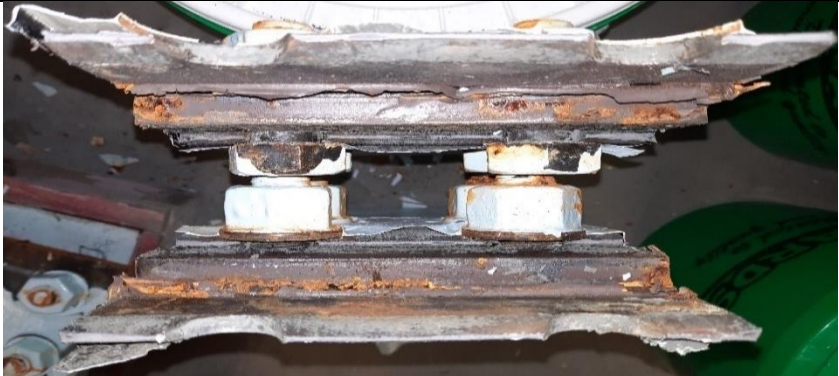
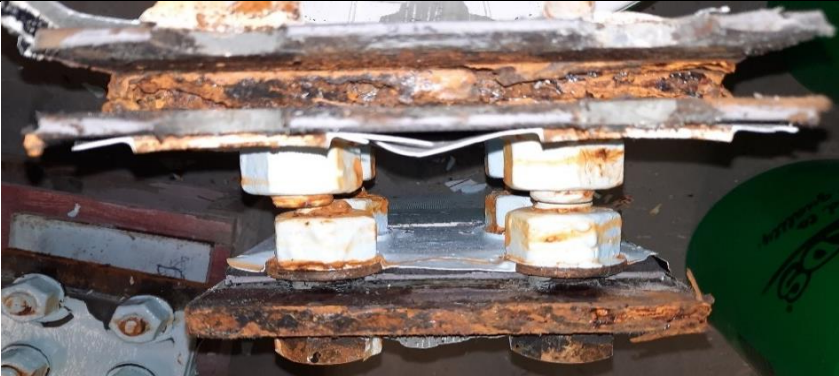
Table 5.6. Rust formation in the cross section of initially treated specimens.

Condition B/Time of exposure: 172 days	
GE Silicone Caulk Specimens 17, 24 (Downwards)	Fluid Film Specimens 27, 29 (Downwards)

Termarust Specimens 25, 26 (Left to Right)

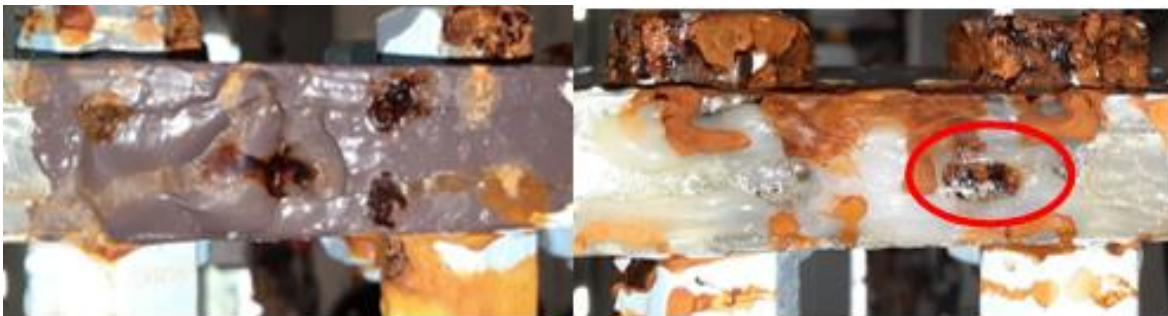
Figure 5.1. Black rust in Termarust (left) and caulked (right) specimens for Condition A.

A and condition B. Black rust staining is observed for the caulked specimens and the Termarust specimens. For the caulked specimens, the formation of black rust is caused by sealing the gap at the ends. During repair, the corrosion products were removed by means of pressure washing. Nonetheless, 100% rust material removal is not guarantee during this step. Consequently, the remaining rust plus the action of sealing the gap is not a recommended step towards mitigating corrosion. For the Termarust specimens, the topcoat did not flow smoothly in the small confined gap. Additionally, it was observed that at the moment strength tests took place, the topcoat inside the specimens was still wet despite the specimens being allowed to cure for three days. The clogging of the gap with the topcoat did not allow air to flow and dry the surfaces. Clogging the gap also allows black rust to form by restricting the air flow in that space. For the Fluid Film specimens, the action of the sacrificial wax is observed again (similar to the initially treated specimens), but concerns regarding its capability to bear more aggressive conditions rose. Likewise, black rust developed in these specimens, but in a moderate degree.

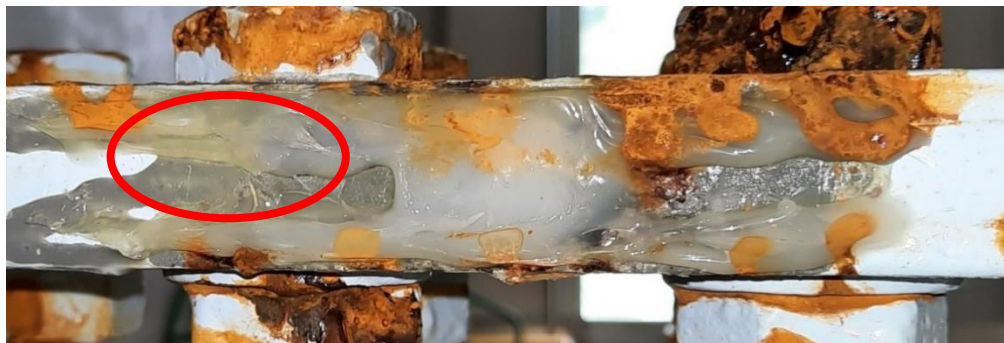
Figure 5.2. Discoloration of caulked specimen.

The specimens that were going to be tested for condition B and then repaired, were exposed to salt misting for 175 days. The overall results for all specimens were catastrophic for the area surrounding the mouth of the crevice. At 35 days after repair, the Termarust protected specimens had already developed considerable surface corrosion. The caulk material and Fluid Film product did not show signs of excessive deterioration. However, 82 days after repair (3 days of curing plus 79 days of misting), the surface surrounding the mouth of the gap was significantly damaged for all specimens. Surface corrosion spread on top of the fluid film wax and the Termarust topcoat. Similar to the caulked and Termarust protected specimens under condition A, black rust was observed on the bottom end of the gap. The caulk material showed discoloration, but not adhesive deficiencies.

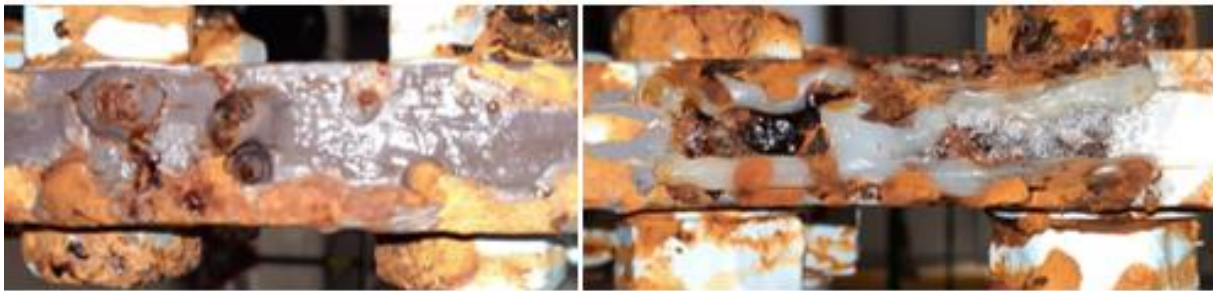
Figure 5.3. Black rust in Termarust (left) and caulked (right) specimens for Condition B.

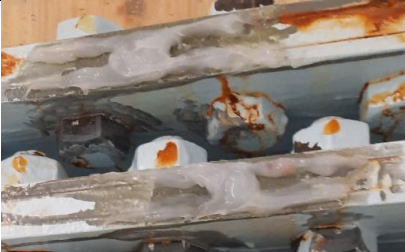
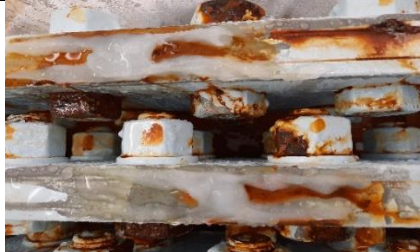
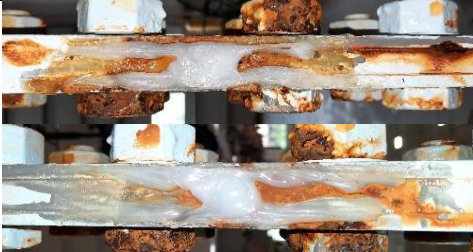
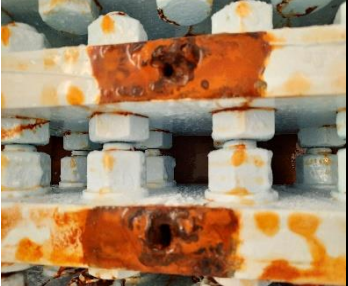
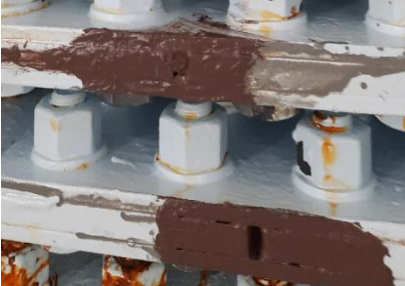
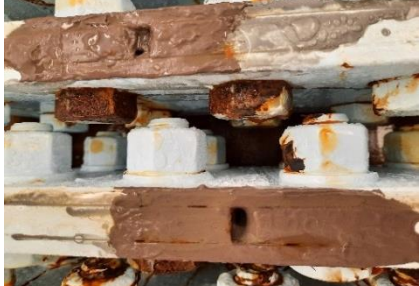
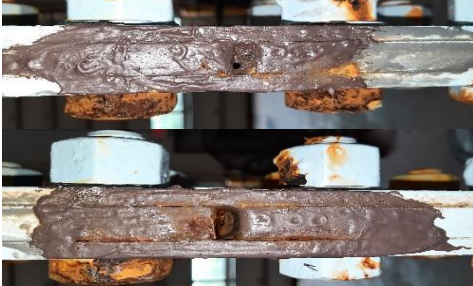
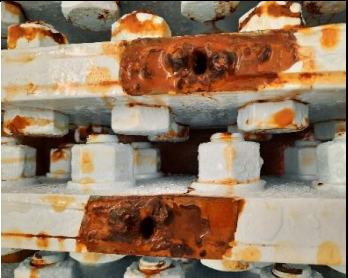
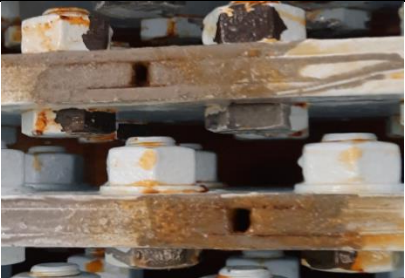
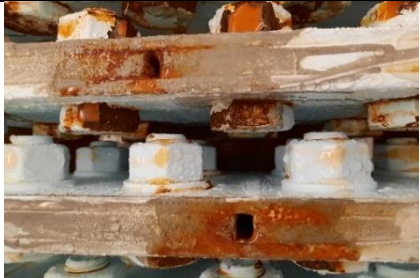
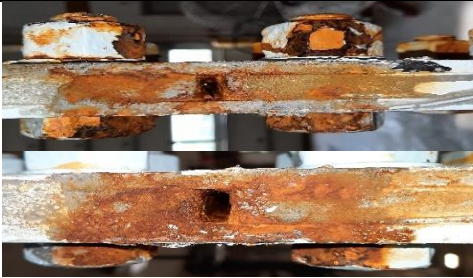
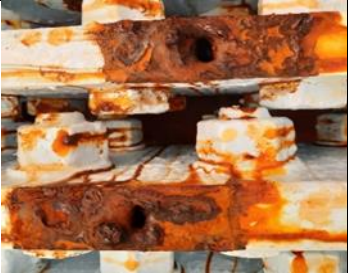
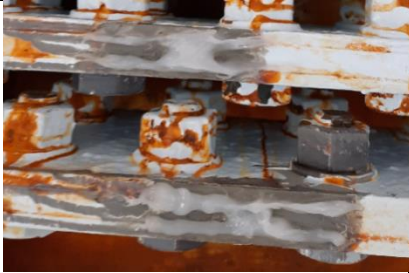
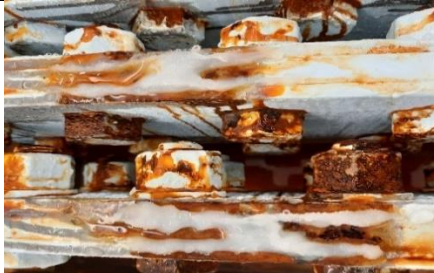
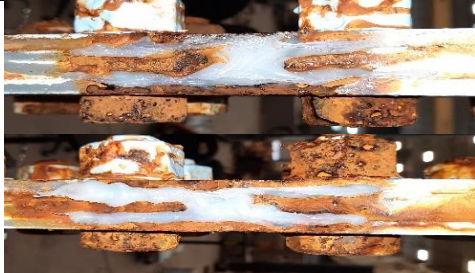
Table 5.7. Comparison between strategies for specimens repaired for condition A and B.

Condition/ Specimens	Time of exposure			
	111 days/Before Repair	111 days/After Repair	30 days After Repair (141 days)	44 days After Repair (155 days)
Caulk: Cond A: 11 (Top) and 24.

Termarust: Cond A: 35 (Top) and 36.

Fluid Film: Cond A: 16 (Top) and 24.

Remarks	Specimens reached condition A of corrosion.	Specimens were pressure washed for removal of pack rust. Then, Rust-Oleum was applied on the outside surface, and the mitigation products were applied.	Significant staining occurs around the caulk, but no caulk degradation. Termarust shows little to none staining. One of the Fluid Film specimens shows significant staining around the mouth of the gap.	The caulk had some yellowish color degradation. Termarust staining had a slight increase in quantity. Fluid Film had significant surface corrosion. The consistency of the material changed from waxy to porous and semi rustic.

Condition/ Specimens	Time of exposure			
	175 days/Before Repair	175 days/After Repair	35 days After Repair (210 days)	82 days After Repair (257 days)
Caulk: Cond B: 20 and 21 (Top).

Remarks	Specimens reached condition B of corrosion.	Specimens were pressure washed for removal of pack rust. Then, Rust-Oleum was applied on the outside surface, and the mitigation products were applied.	There is no sign of caulk degradation. Termarust specimens developed significant surface corrosion. Fluid Film specimens developed some surface corrosion.	Black rust was spotted on the bottom end of the gap for the caulked and Termarust specimens. Caulk had slight yellowish degradation. Termarust and Fluid Film show significant degradation on the surface.

For the first 30 days of Condition A repair, the Termarust topcoat was not affected by the corrosive environment while Fluid Film showed considerable surface corrosion. The caulked specimens showed surface corrosion around the caulk application area, but the caulk product itself did not show any signs of deterioration. At the end of the second repair cycle, Termarust specimens showed a few orangey spots near the plate interfaces. Also, black rust was leaking from the bottom end of the gap for one of the specimens. This means that the topcoat was obstructing air from flowing through the gap. This problem is related to the viscosity of the topcoat and its difficulty to be applied in such a small space.

The Fluid Film wax developed a semi rustic and porous surface around the mouth during misting. This porous surface developed during misting may be indicative of a chemical reaction. The specimens initially treated with Fluid Film were stored in the chambers mostly over the period of time when the pH of the solution was within the recommended range. On the other hand, the specimens repaired with Fluid Film were stored in the chamber over the period of time when the pH solution was slightly below the recommended range. Therefore, it is possible that the Fluid Film product cannot bear progressively acidic environments. Further experimental studies are required to examine this effect. Finally, the caulked specimens showed signs of discoloration, but no problem with adhesion to the metallic material. This can also be attributed to a more corrosive environment during the second period of misting.

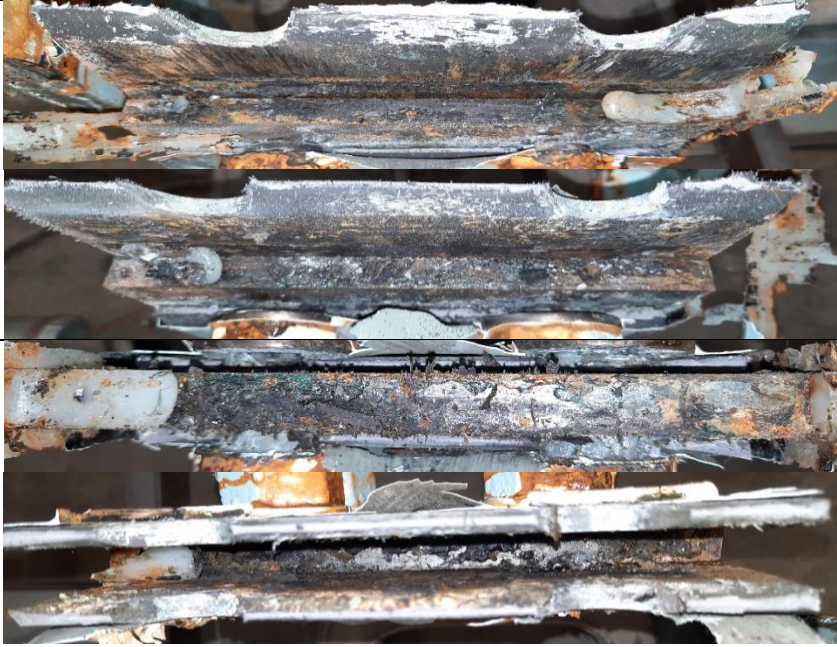
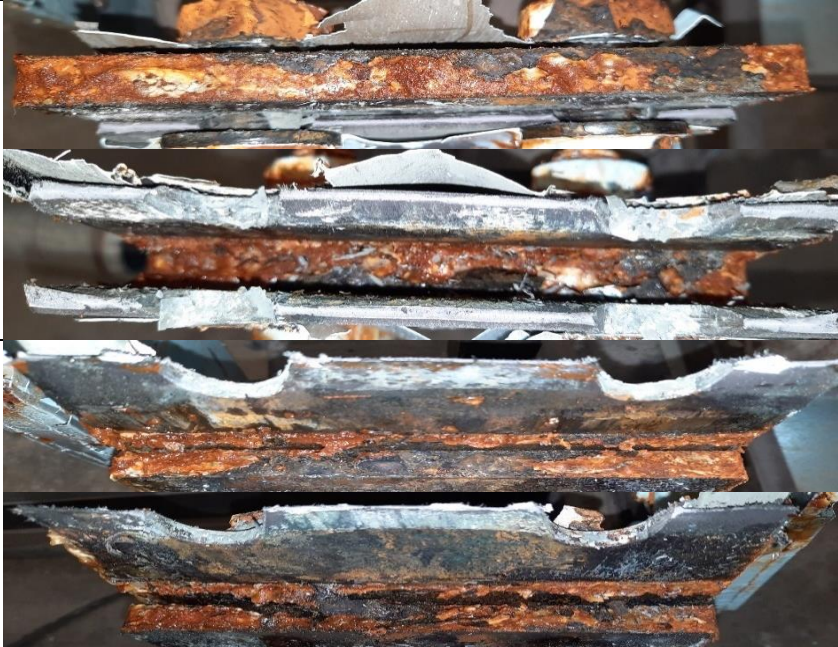
Table 5.8. Rust formation in the cross section of specimens repaired for condition A and B.

Repaired Condition A/Time of exposure: 155 days (44 days after repair)	
GE Silicone Caulk Specimens 11, 12 (Downwards)	Fluid Film 16, 34 Specimens (Downwards)

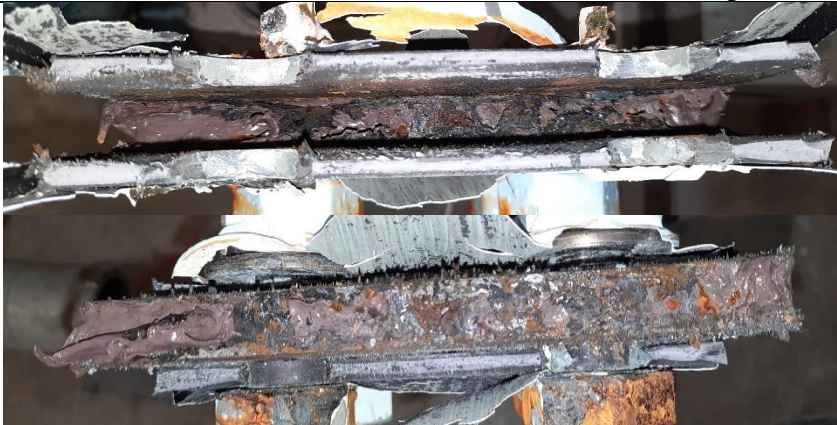
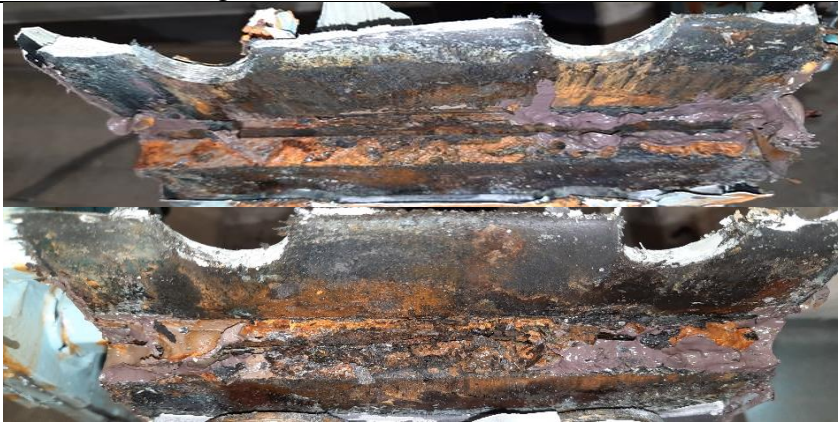
Termarust Specimens 35, 36 (Left to Right)

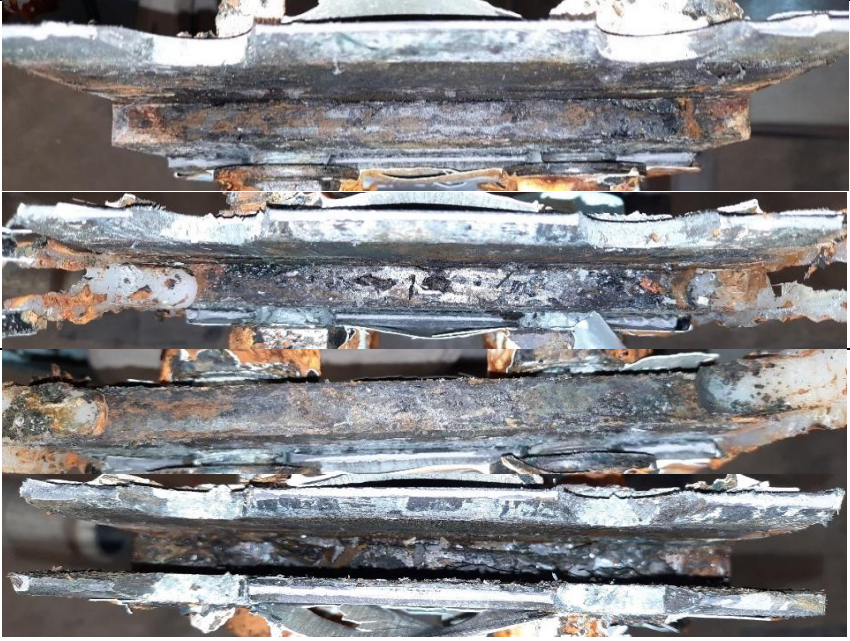
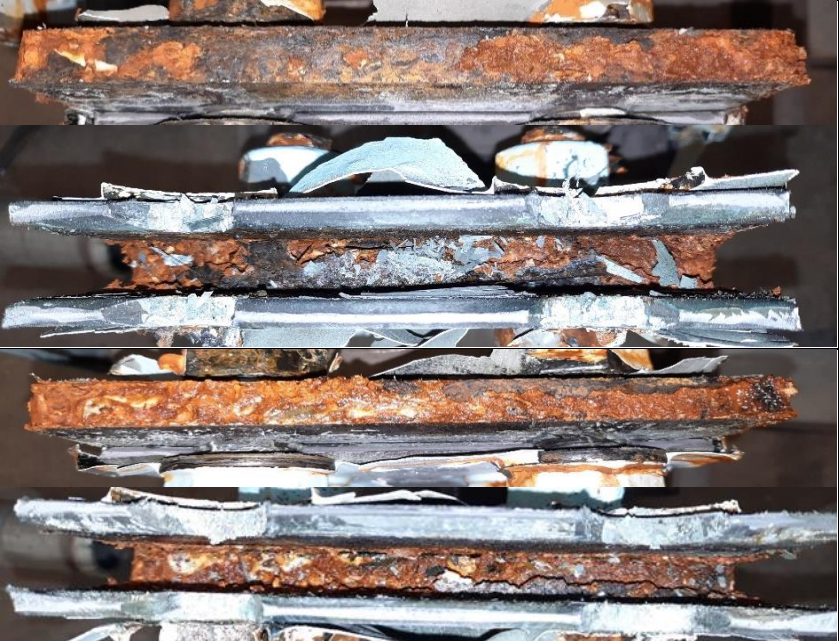
Repaired Condition B/Time of exposure: 257 days (82 days after repair)	
GE Silicone Caulk Specimens 20, 21 (Downwards)	Fluid Film Specimens 4, 23 (Downwards)

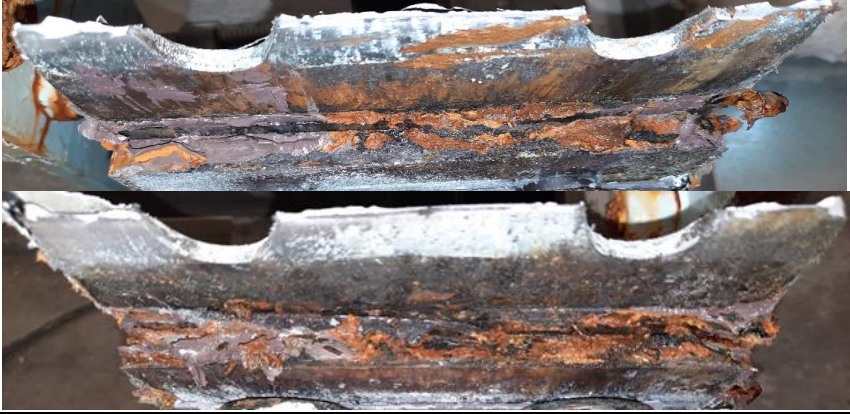
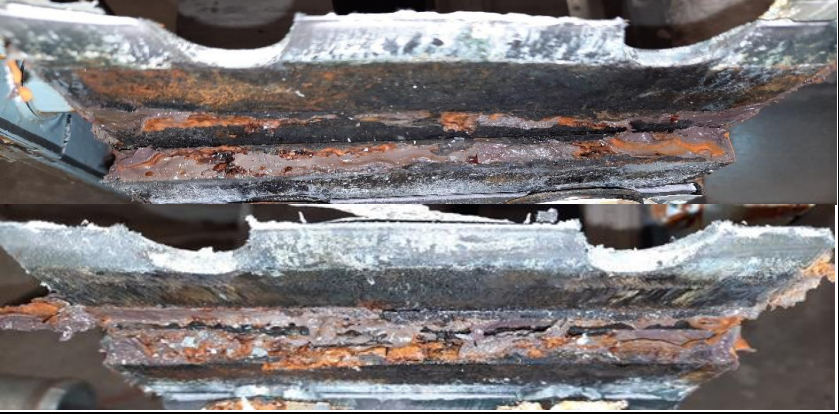
Termarust Specimens 22, 28 (Left to Right)

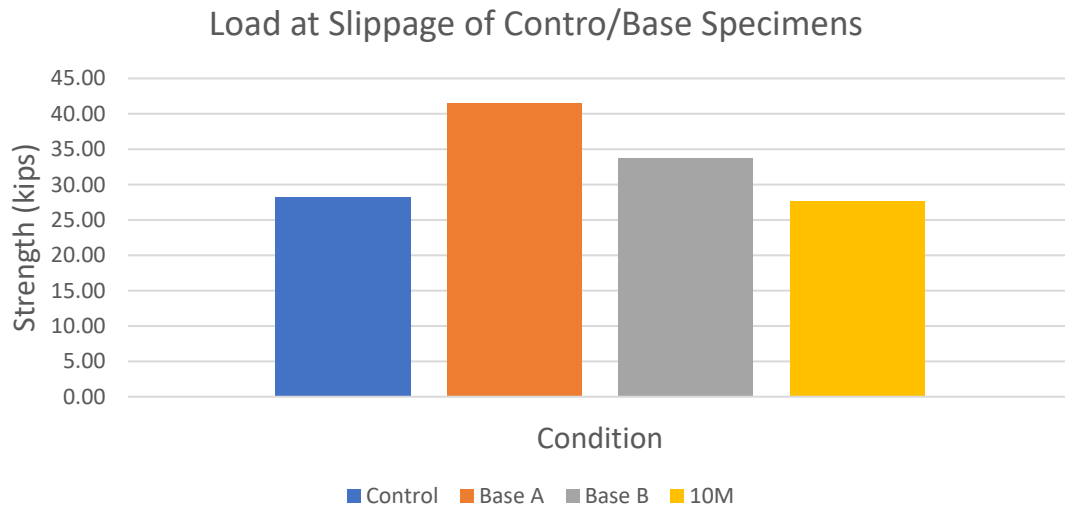
Figure 5.4. Load at slippage of control and base corroded specimens.

The slip resistance of the connection increased with the presence of corrosion within the gap. However, it decreased after further corrosion developed. As seen in the Table 5.10 and Figure 5.4, the load at slippage increased for Base A specimens and later decreased for Base B and 10M specimens. The increase in slippage load may be attributed to the formation of rust in the gap, which “glued” the middle plates, allowing for an “extra” resistance for slippage. During tension testing, snapping sounds were heard, which probably means that the bonding effects of the “gluing” rust was being broken.

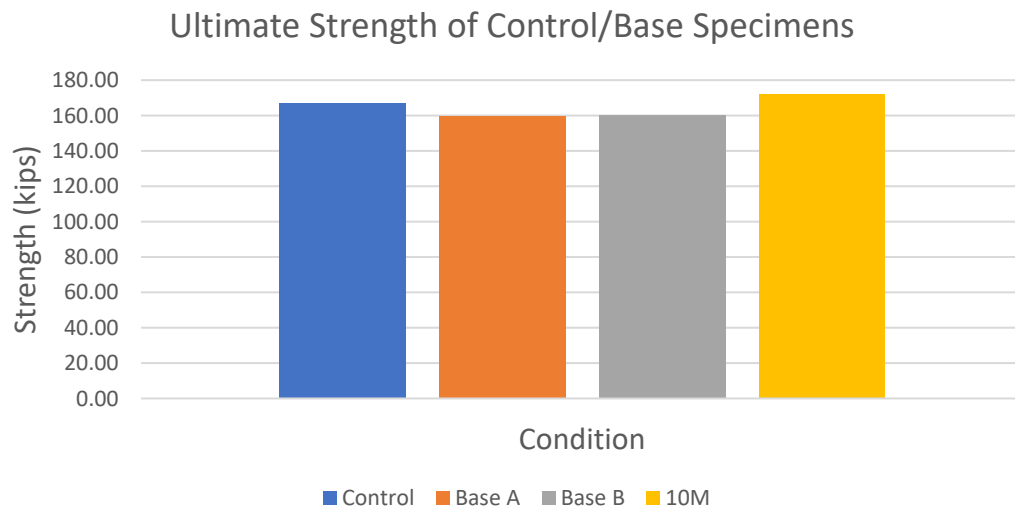
Figure 5.5. Ultimate load of control and base corroded specimens.

With respect to ultimate strength, there is not an identified pattern. Base A and Base B specimens exhibited an approximate 4% strength reduction with respect to the control specimens. However, the 10M specimens exhibited 3% higher strength than the control specimens. It is important to spotlight that only 2 10M specimens were tested due to limited material. The results are an indicator that there is variability of the connection strength due to the variability of material strength, and not due to corrosion deterioration.

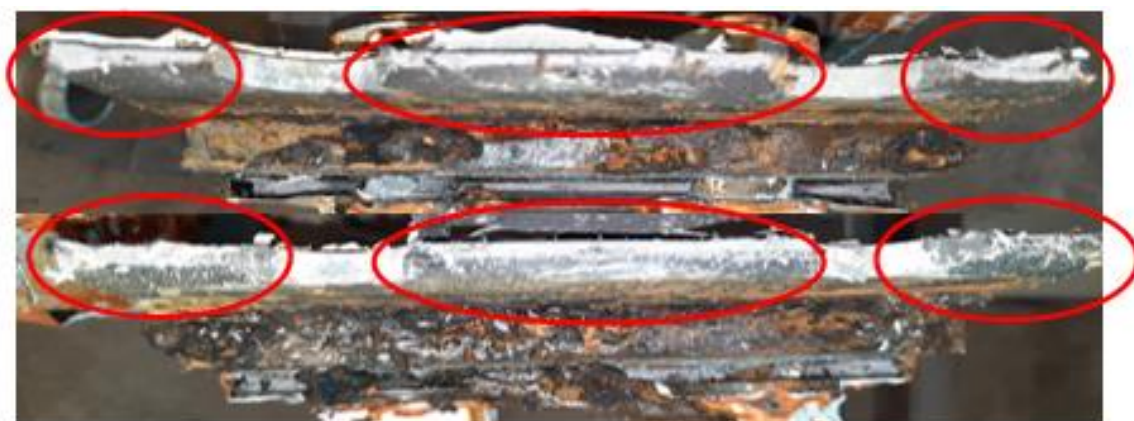
Figure 5.6. Specimen 19 cross-sectional area, exposed to 284 days of corrosion.

Additionally, there is no physical evidence that the corrosion affected the cross-sectional area where the fracture failure occurred. Figure 5.6 shows that the area where the fracture occurred is mostly clean and exhibited ductile behavior. Only some rust staining was able to reach that zone because the specimens were protected with the coating system on the sides, not allowing the salt solution to infiltrate. Photographs of the cross-sectional areas can be seen in the qualitative analysis section. Finally, it can be determined that there is conclusive evidence that no deterioration of the connections occurred due to the corrosion produced under the set of conditions established in this experiment.

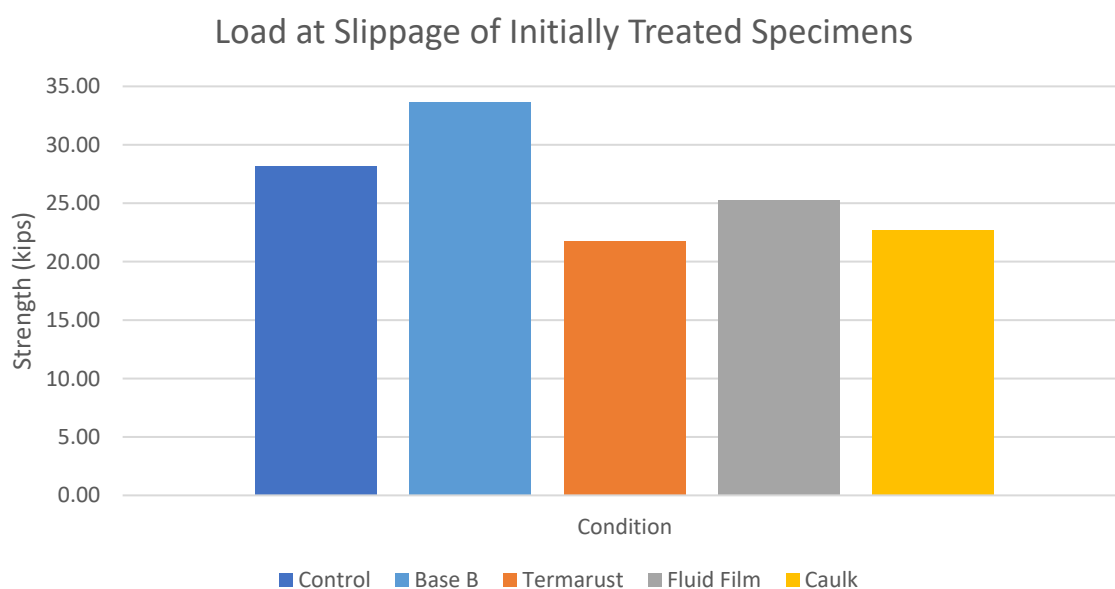
Figure 5.7. Load at slippage of initially treated specimens.

The results for slip resistance demonstrate that specimens exposed to corrosion without any protection on the crevice exhibited higher slip resistance than those without exposure to corrosion (control) and those treated with the mitigating products. These results strengthen the idea that corrosion contributed to the slip resistance of specimens. Specimens that were initially treated did not develop considerable corrosion within the gap region in comparison to the Base B specimens.

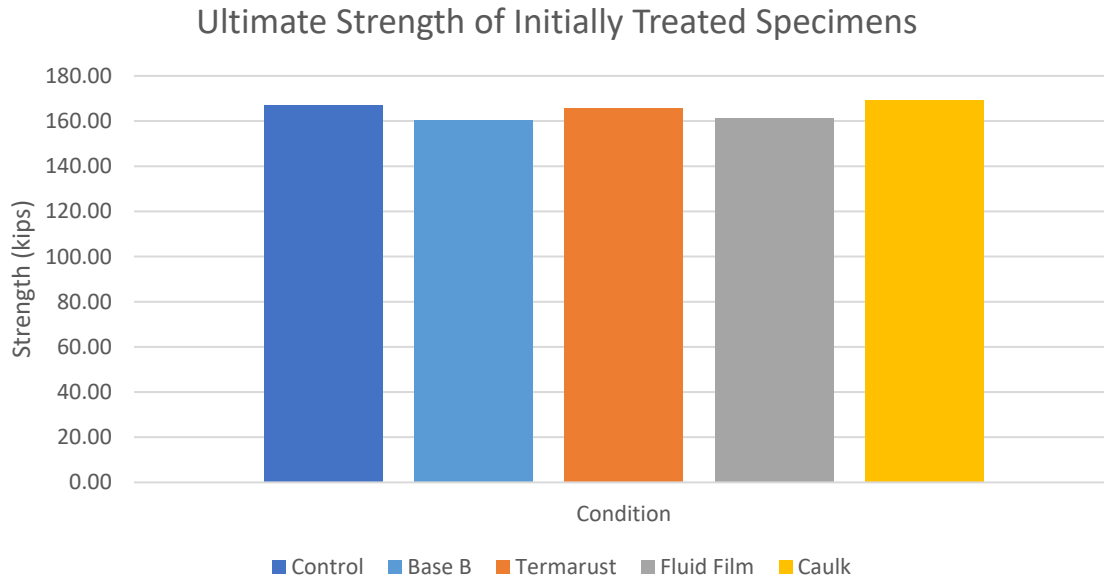
Figure 5.8. Ultimate load of initially treated specimens.

In regards to ultimate strength, deterioration of the specimens did not take place from the data point of view. Even though all the strength values for the initially treated specimens were higher than the strength value for Base B specimens, the relative difference is not significant due to the presence of material variability. Based on the cross-sectional area, Base B specimens were already expected to yield lower values of ultimate strength in this group of specimens in Table 5.11. Moreover, cross-sectional loss was not observed around the area where the fractures occurred, as depicted in the photographs in Section 5.1.2. Therefore, the performance of the mitigating products cannot be assessed directly from the ultimate strength results. The final remarks will rely mostly on the visual inspections of the corrosion prevention.

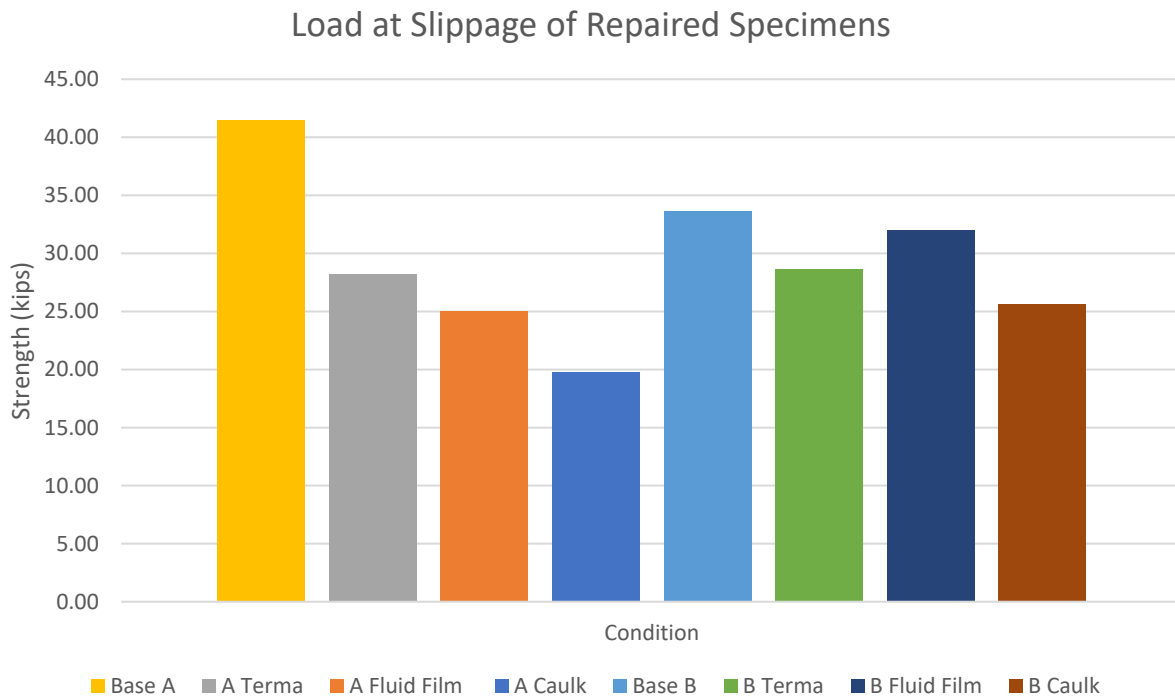
Figure 5.9. Load at slippage of base and repaired A specimens.

The slip resistance of the connection decreased after the connections were repaired for both condition A and B. The difference in slip resistance between Base and Repaired A specimens is more remarkable than for condition B specimens. This might be related to the time of exposure after repair. While rust removal was applied in the same manner for both types of specimens, condition B specimens were exposed for a significantly longer time after repair. Condition A specimens were placed in the chambers for a second cycle of misting of 41 days while condition B specimens were placed back in the chambers for a second cycle of misting of 79 days. The difference in time of exposure allows for more formation of rust within the gap. Nonetheless, based on the cross-sectional photographs for repaired condition A and B, there is not much difference in corrosion material formation for these two conditions that is evident in the gap region after the specimens have been fractured and the gap region can be inspected.

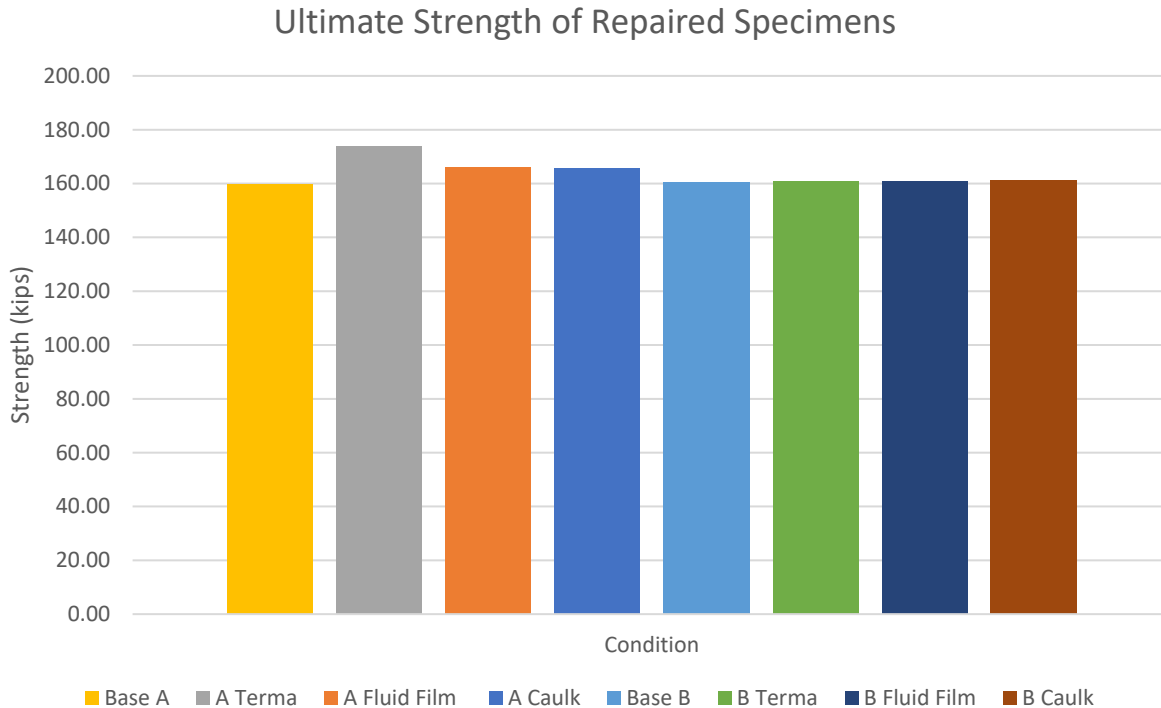
Figure 5.10. Ultimate load of base and repaired specimens.

With respect to the ultimate strength of the connections, the same conclusion obtained from section 5.2.1 and 5.2.2 is reached in this section. The fact that the repaired specimens did not experience further strength reduction cannot be attributed to the effectiveness of the mitigating products. The

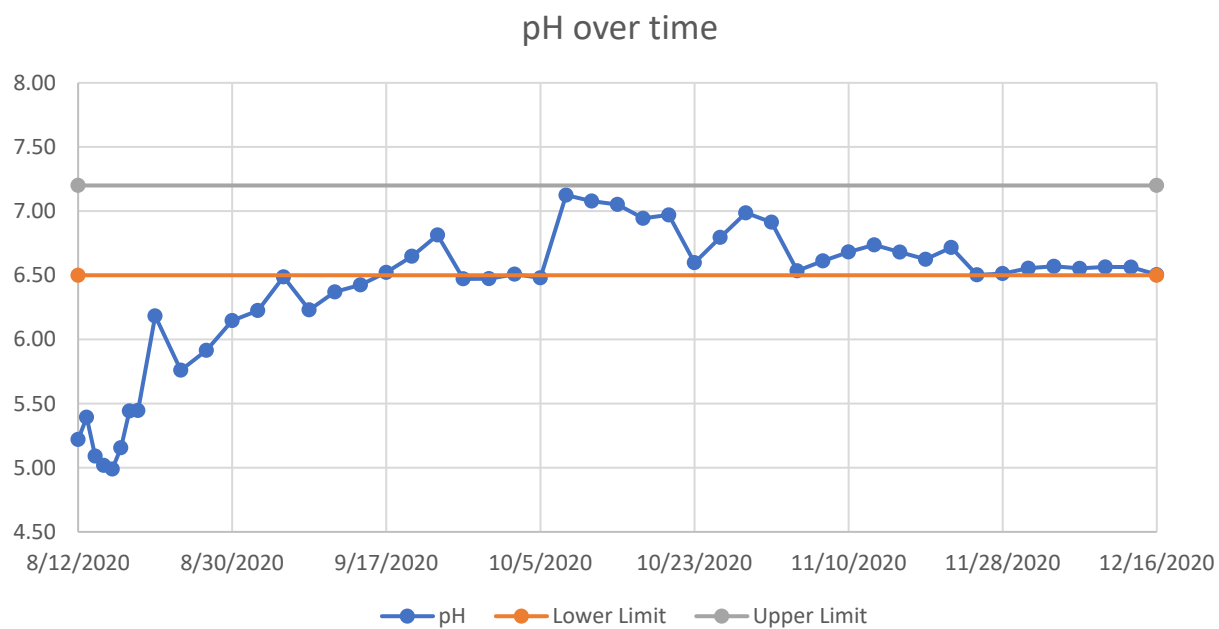
Figure A.1. pH measurements for the first period of misting.

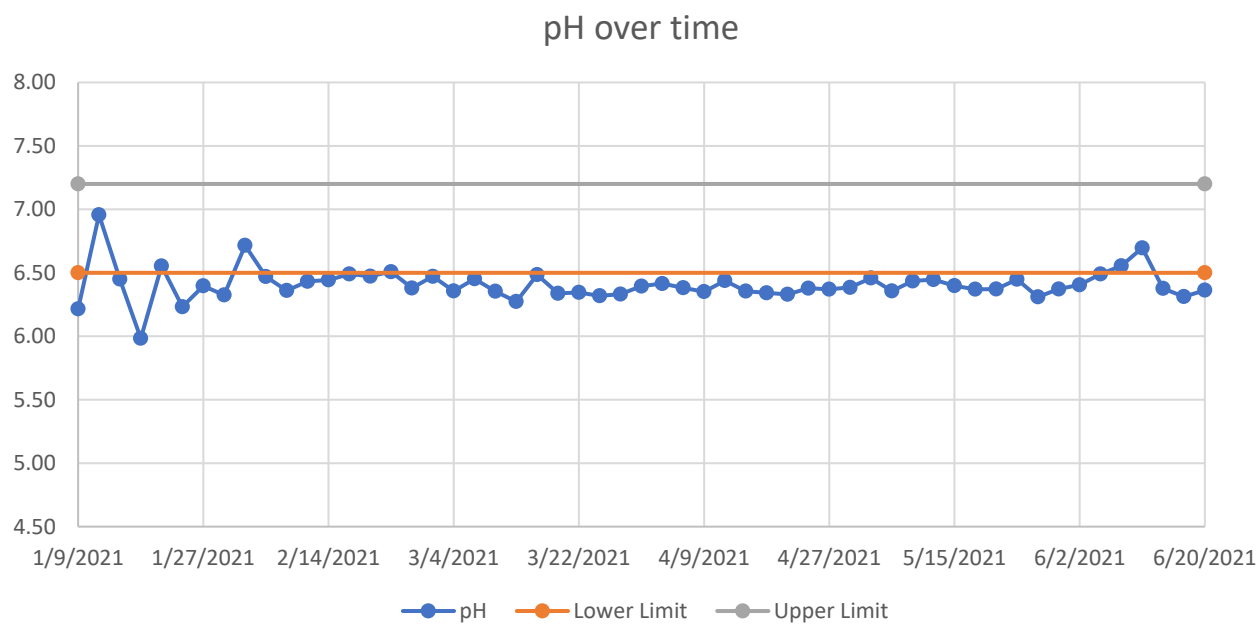
Figure A.2. pH measurements for the second period of misting.

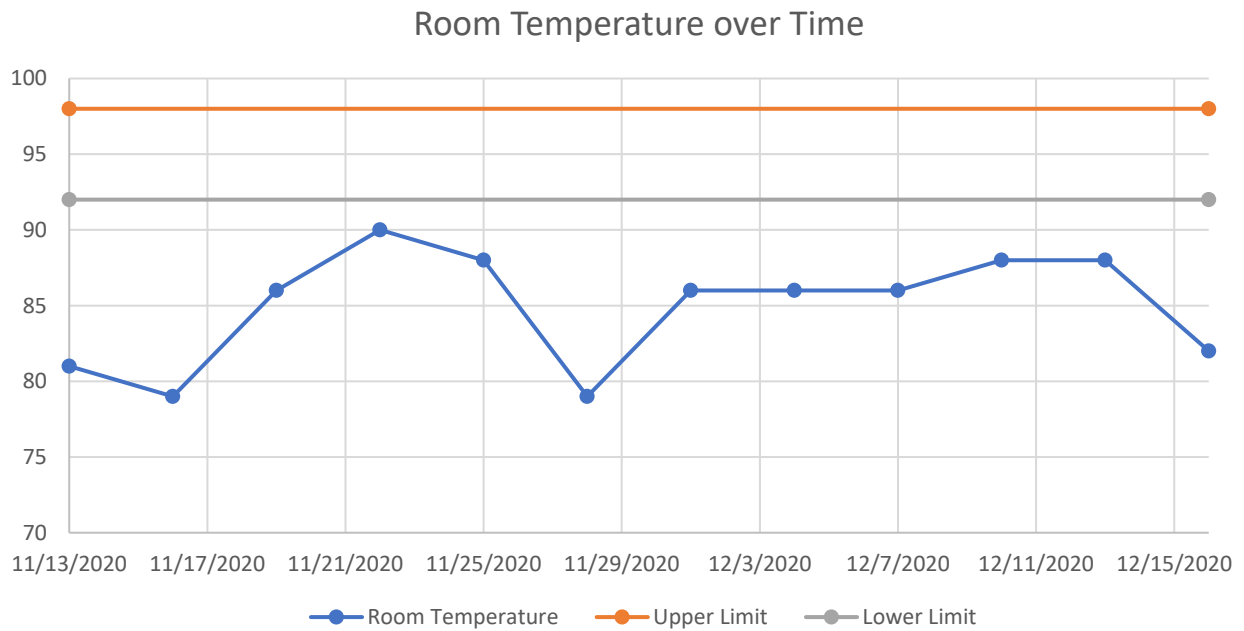
Figure A.3. Temperature measurements for the first period of misting
