CORROSION MITIGATION STRATEGIES FOR FLANGE SPLICE CONNECTIONS IN STEEL BRIDGES

A Thesis

Master of Science in Civil Engineering

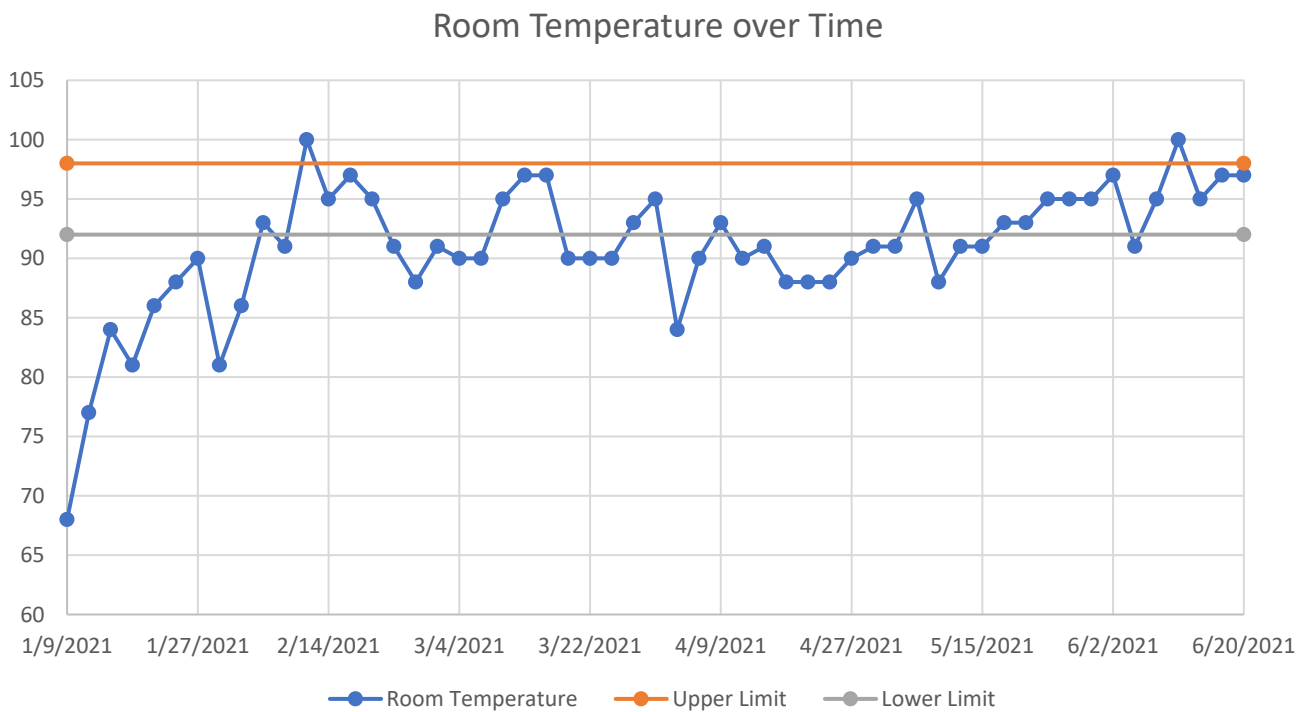
Figure A.4. Temperature measurements for the second period of misting.

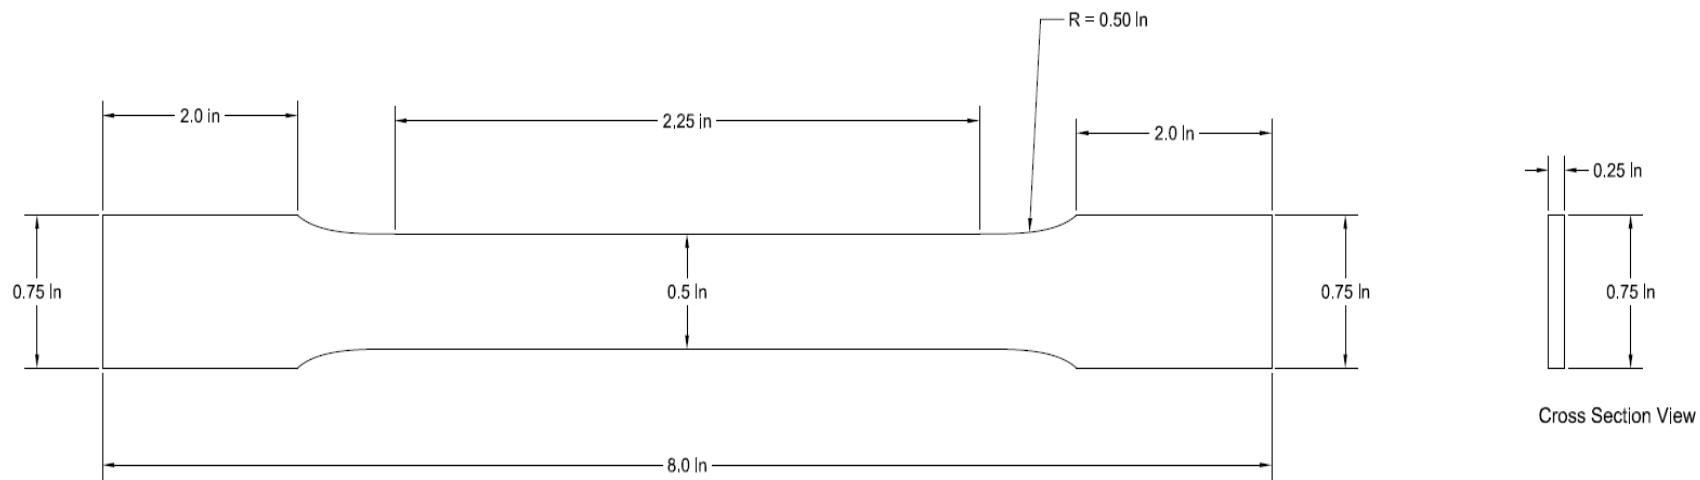
Figure B.1. Coupon geometry for splice plates.

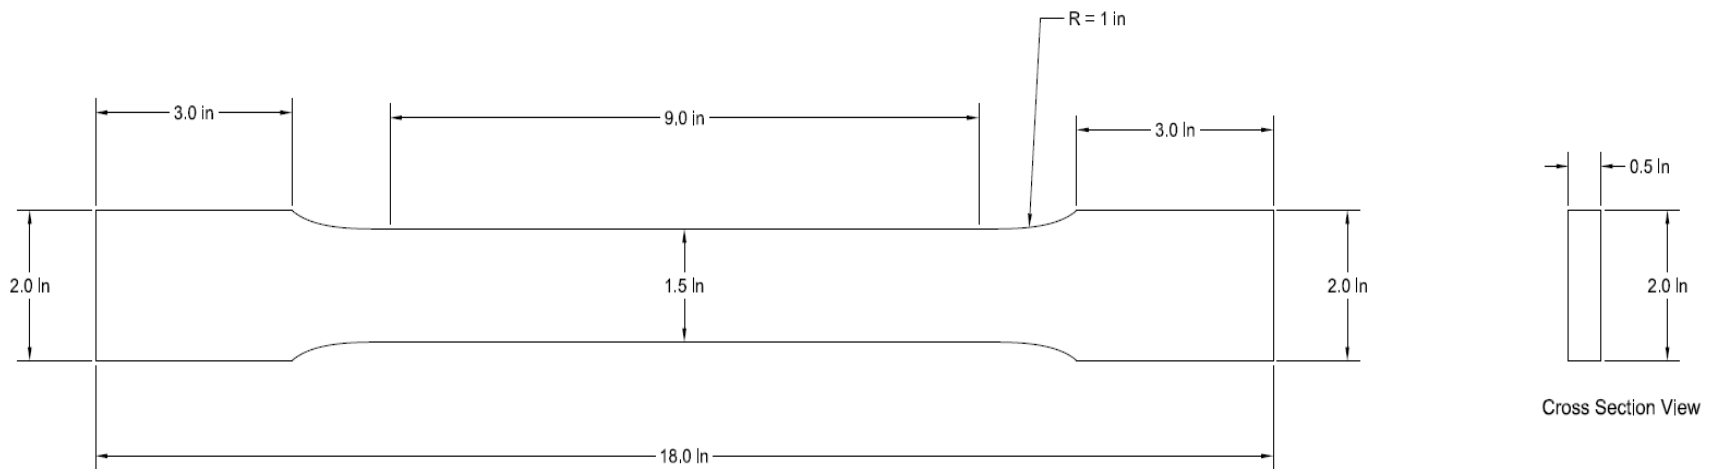
Figure B.2. Coupon geometry for middle plates.

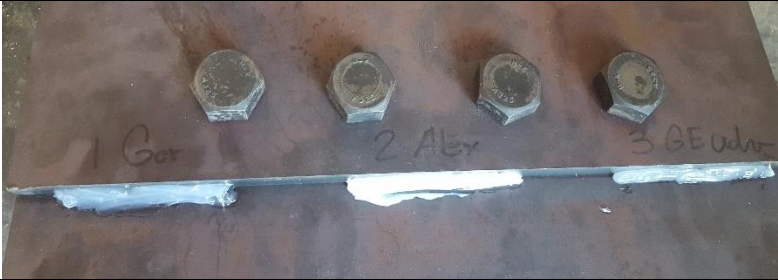
Caulking products are applied at the interface of the plate elements.
7 days

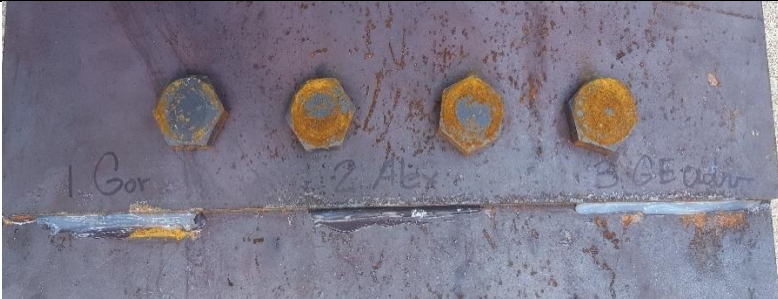
Gorilla and GE are in good shape. Alex Plus shrank a significant amount.
26 days

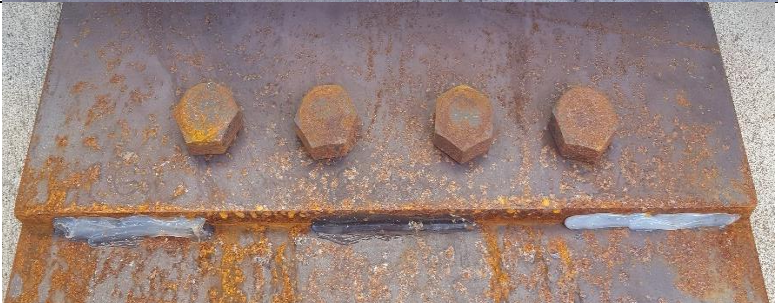
Gorilla and GE are in good shape. Alex Plus has vanished.
87 days

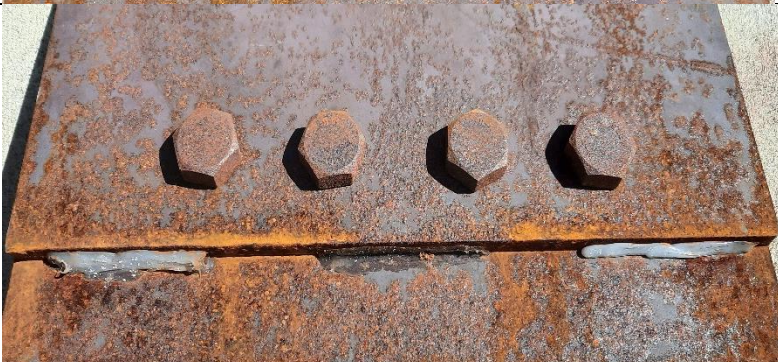
Gorilla showed some signs of discoloration, and lost adhesion in a corner. GE also lost adhesion in a corner.
